BUTTERWORTH QUARRY

ENVIRONMENTAL PERFORMANCE ASSESSMENT / ENVIRONMENTAL AUDIT REPORT

DMRE REFERENCE NUMBER:	EC 30/5/1/2/2/0183 MR
AUDIT PERIOD:	August 2023 – May 2024

Right Number:	EC 30/5/1/2/2/0183 MR	Date of Commencement:	January 2010
Site Name:	Butterworth Quarry	Inspection Date:	22 May 2024
Right Holder:	Transkei Quarries (Pty) Ltd	Other Authorisations:	General Authorisation: 27/2/2/T420/2/1
Report Number:	02

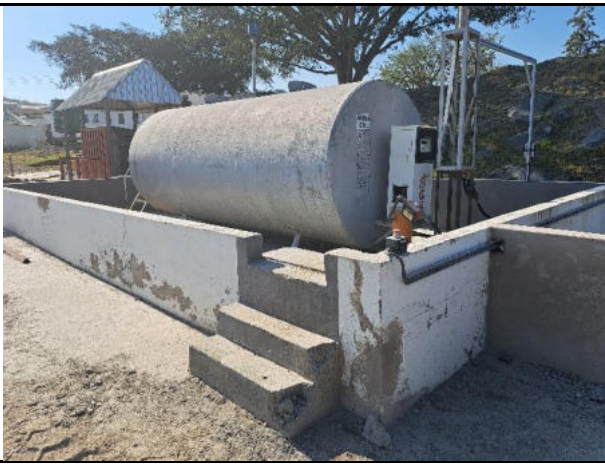
Diesel tank bund wall to be sealed

As mentioned earlier, the bunds of the diesel tank, used oil tank and generator must be sealed and management must ensure that the bunds are large enough to contain 110% of the liquid stored within.

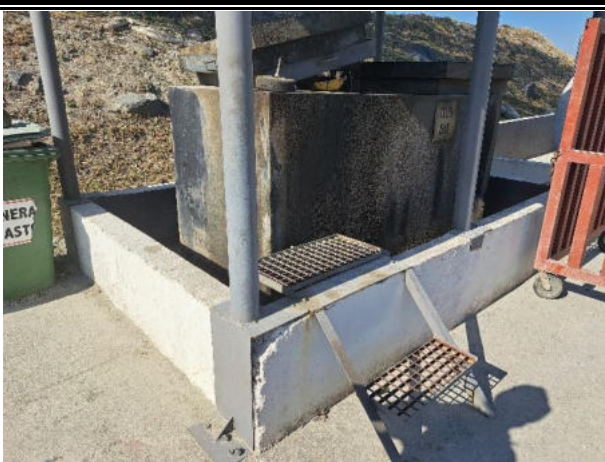
Used oil tank bund to be sealed

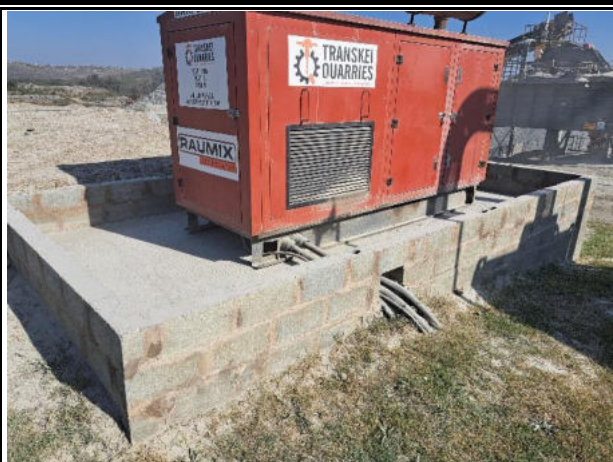
Generator bund to be sealed

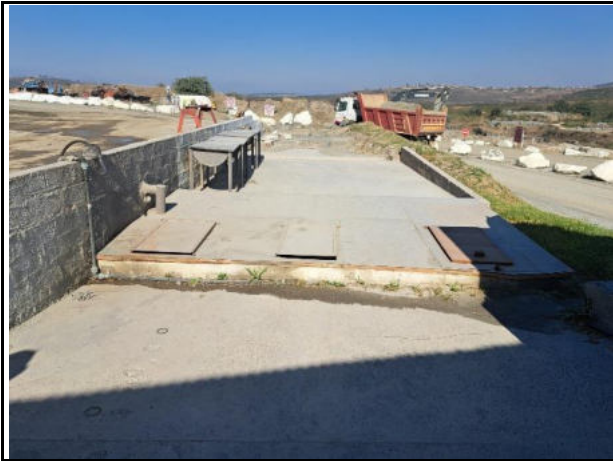
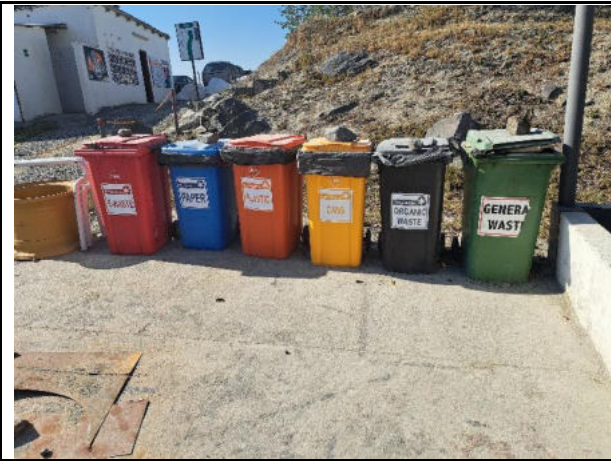
Bioremediation of soil in progress

Refuse bins available – hazardous waste bin to be added

A hazardous waste bin must be added at especially the workshop where hazardous waste such as oil rags etc. can be deposited. This waste must then be removed from site by the hazardous waste handling contractor and proof must be filed.

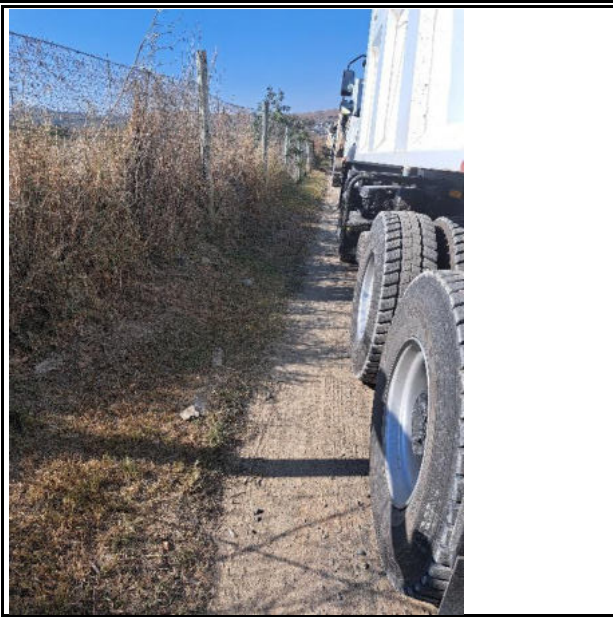
Litter cleaned from truck entrance

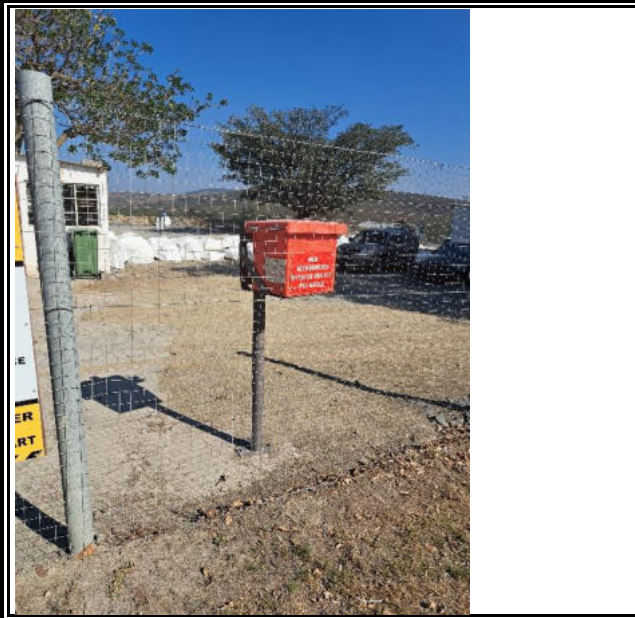
Complaints box to be signposted

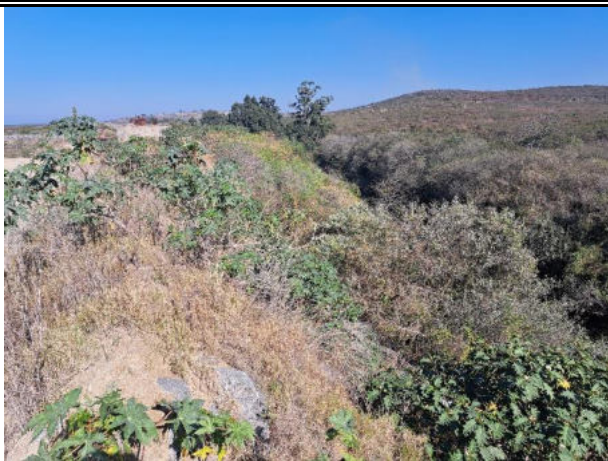
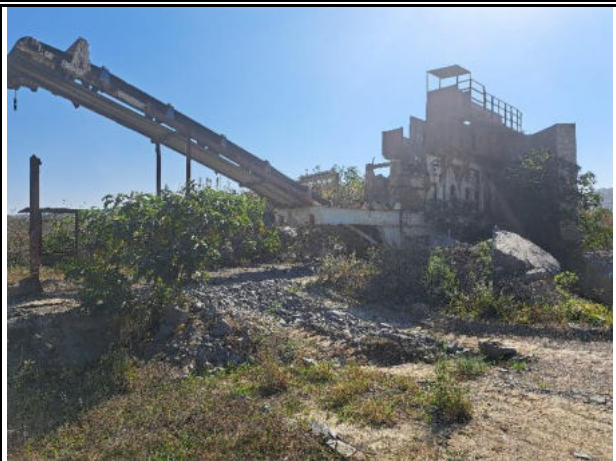
Problem plants to be removed

Site management removed the problem plants that re-established in zones 1, 4-6, and 12. Unfortunately the mine and surrounding areas are heavily infested with invader plant species such as Bugweed (*Solanum mauritianum*), Castor-oil (*Ricinus communis*), and Seringa (*Melia azedarach*) that requires constant management. It is proposed that the cleared areas are sown with indigenous grass species to minimise the denuded areas and lessen the re-occurrence of problem species.

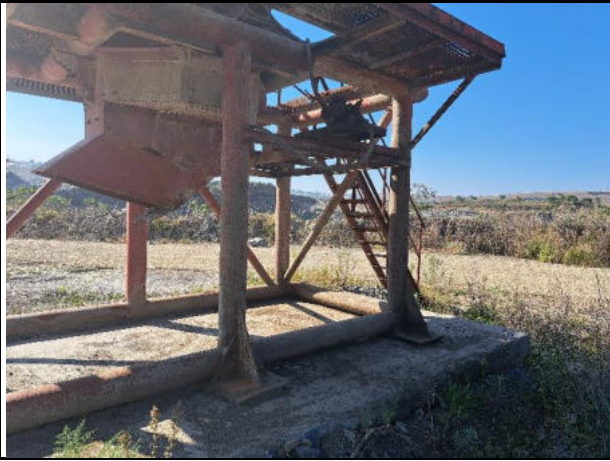
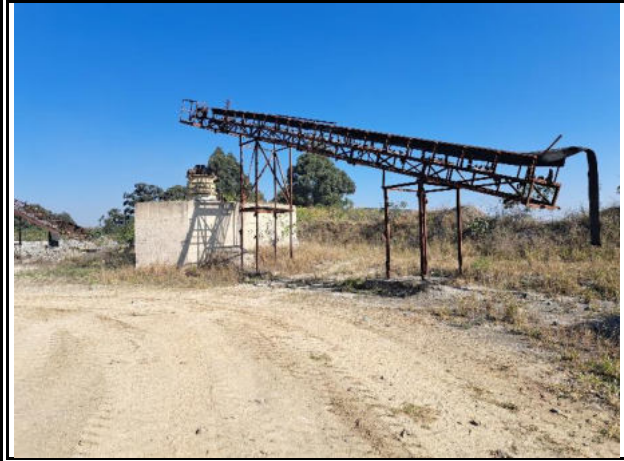
Old plant being removed

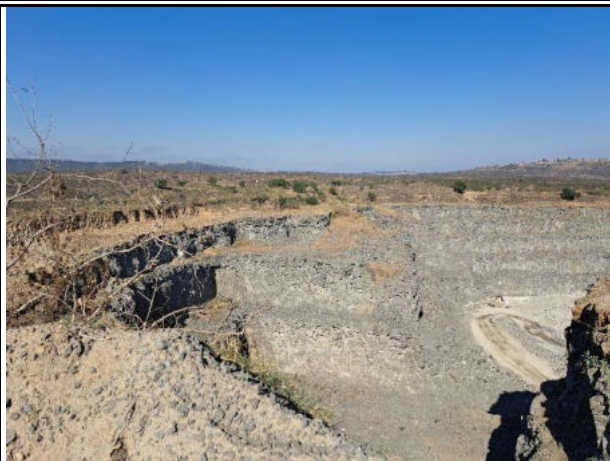
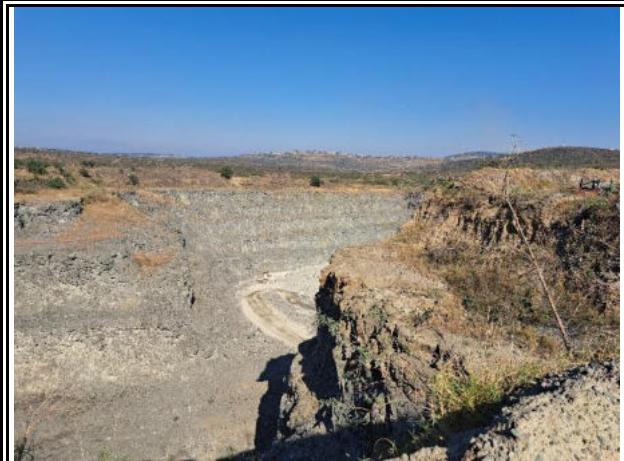
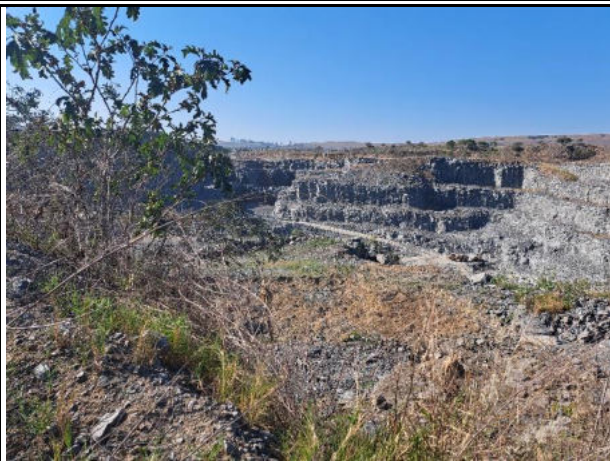
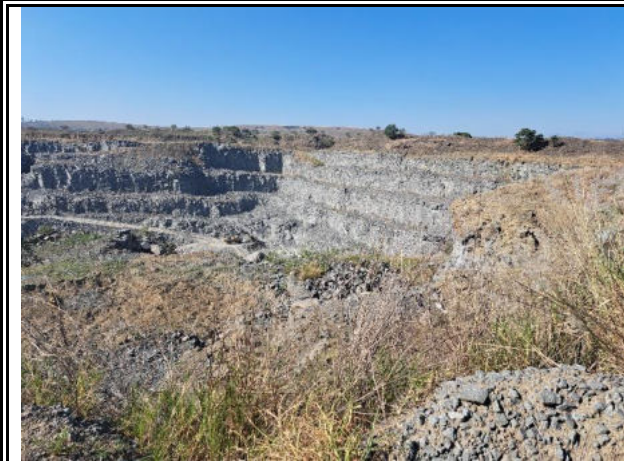
Alien invader plants to be removed

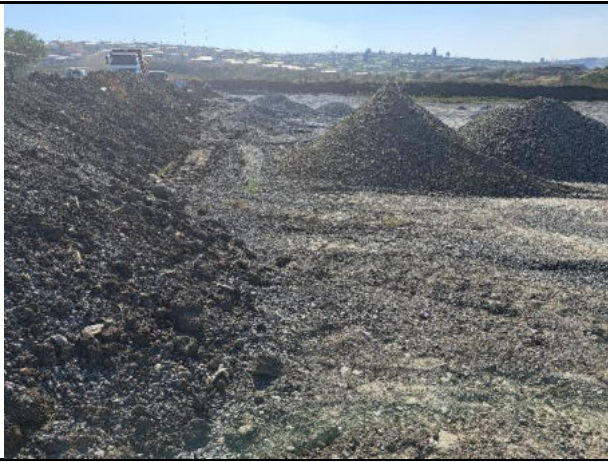
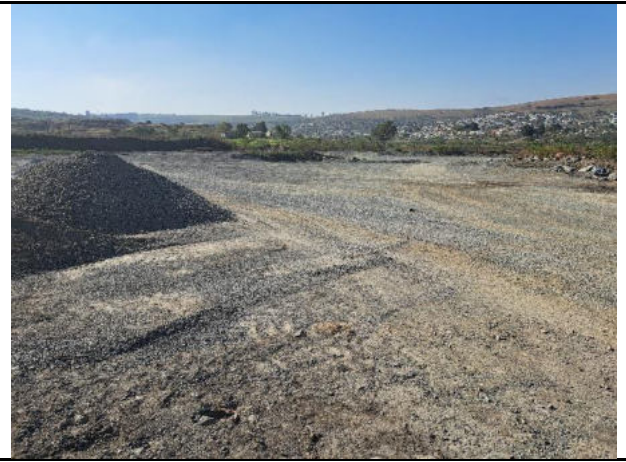
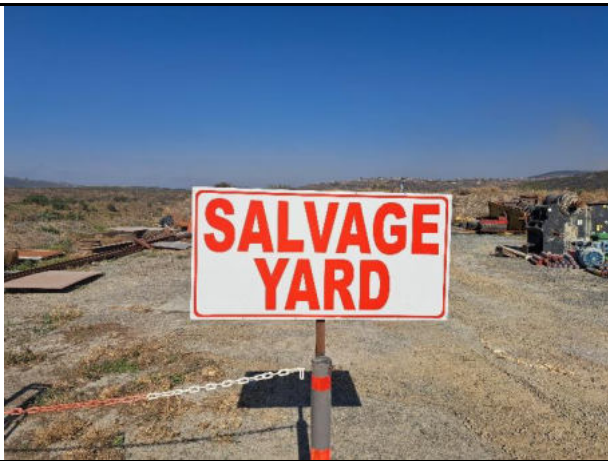
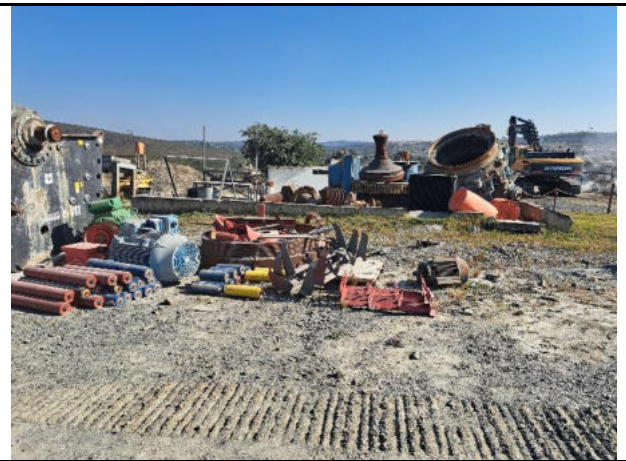
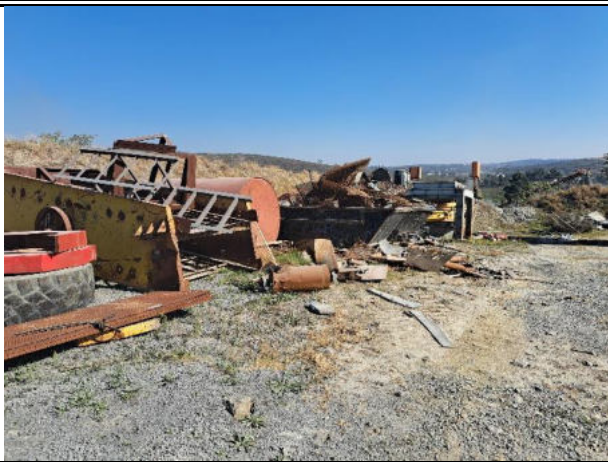
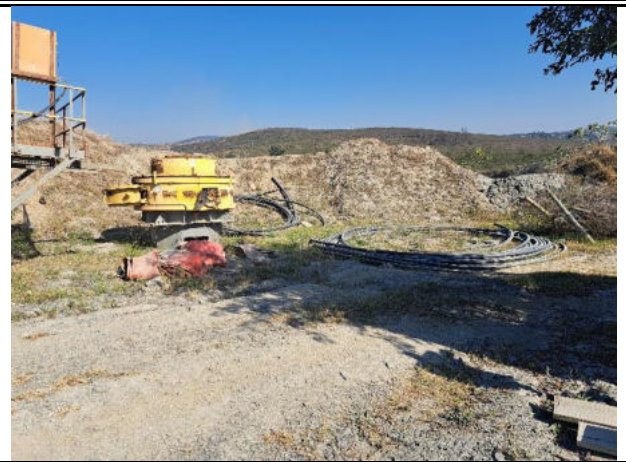
Cleaned salvage yard with sediment trap in the stormwater berm
