**INSPECTION SHEET ENVIRONMENTAL CONTROL OFFICER**

**SAND MINE ON A PORTION OF THE FARM DE  
KLERKSKRAAL 231 IN THE THEUNISSEN DISTRICT,  
FREE STATE PROVINCE**

**ENVIRONMENTAL AUDIT REPORT**

<b>Permit Number:</b>	FS30/5/1/3/2/10207MP	<b>Date of Commencement:</b>	November 2019
<b>Site Name:</b>	De Klerkskraal Quarry	<b>Inspection Date:</b>	28 January 2021
<b>Permit Holder:</b>	Blazecor 226 CC	<b>Other Authorisations:</b>	4 March 2017
<b>Report Number:</b>	10

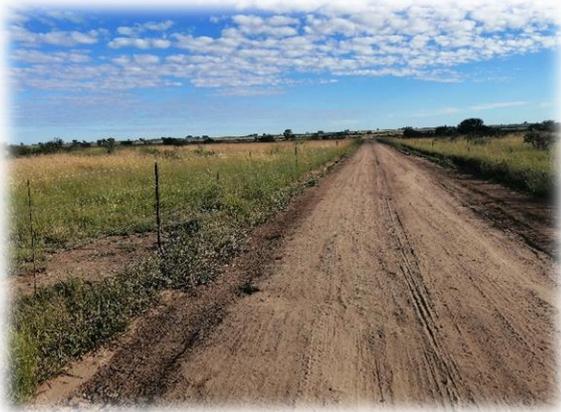
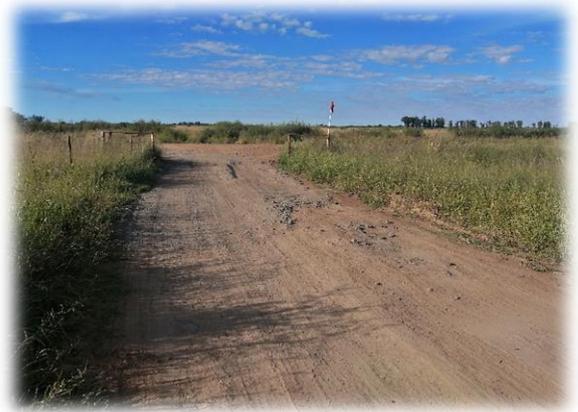
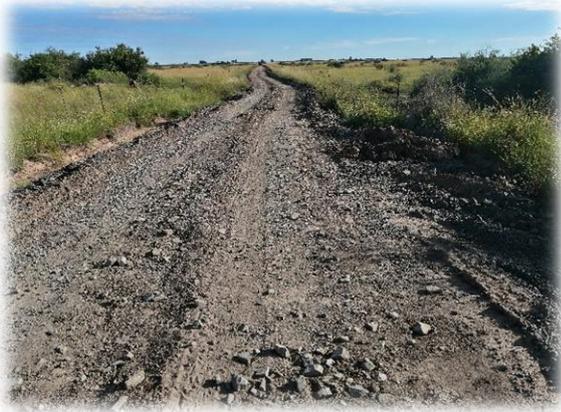
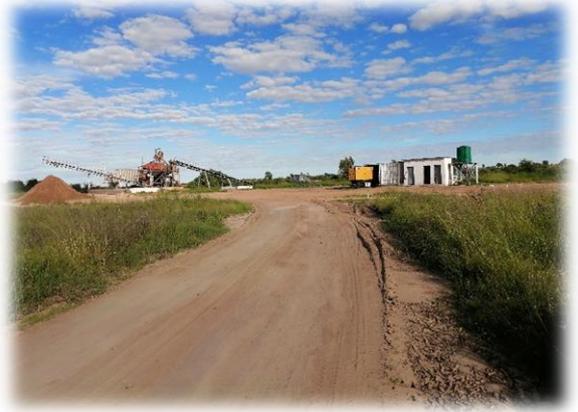
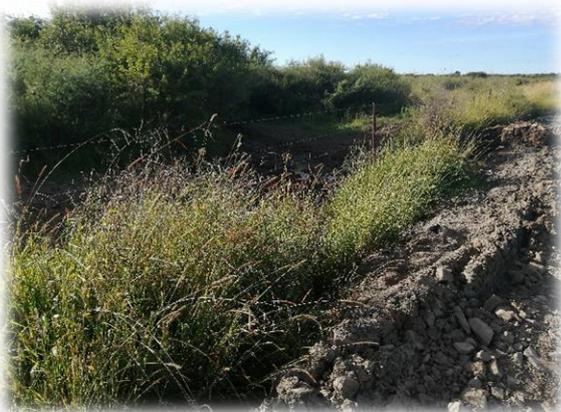
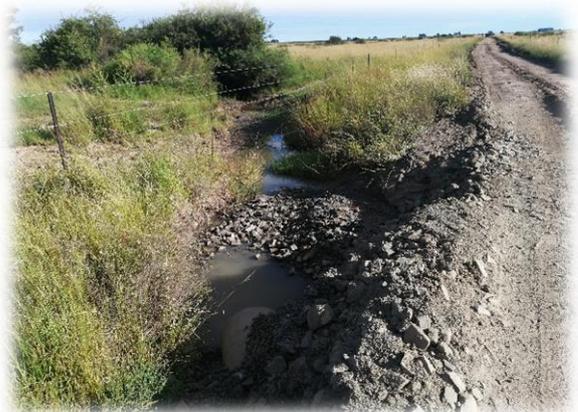
**MINING ACCESS ROAD**

High velocity and volume flow during the previous weeks have resulted in some of the stabilizing material being washed away. This is mainly due to inappropriate culvert size

A larger culvert should be installed and the stabilizing material re-applied following the rainy season.

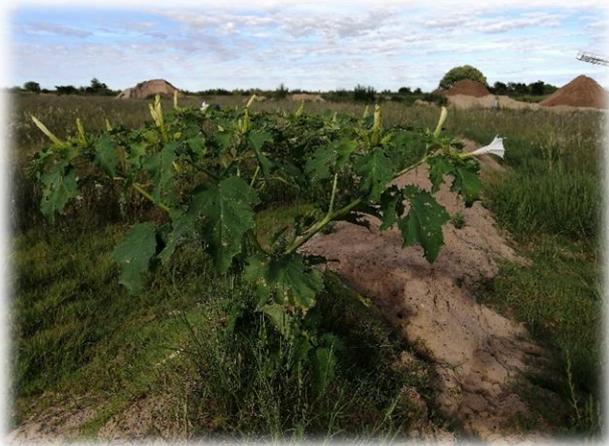
- One activity requires the consideration of mitigation
  - Control of Alien Plants and Weeds: A few Category 1b Alien Invasive Plants, most notably *Datura ferox* (Olieboom) and *Xanthium strumarium* (large cocklebur, kankerroos), have started to establish within the mining footprint.
    - *Recommended Mitigation:* Within three weeks upon receipt of this report, a walk-through of the mining property should be conducted, wherein all affected (invaded) areas should be identified. These areas should then be cleared of these species with care taken not to allow the dispersal of seeds.
- The remaining 67 activities (98.5%) of activities occur sufficient enough and at acceptable levels, that no additional Mitigation Measures area required and the current active Mitigation Measures should only be maintained.

*Datura stramonium* (olie boom)

- Management of Alien Plants and weeds:
  - Recommended mitigation measures:
    - Within three weeks upon receipt of this report, a walk-through of the mining property should be conducted, wherein all affected (invaded) areas should be identified. These areas should then be cleared of these species with care taken not to allow the dispersal of seeds.

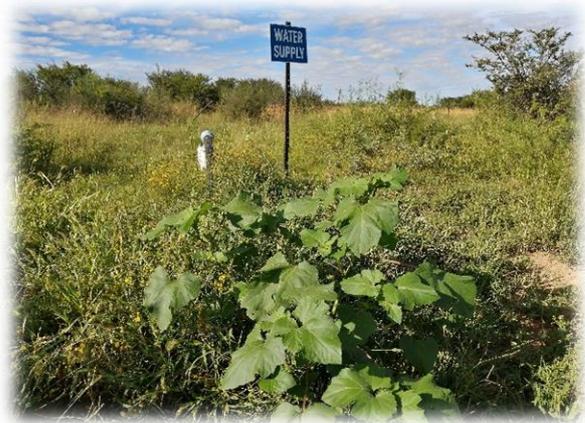
*Xanthium strumarium* (Large cocleblur, kankerroos)
