**SAND MINE ON A PORTION OF THE FARM DE
KLERKSKRAAL 231 IN THE THEUNISSEN DISTRICT,
FREE STATE PROVINCE**

ENVIRONMENTAL AUDIT REPORT

DMR REFERENCE NUMBER:	FS30/5/1/3/2/10207MP
AUDIT PERIOD:	March 2021

Permit Number:	FS30/5/1/3/2/10207MP	Date of Commencement:	November 2019
Site Name:	De Klerkskraal Quarry	Inspection Date:	7 April 2021
Permit Holder:	Blazecor 226 CC	Other Authorisations:	4 March 2017
Report Number:	12

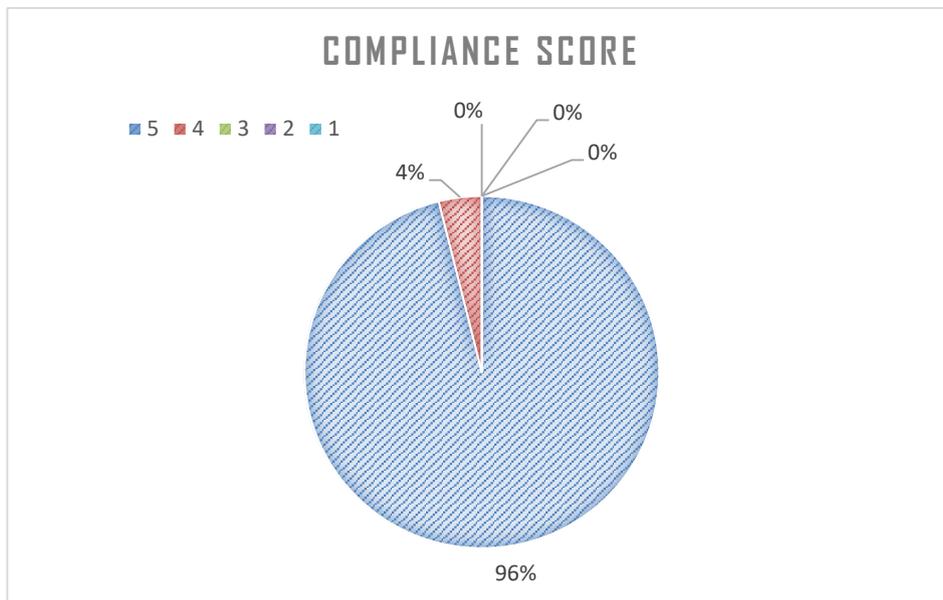
Compliance of the mining site with the EMP approved by DMR was reviewed during the site assessment. The mining area recorded a compliance score of 99.03% for the month of March 2021. This is a slight improvement from the previous month's compliance score of 98.06%.

Figure 1: Compliance scores for all activities as listed within the approved Environmental Management Programme for the De Klerkskraal Sand Mine.

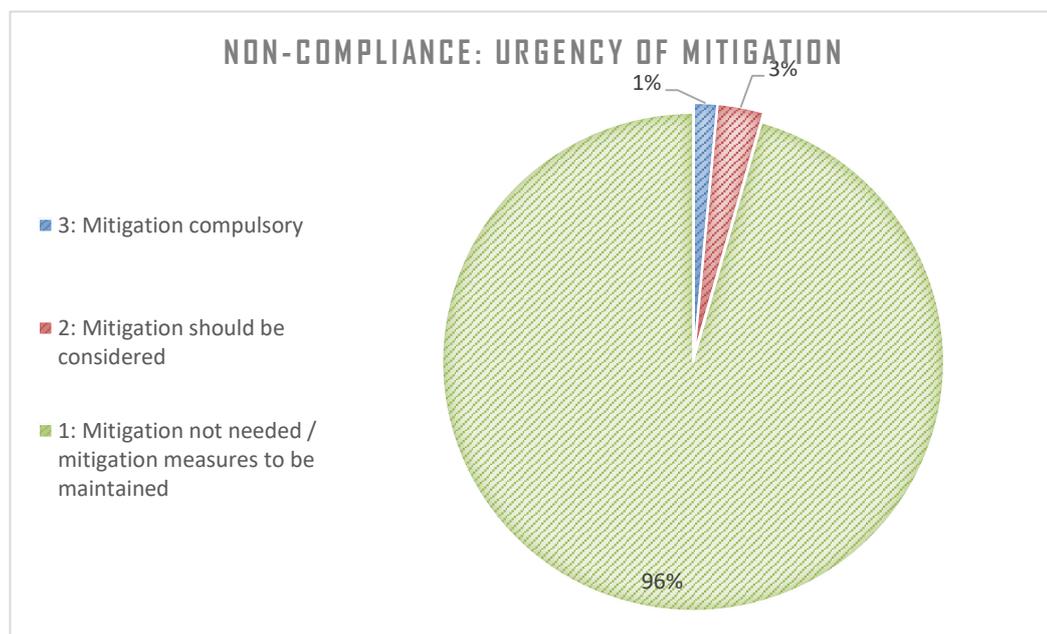
One activity has been identified which requires the consideration of mitigation or the continuation of current mitigation measures.

One activity has been identified which require compulsory mitigation namely:

Figure 2: Degree of urgency in terms of mitigation for the listed non-compliance activities.

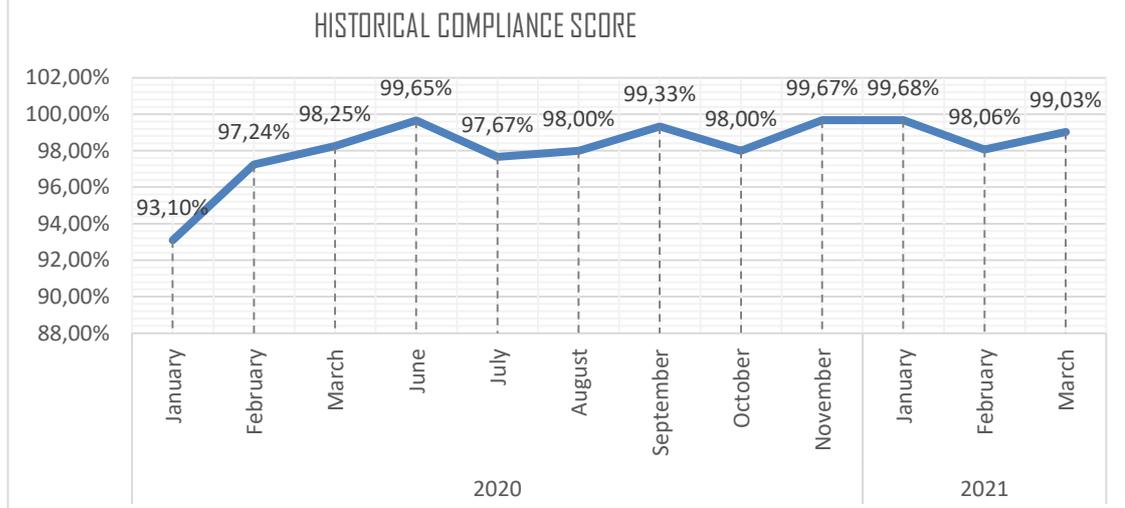
Figure 3: Historical compliance scores for the De Klerkskraal Sand Mine.
