MINING OF AGGREGATE ON PORTION 18 (PORTION 2) OF THE FARM LOUTERBRONNEN 250, THEUNISSEN DISTRICT FREE STATE PROVINCE

ENVIRONMENTAL PERFORMANCE ASSESSMENT / ENVIRONMENTAL AUDIT REPORT

DMR REFERENCE NUMBER:	FS 30/5/1/2/2/10040 MR
AUDIT PERIOD:	May 2023 – May 2024

Permit / Right Number:	FS 30/5/1/2/2/10040 MR	Date of Commencement:	15 May 2019
Site Name:	Louterbronnen Quarry	Inspection Date:	28 May 2024
Permit / Right Holder:	Vengablox (Pty) Ltd	Other Authorisations:	General Authorisation:
Report Number:	EPA 05	Other Authorisations:	27/2/1/C741/13

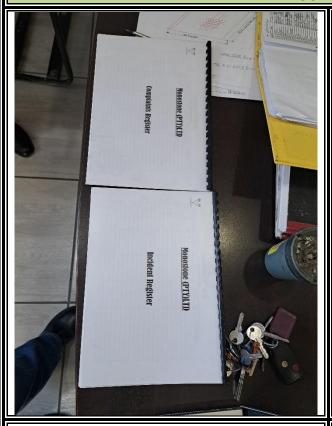
Complaints- and Incident Registers

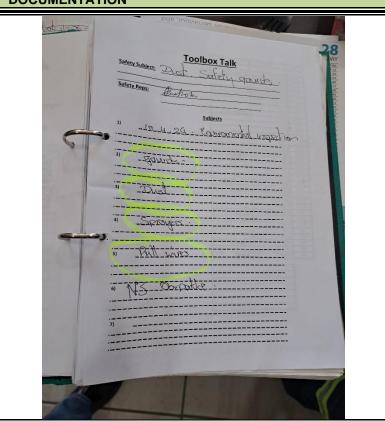
Toolbox talks with employees

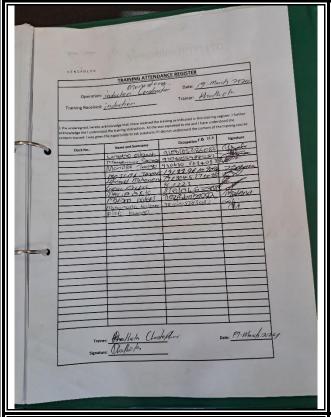
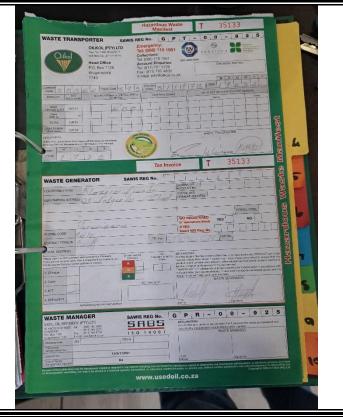
Proof of hazardous waste removal - Oilkol

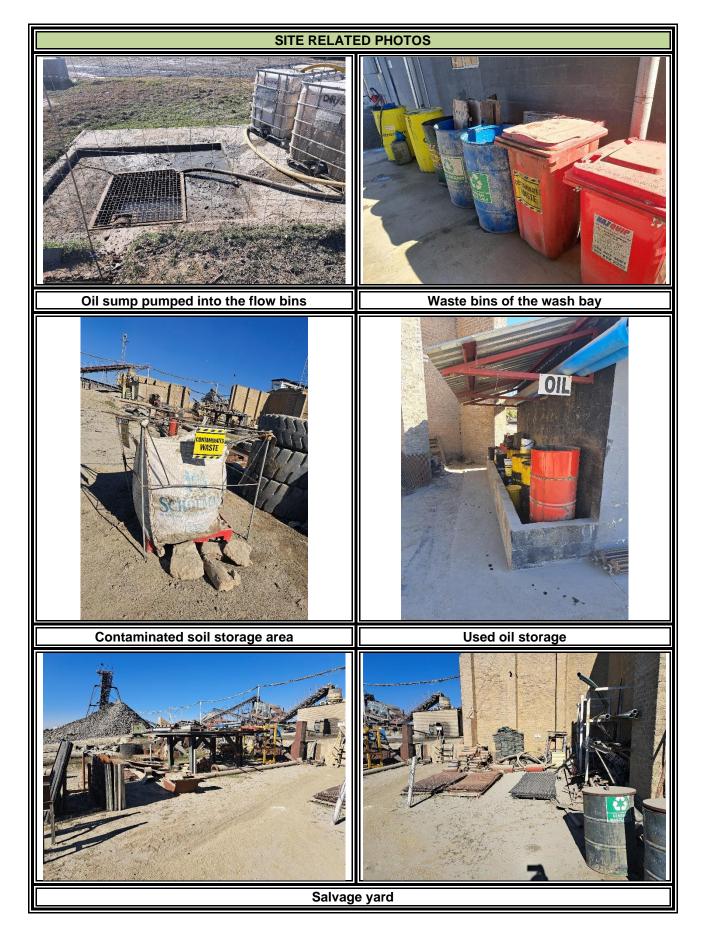
During the audit period the site further improved the oil sump (of the wash bay) through the addition of a concrete apron around the sump. The flow bins were moved to the concrete lining that is sloped so any water falling on the lining flows back into the sump.

Wash bay draining into the oil sump
