MAKHANDA MINING (PTY) LTD
REMAINING EXTENT OF THE FARM BRAKKEFONTEIN NO 243
MAKHANDA, EASTERN CAPE PROVINCE

ENVIRONMENTAL PERFORMANCE ASSESSMENT

DMRE REFERENCE NUMBER:	EC 30/5/1/2/2/0056 MR
AUDIT PERIOD:	AUGUST 2022 – JULY 2024

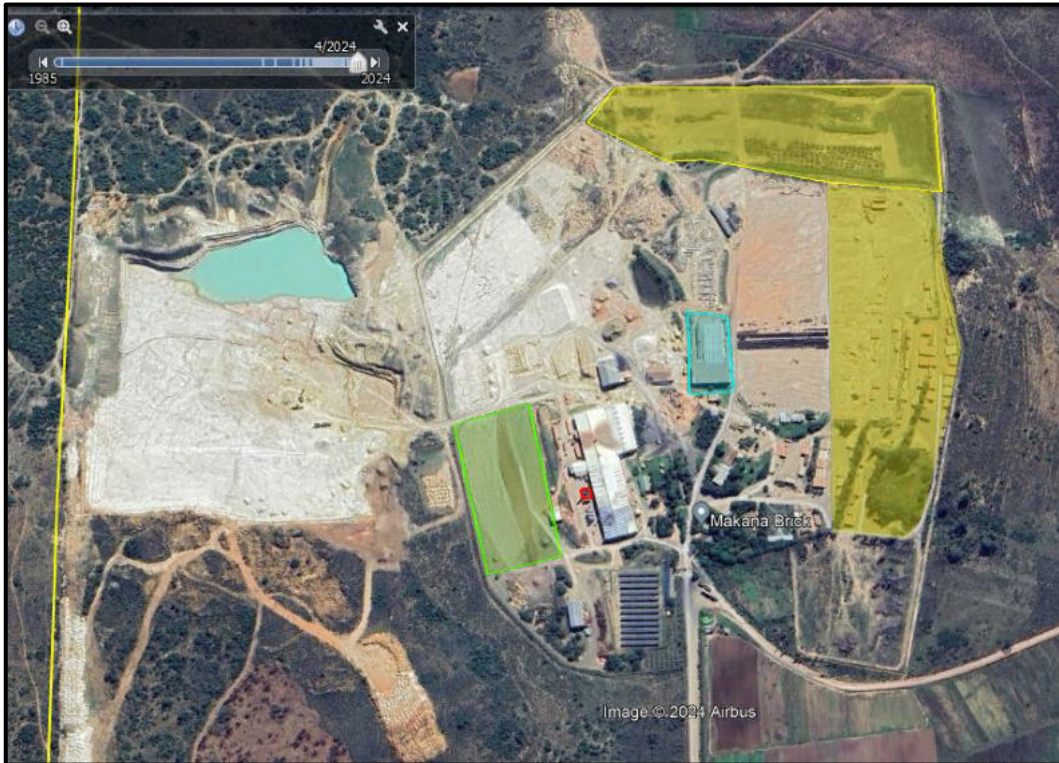
The old stockpile area (green polygon in following image) between the clay pit and the brick factory was cleaned and levelled. As mentioned earlier mesembs were planted along the berms. The brick plant also ceased the use of Plant 1 (blue polygon in following image), and the building will be cleaned out and repurposed. Site management also noted that the most northern- (where wood was previously stored) and eastern sections (where bricks are stored) within the fences will be rehabilitated and reinstated to lessen the operational areas (yellow polygons below). As discussed, all compacted areas earmarked for rehabilitation must be ripped and landscaped after the materials/product was removed. Seeding of the areas will speed-up the recovery of the vegetation cover and lessen dust generating areas.

Figure 1: Satellite view of the stockpile area that was reinstated (green polygon), Plant 1 that will no longer be used (blue polygon), and the areas earmarked for rehabilitation (yellow polygons).

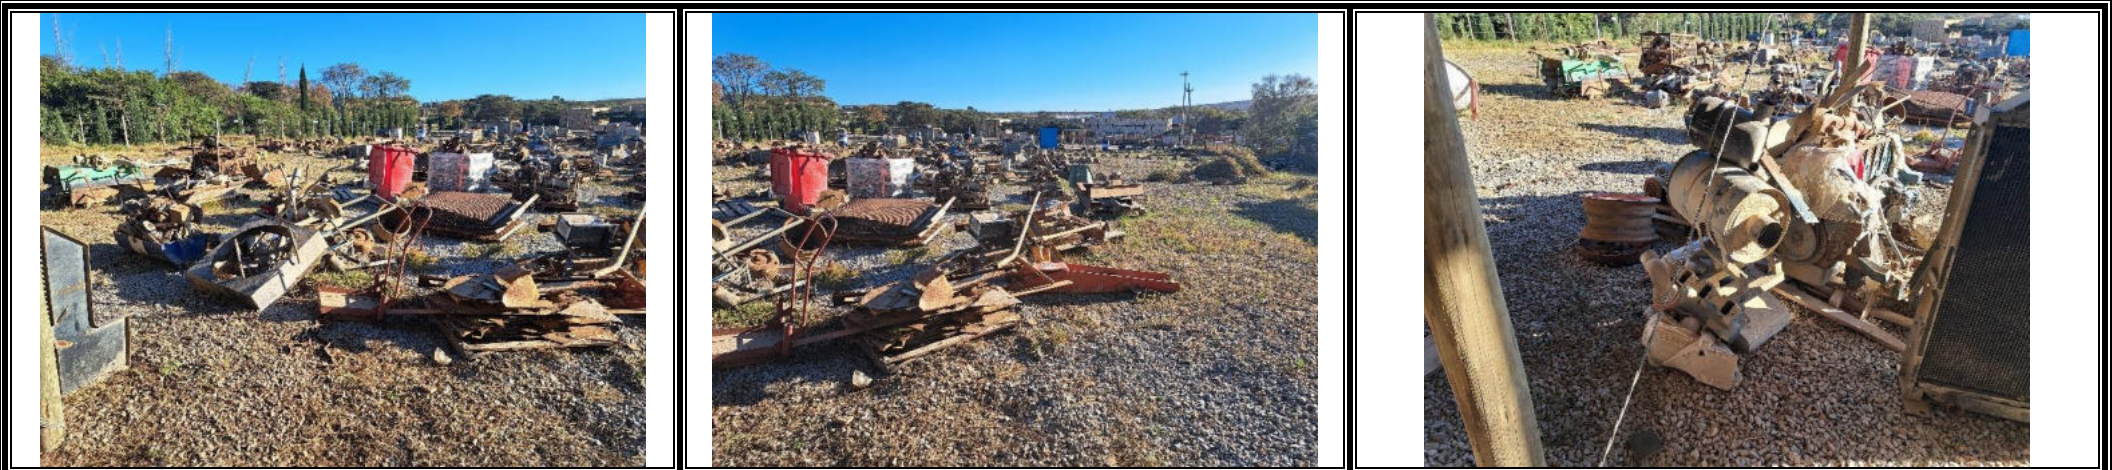
Scrap yard neatly sorted, but all hydrocarbons to be removed

The materials/equipment in the scrap yard are being sorted. As discussed, the hydrocarbons must be drained from all equipment in the scrap yard, alternatively the engines/motors etc. must be placed in drip trays to prevent spillages.

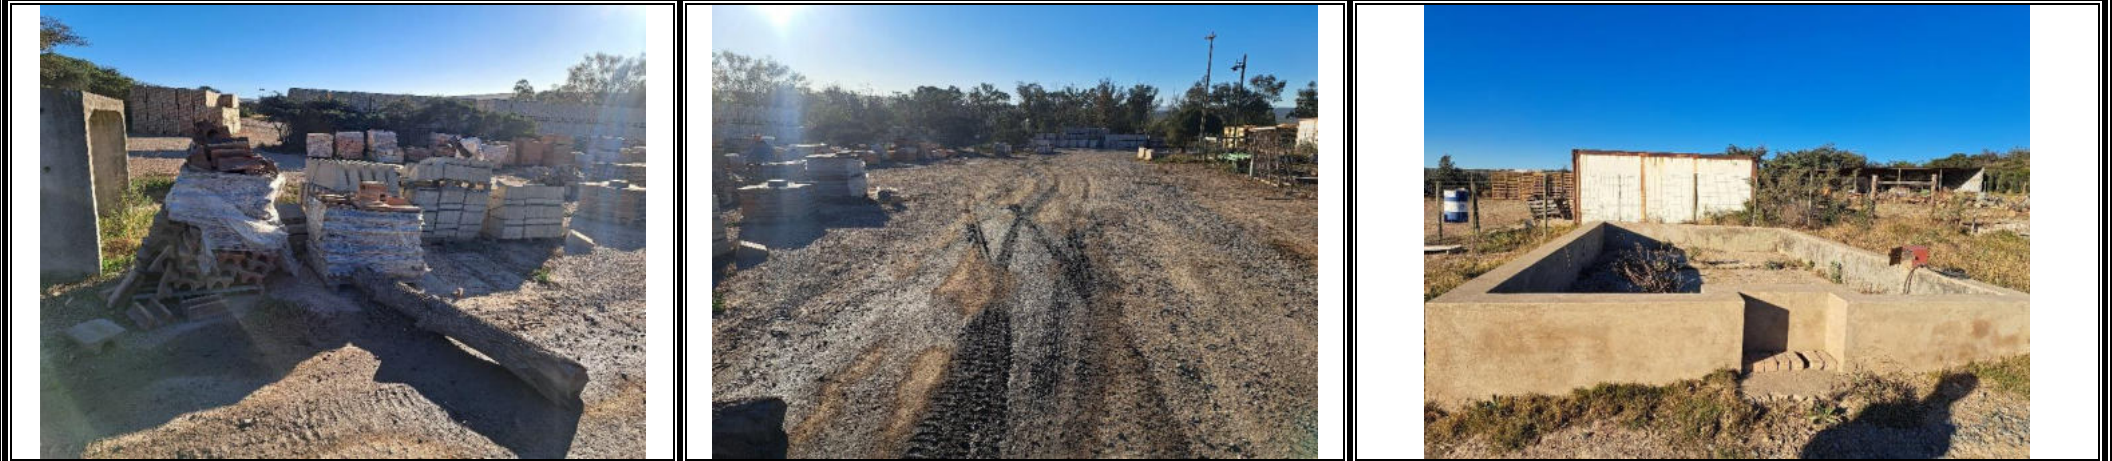
Stored products to be removed from site

Storage tank removed from bunded area

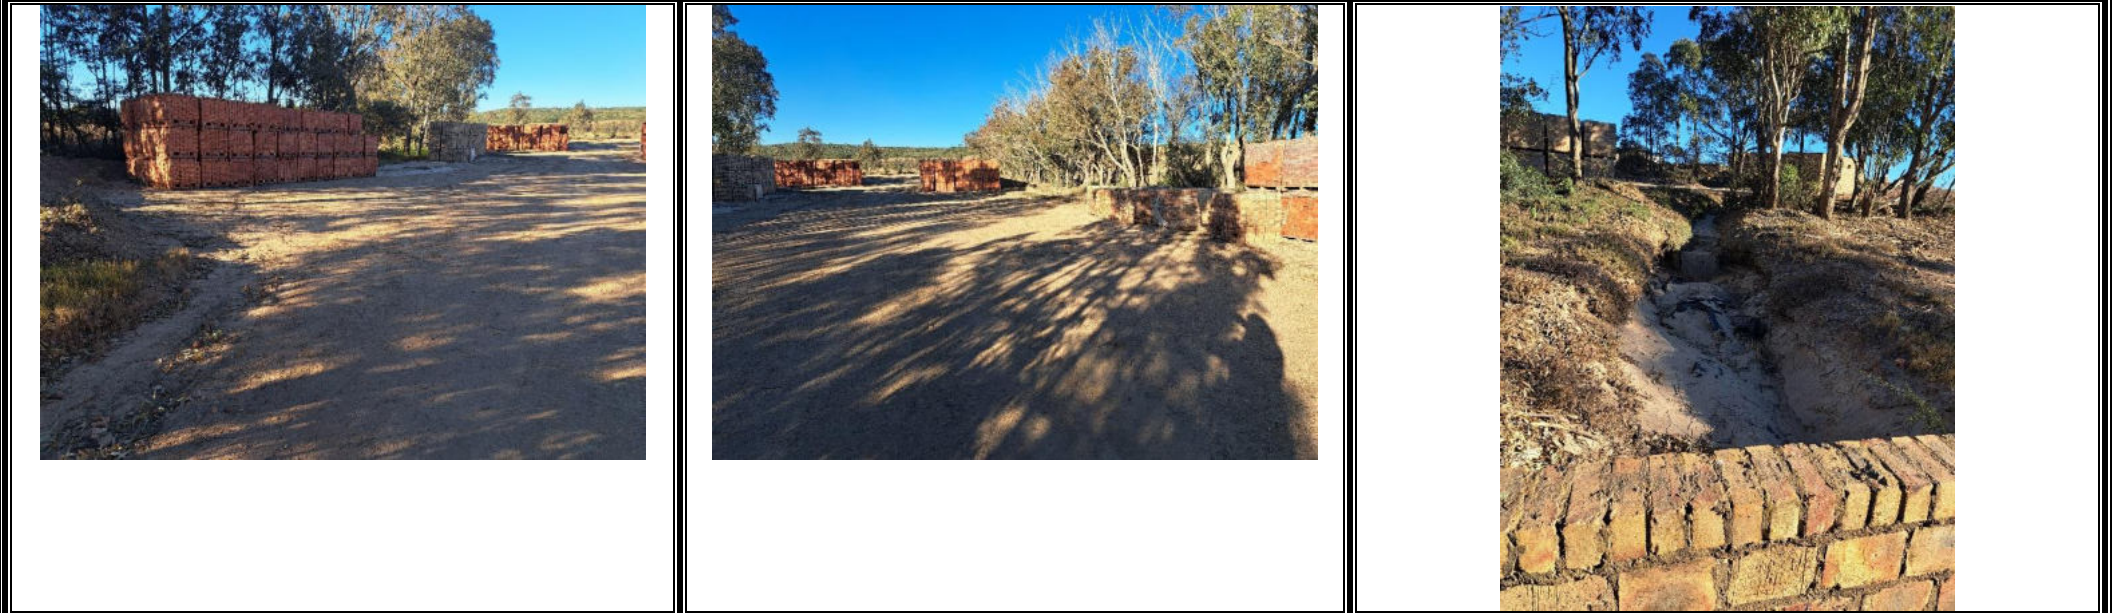
Brick storage area

Drainage channel to be cleaned

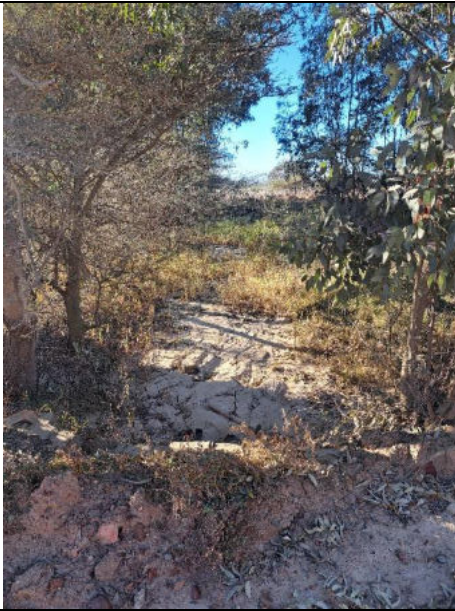
Drainage channel to be cleaned

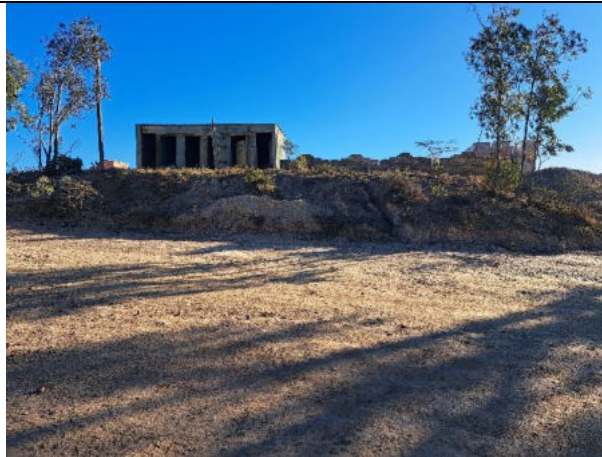
Long drops no longer in use. To be removed.

As mentioned earlier, the long drops at the clamp yard are no longer used on site as all employees now make use of the formal ablutions that drain to a septic tank. The building of the long drops will be decommissioned when the associated area is rehabilitated/reinstated.

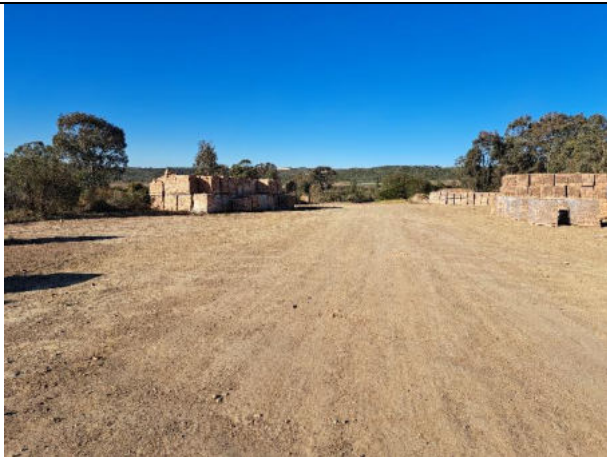
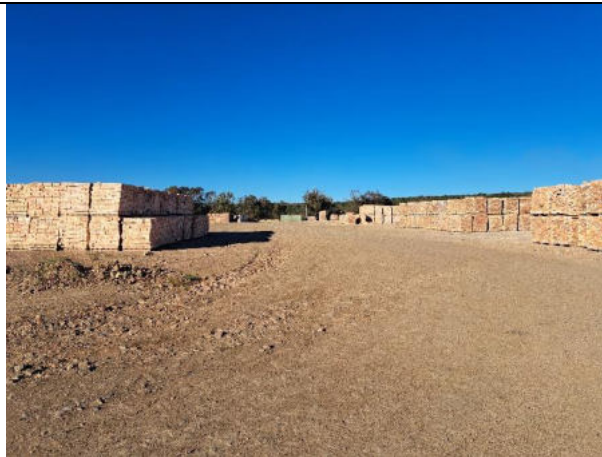
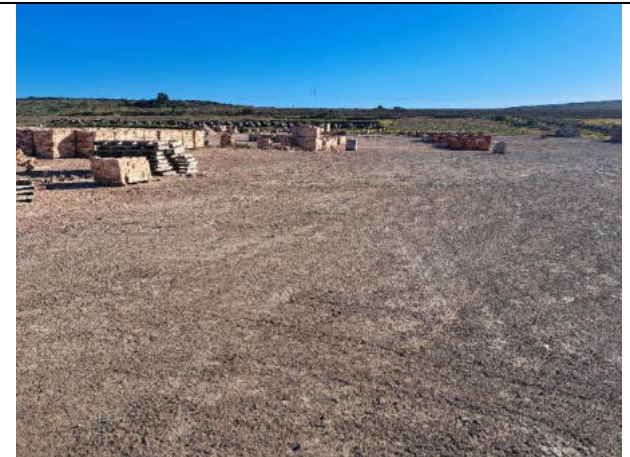
Packing area to be potentially rehabilitated

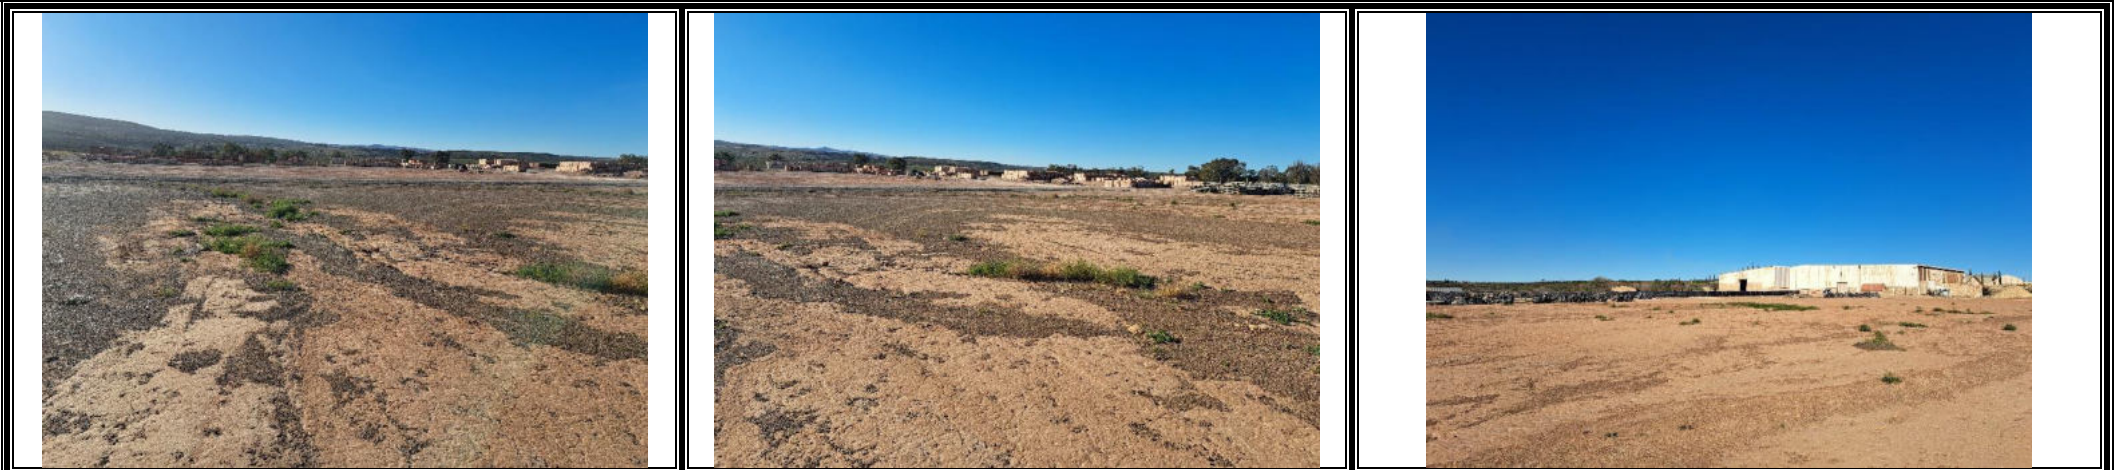
Rehabilitation/reinstatement of area considered

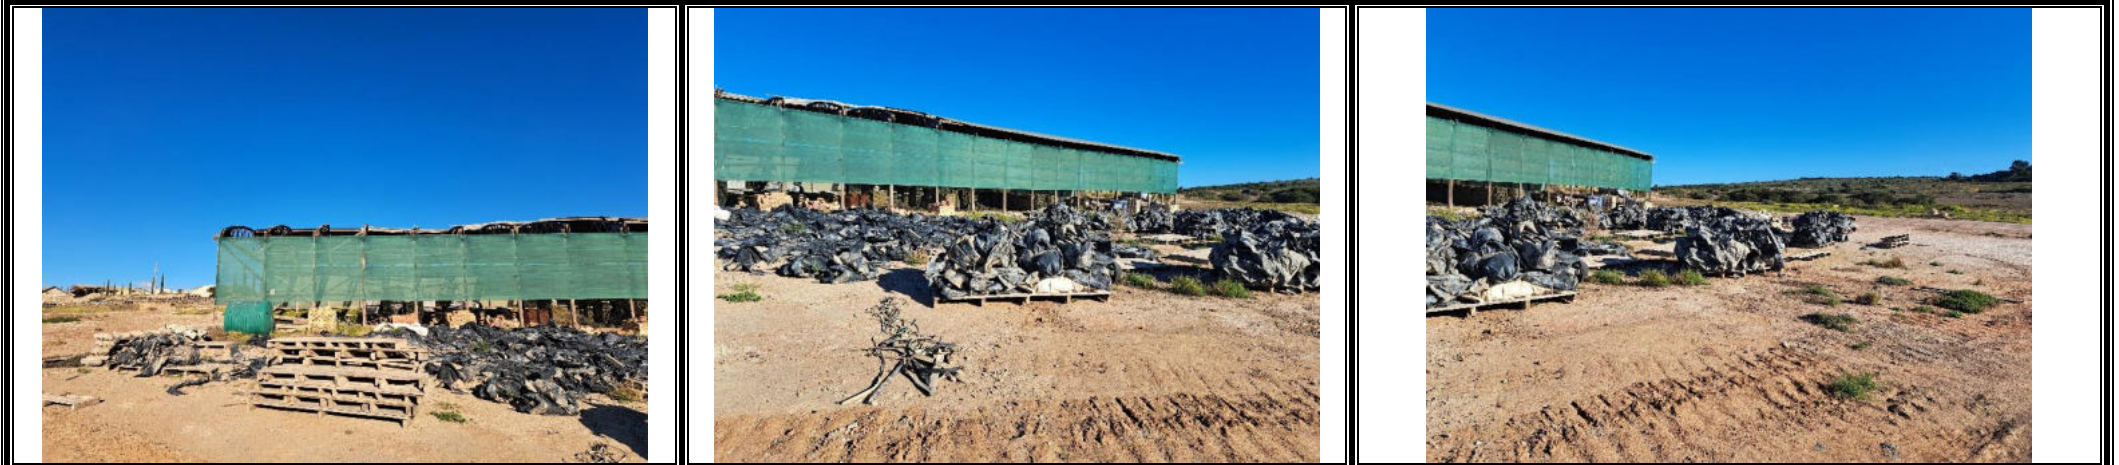
Plastic being sorted for reuse / removal from site

The old refuse bins of the site are being replaced with new wheelie bins that have lids. Site management must ensure that the plastic sheeting is daily removed from the operational areas to prevent it blowing/being washed into the stormwater channels.

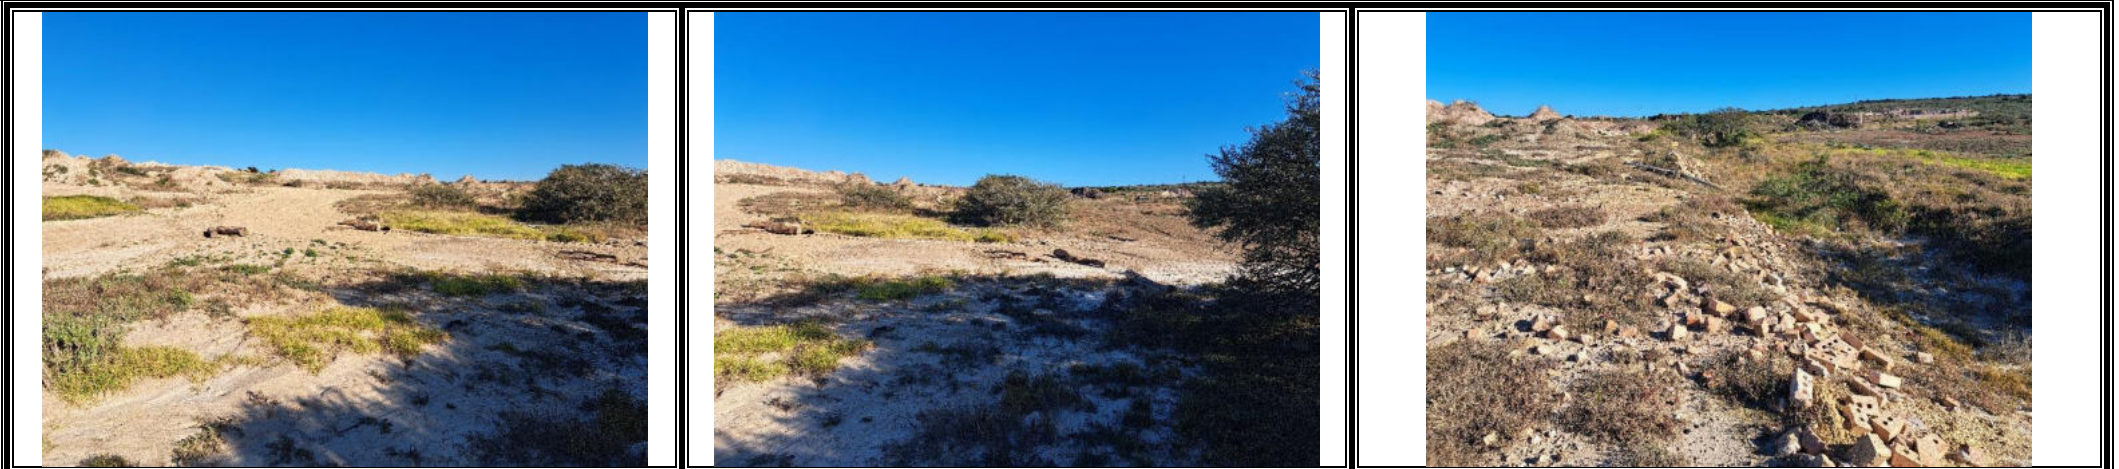
Drainage channel blocked by a road – to be opened and discarded bricks to be removed

The road passing through the stormwater channel along the northern side of the work area must be redesigned to allow continuous flow of water in the channel without it escaping and causing sheet erosion along the side of the channel.

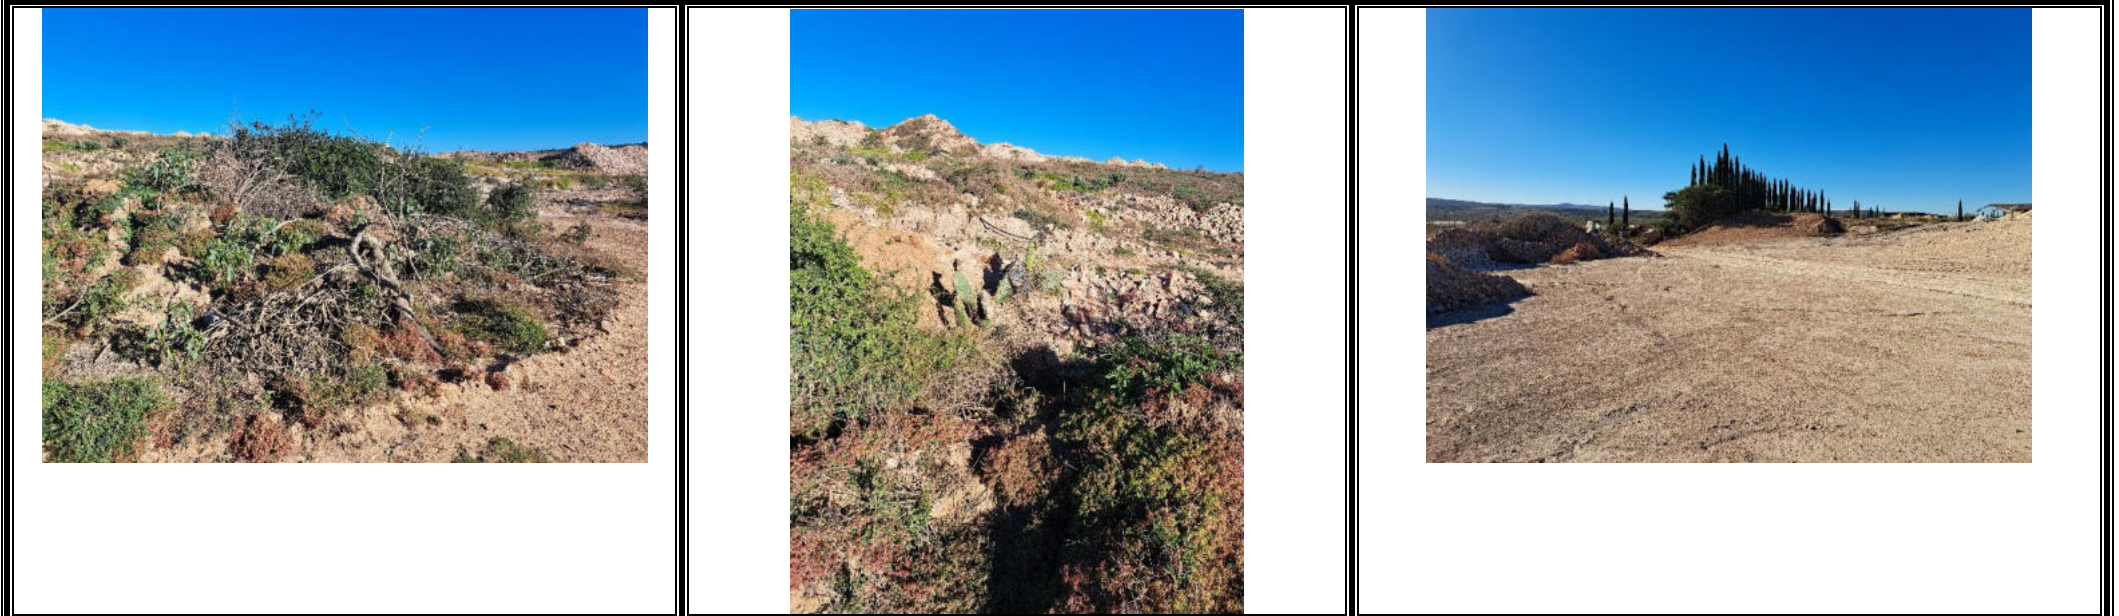
Weeds to be removed

Stockpile area and road to quarry neatly managed

Since the previous audit, the Tumbleweed (*Salsola kali*) was removed from most of the berms and work areas. Site management must also focus on the removal of the Thornapple (*Datura ferox*) plants that germinated along the berms and disturbed areas as these plants are also classified as a Category 1b species in terms of the Alien and Invasive Species List, 2016 (as amended). Other invader plants that needs to be removed are the Thorny Prickly Pear (*Opuntia ficus-indica*), and Mexican Poppy (*Argemone mexicana*)

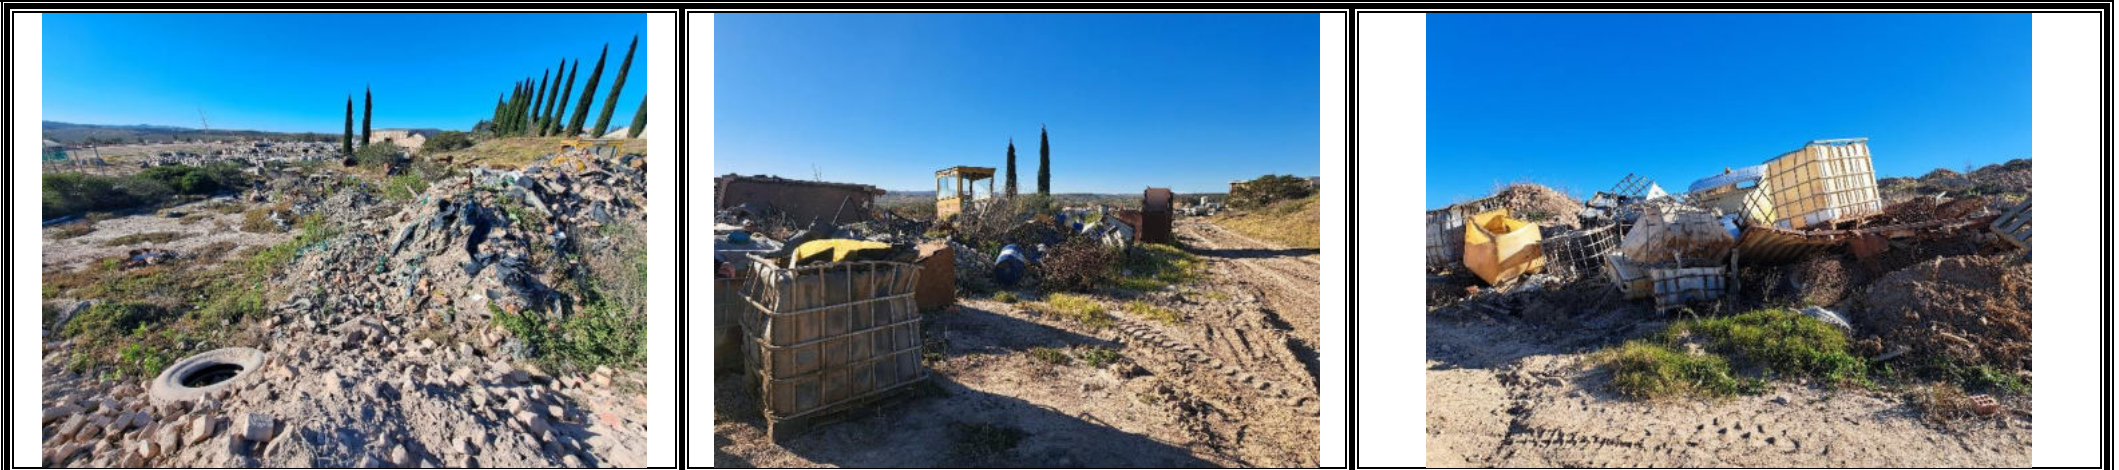
Building rubble and waste to be sorted and removed from site

The area where building rubble was piled (north of Plant 1) must be cleaned. The general waste must be removed to the landfill site, broken bricks and other building rubble that can be salvaged must be removed and any container/equipment with hydrocarbons in must be removed to a bunded area.

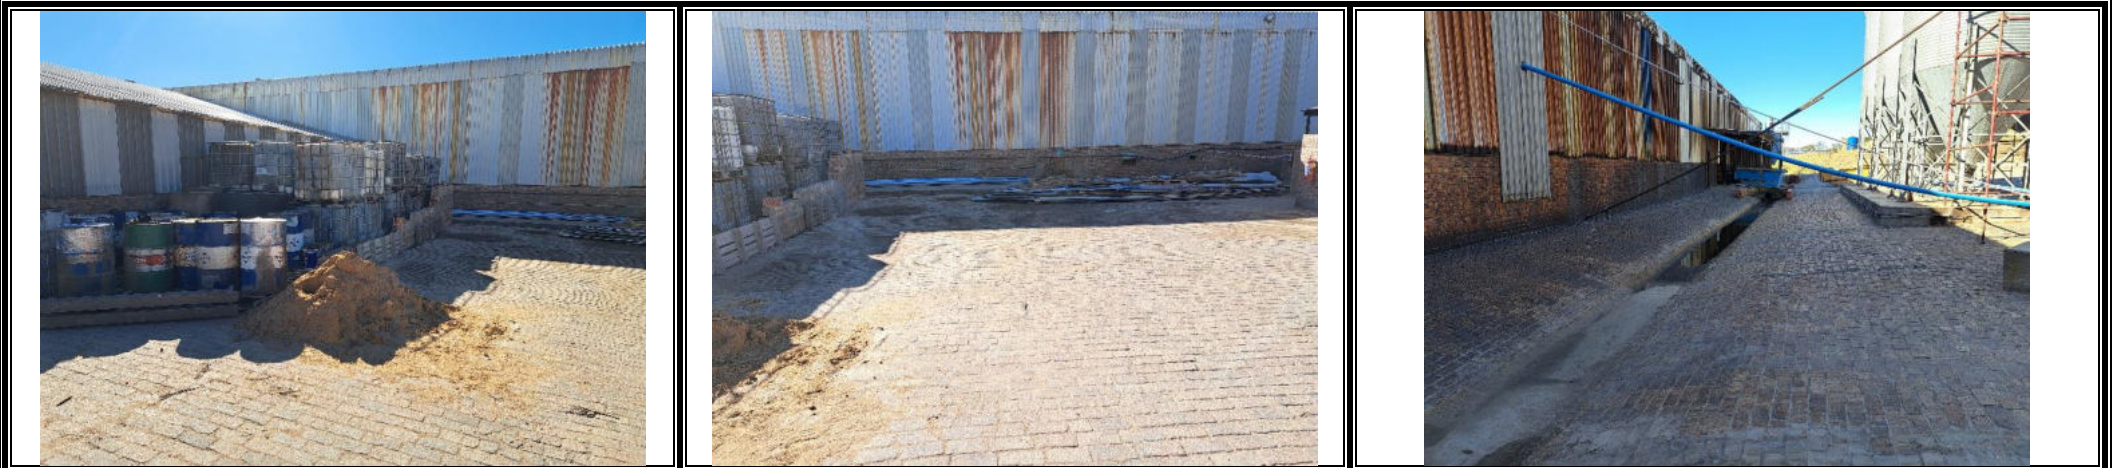
Bund of the used oil containers to be finalised to prevent dirty water runoff entering the nearby stormwater channel

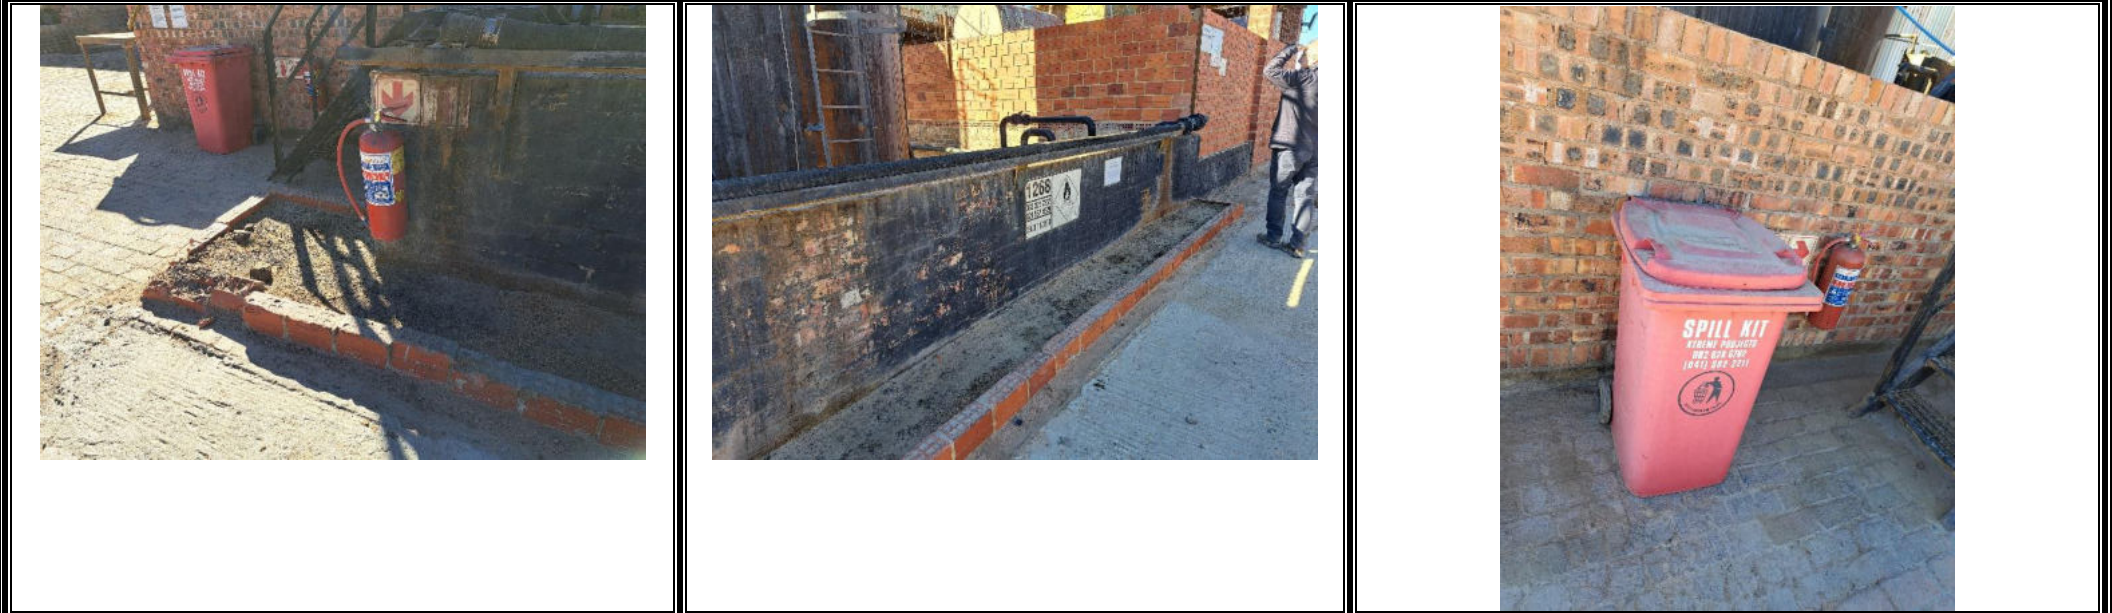
Bund to be repaired

Oil spill kit on site

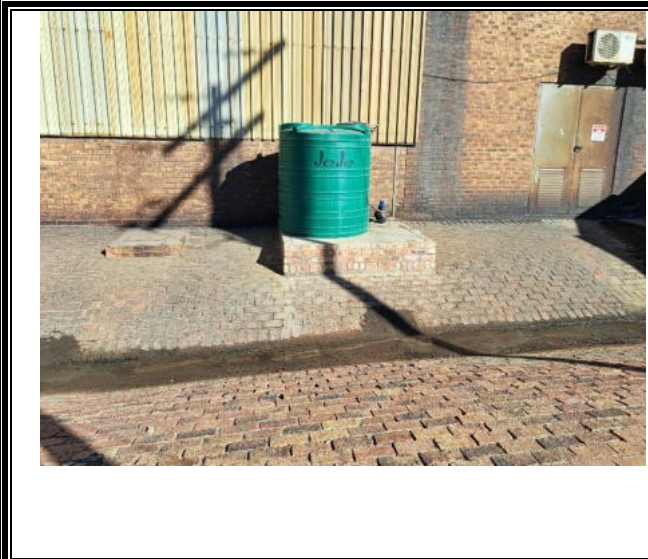
Tank to be placed in a bunded area

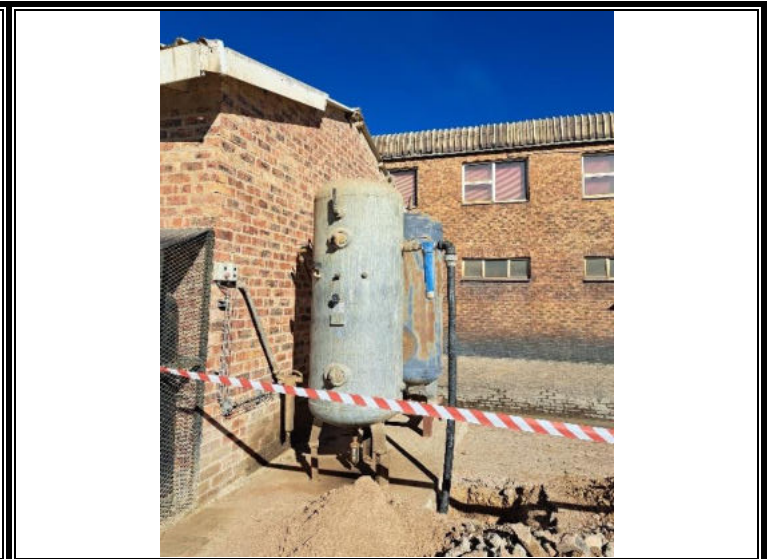
Tank to be placed in a bund

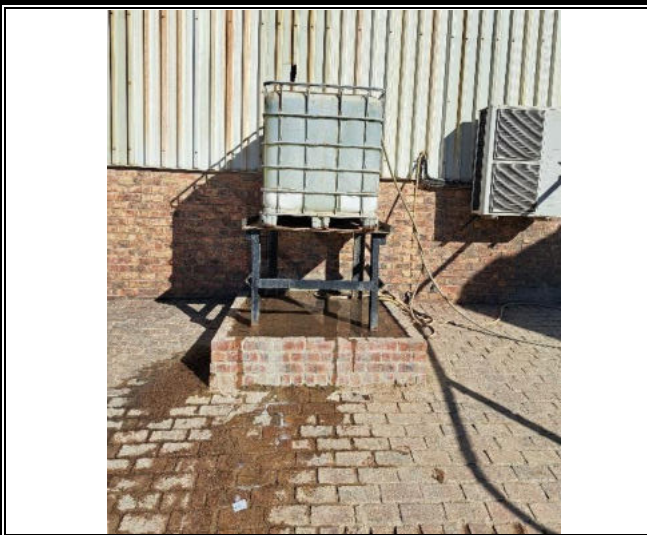
Bund to be increased

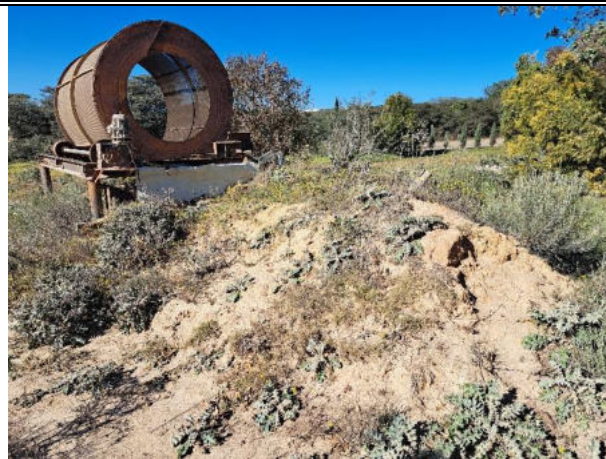
Mexican poppy plants to be removed

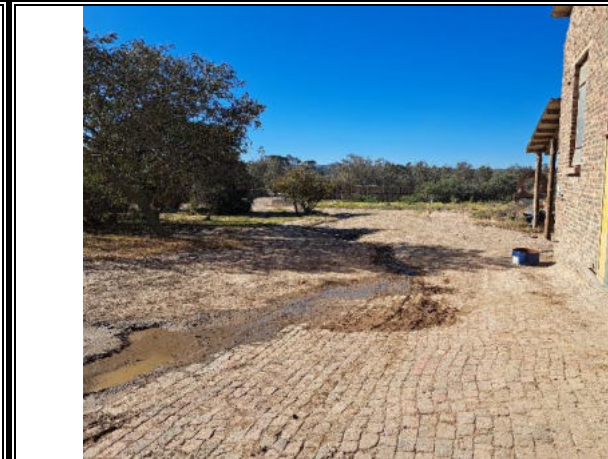
Runoff from workshop to be contained

The storm water management of the factory and workshop areas must still be improved to separate dirty and clean water. Clean water (e.g. rainwater) must be kept clean and be routed to a natural watercourse by a system separate from the dirty water system. Clean water must be prevented from running or spilling into dirty water systems. Further to this, site management must distinguish between dirty water that can be directed to the pollution/settling ponds (e.g. runoff water with a high non-hazardous sediment load for instance the processing area or carbon stockpile) and contaminated water (e.g. wash water from the wash bay and vehicle service areas) that must be directed to an oil separation sump. No water containing hydrocarbons/other non-organic chemicals may be directed to the pollution/settling ponds.

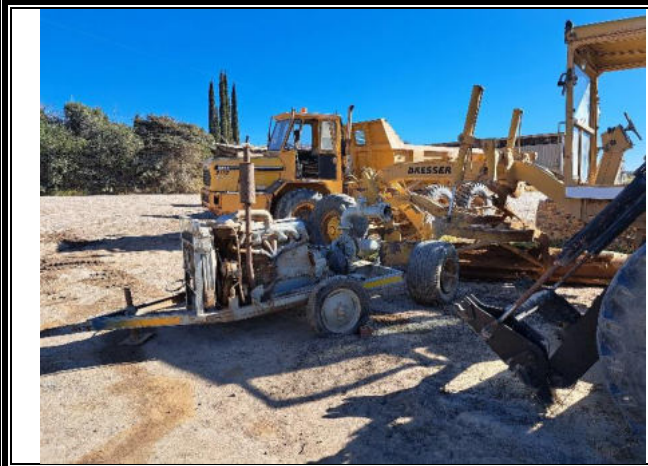
Service area to be lined

It is proposed that the surface of the vehicle service area be lined to prevent soil contamination, and any spillages/contaminated water must drain into an operational oil sump. Vehicle/equipment repairs must be contained to the service area.

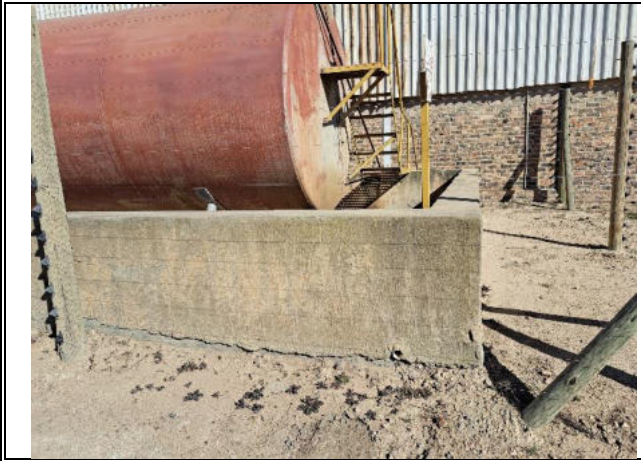
Bund to be sealed

- All chemicals stored on site must be kept within bunded areas.
- Any used-oil tanks must be kept in a formal bund wall with a lined surface, and no containers holding chemicals/hydrocarbons may be placed directly on the soil.
- All the bund walls must be sealed.

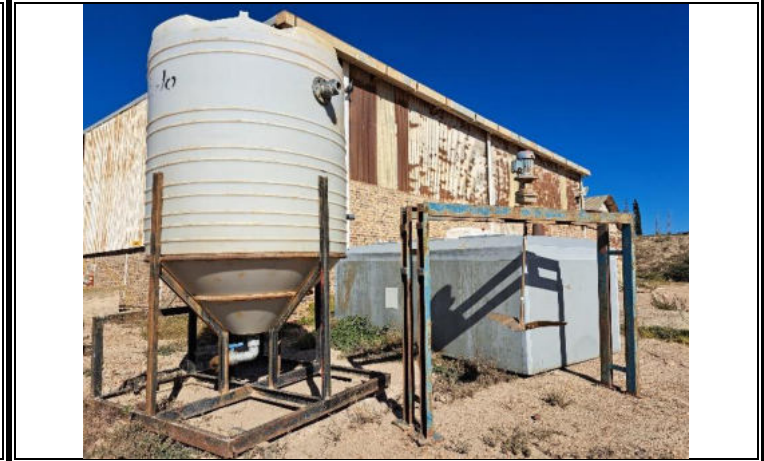
Tank to be placed in a bund
