MTHATHA QUARRY PORTION OF ADMINISTRATIVE AREA NO 11 CALLED ZITATELE, MTHATHA, EASTERN CAPE PROVINCE

ENVIRONMENTAL PERFORMANCE ASSESSMENT / ENVIRONMENTAL AUDIT REPORT

DMRE REFERENCE NUMBER:	EC 30/5/1/2/2/0135 MR
AUDIT PERIOD:	August 2023 – May 2024

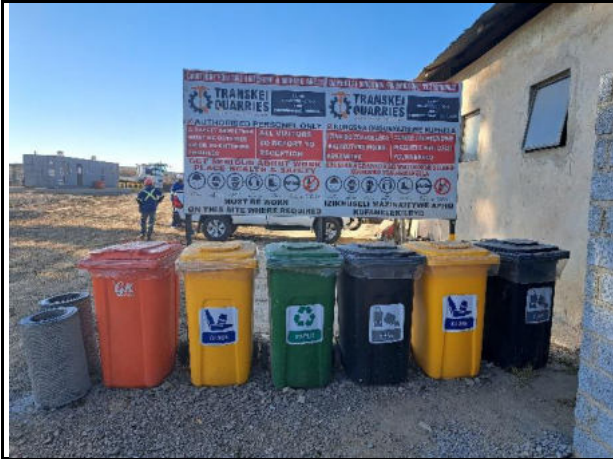
Refuse bins used on site

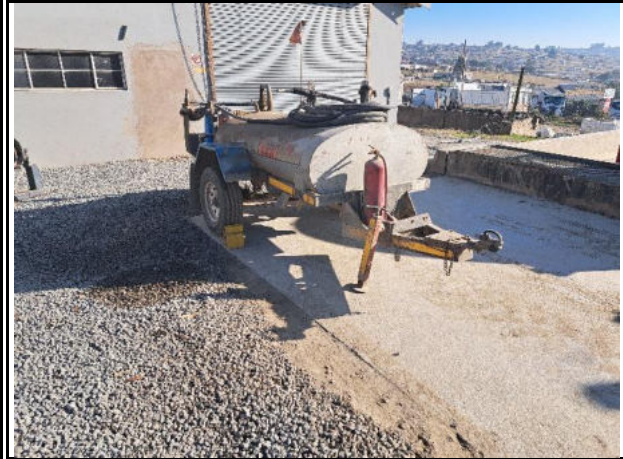
Diesel bowser parking area to be bunded/fitted with berms

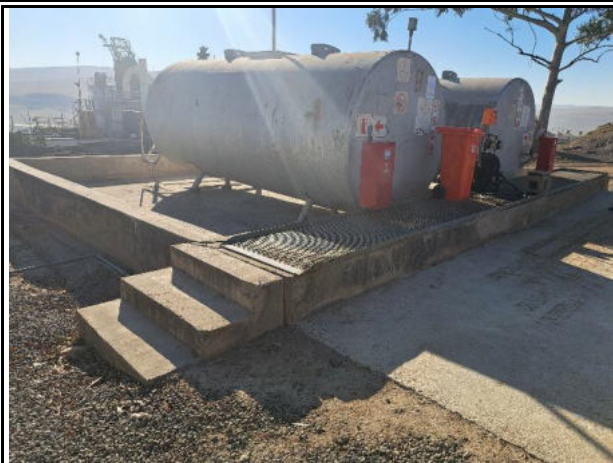
Bund of diesel tanks. Water to be contained and poured into oil sump when needed

The Quarry continued with the improvement of various bund walls near the workshop and storage areas. As discussed, all bunds must be sealed, and no open drains/cracks may be allowed/left in the walls. The bund of the generator at the back of the ablutions must be sealed as the pipe extending from the bund cannot be closed currently. The parking area of the diesel bowser must be fitted with bund walls/berms to prevent dirty water running from the parking area. The water draining from the diesel tanks banded area into the concrete extension/pit must be controlled. The water may not be allowed to drain into the surroundings and cannot be used for dust suppression as it may contain hydrocarbons. The water can be poured into the oil sump.

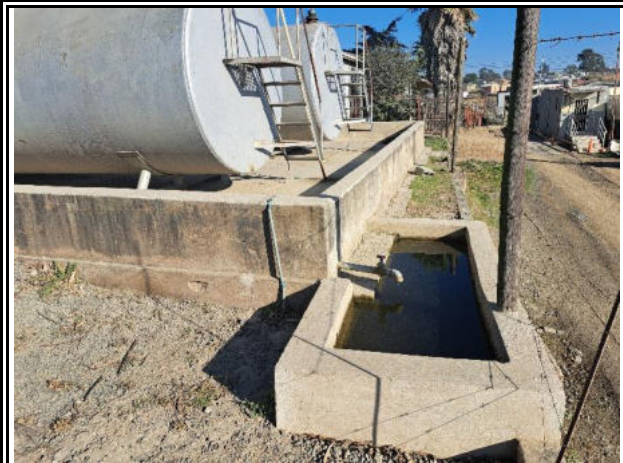
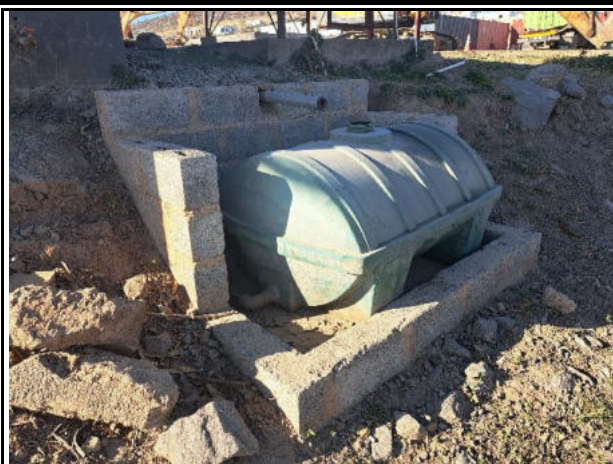
Size of bund to be increased and the bund to be sealed. Pipe to be lengthened

A tank was installed that will contain the waste water from the bund of the used oil store. It is proposed that the pipe leading to the tank be lengthened and that the size of the bund be increased to contain 110% of the liquid stored within. The bund walls must also be completed. Bund walls were also added to the used oil storage area that must be sealed.

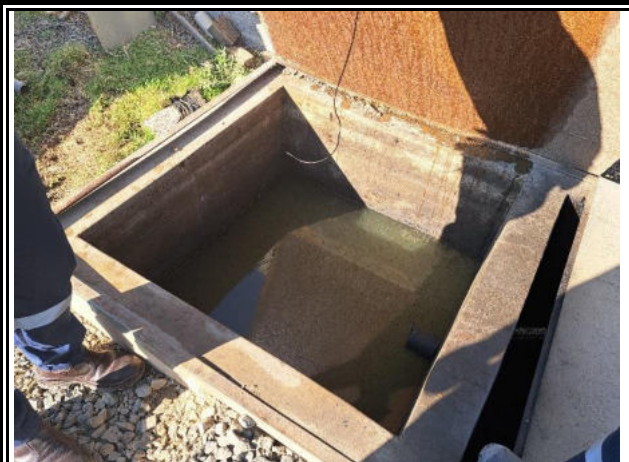
Oil sump. Water from the last chamber to be tested for hydrocarbon traces

The 2024 water quality results indicate elevated magnesium and nitrate levels. According to the report, the magnesium levels can be reduced by purification technologies. The report deems the water (of the quarry pit and last chamber of the oil sump) fit for agricultural use. However, it is proposed that the Quarry implement rectification measures to lower the magnesium and nitrate levels to the acceptable standards. Water samples must also be collected from the river upstream and downstream of the mine. The water from the oil sump must also be tested for the presence of hydrocarbons.

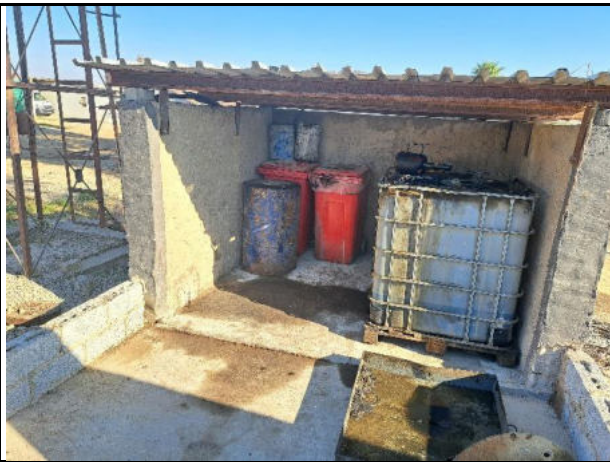
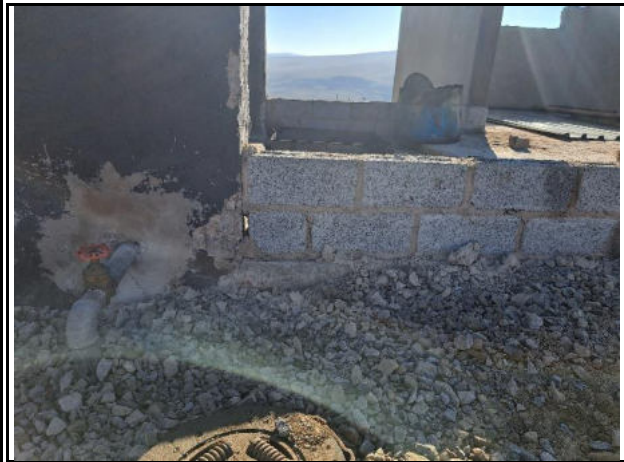
Bund of the used oil storage area to be sealed

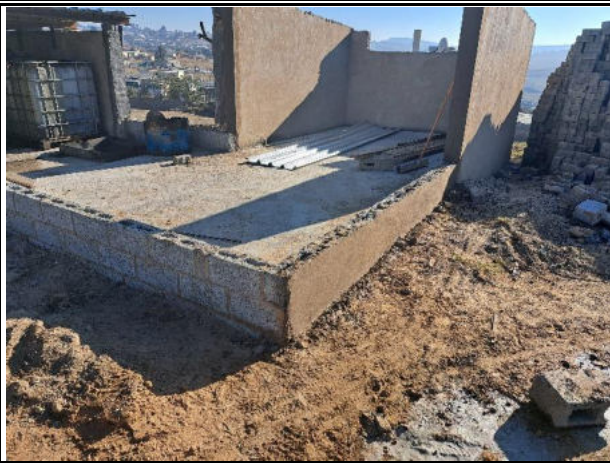
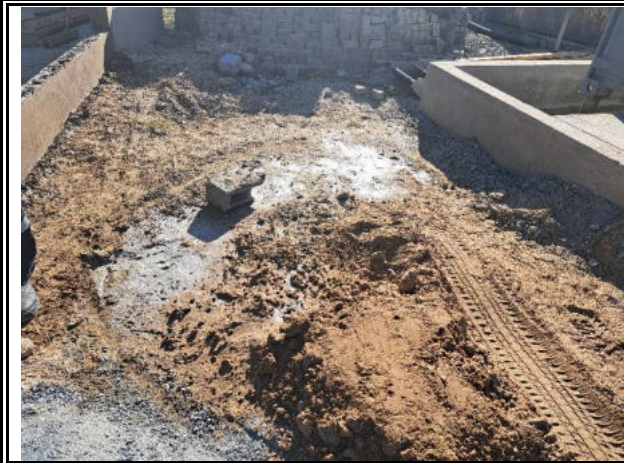
Paint store under construction. No mixing of cement on the bare soil may be allowed

No cement/concrete mixing may be allowed on the bare soil. All cement mixing must take place in wheelbarrows or mixing pans.

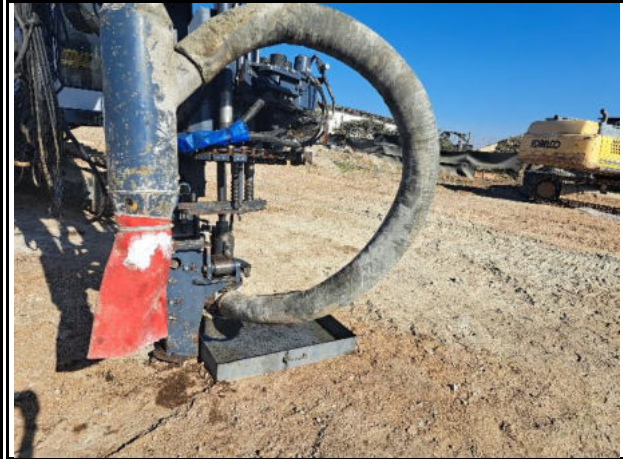
Spills to be cleaned and drip trays of adequate size to be used

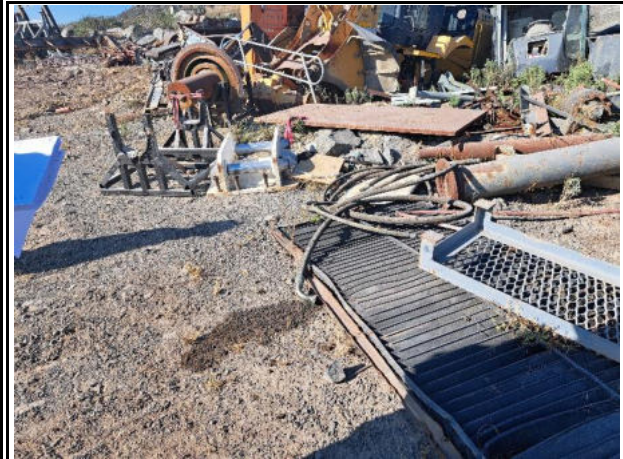
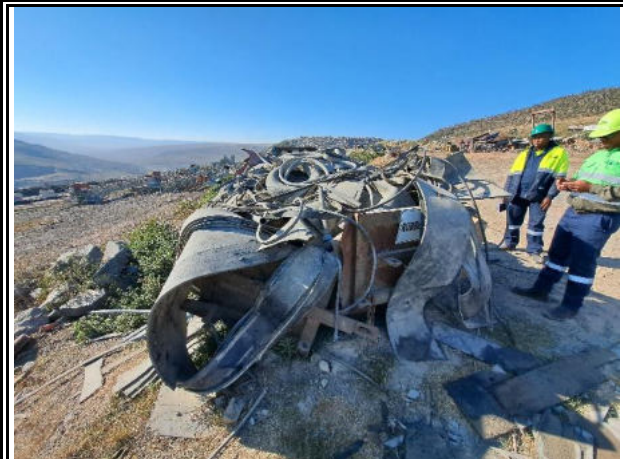
Equipment causing hydrocarbon spills to be removed from the salvage yard and spills to be cleaned

All equipment that may cause hydrocarbon spills must be removed from the salvage yard to banded areas with impermeable surfaces.

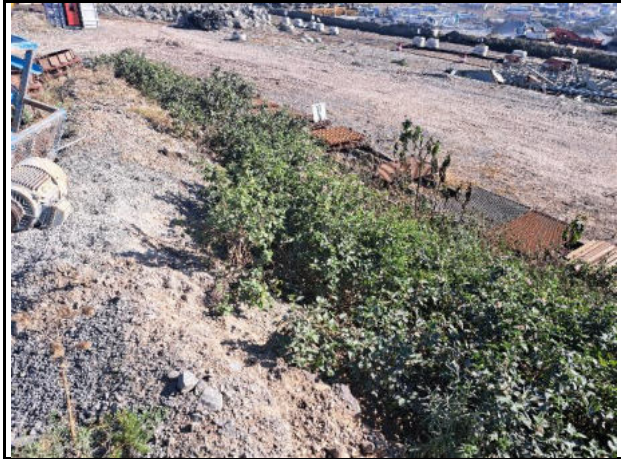
Problem plants (Lantana) to be removed from berms

The Quarry periodically appoints a service provider to clear the problem plants. During the audit period problem plants were removed from six of the seventeen target areas. The service provider uses machinery to clear most of the plants, upon which general labourers manually remove the remaining plants. Wood from the cleared plants is donated to the community. As discussed, it is proposed that the cleared areas be sown with indigenous grass species to minimise the denuded areas and lessen the re-occurrence of problem species. The use of herbicides, to lessen re-growth of especially Lantana must also be considered by the mine.

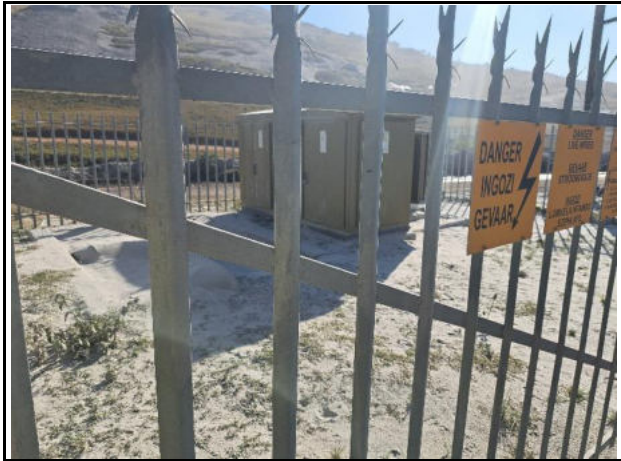
Generators to be fitted with bund walls

The generators at the processing area must be fitted with bund walls of appropriate size.

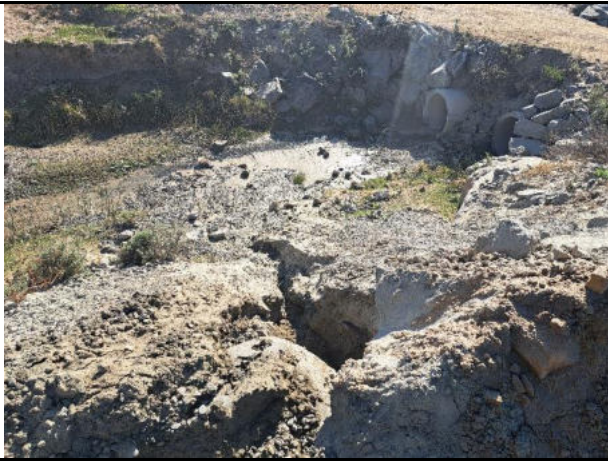
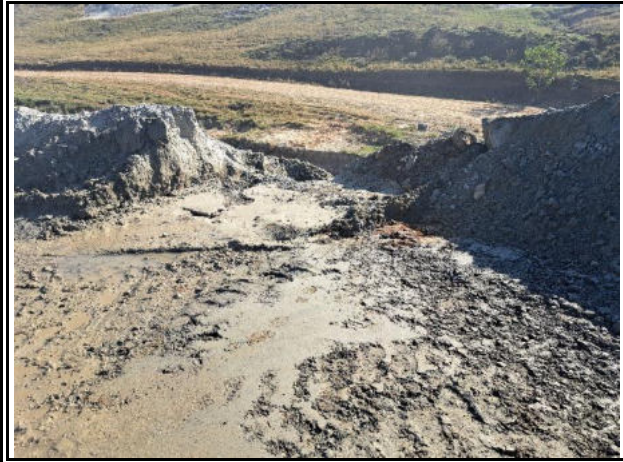
Stormwater berms may not be breached to drain water into the river without DWS approval

As mentioned earlier, the site must compile a site specific stormwater management plan and no water may be released into the rivers prior to authorisation by the DWS. The crossings through the rivers must also be authorised by the DWS.

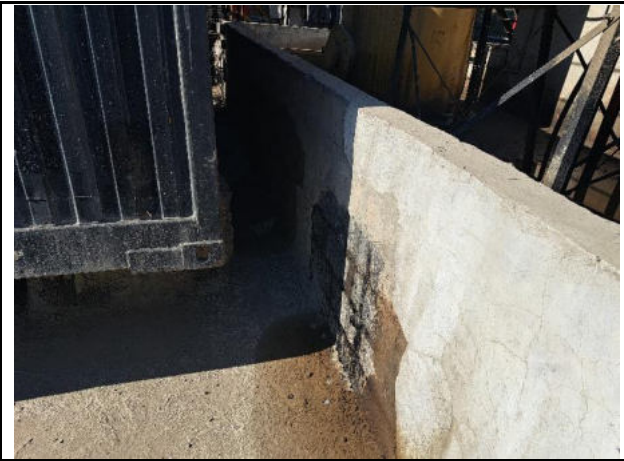
Bund to be sealed

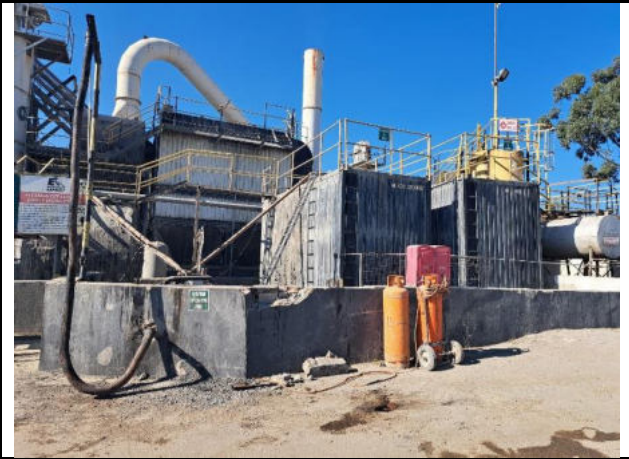
Bunds to be improved

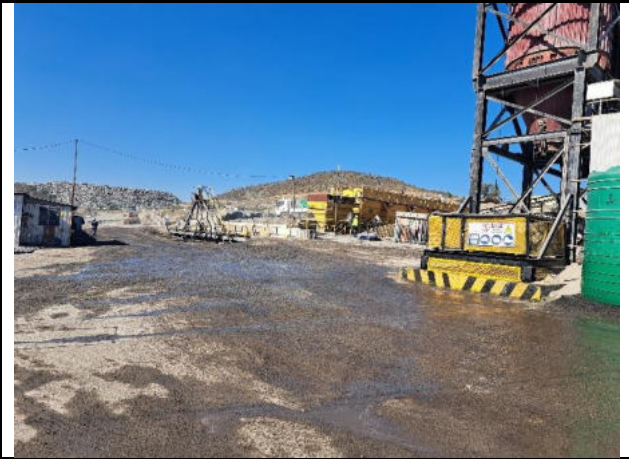
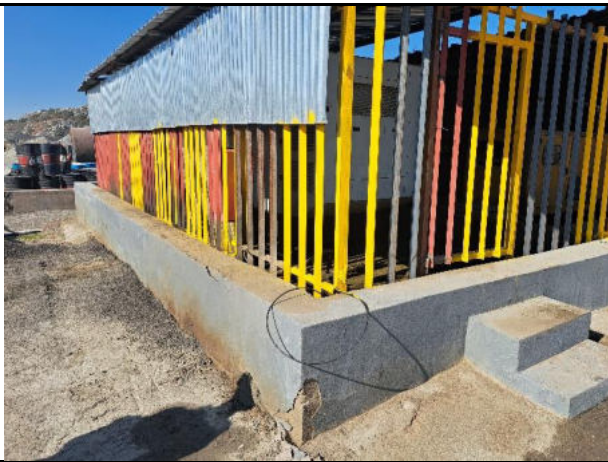
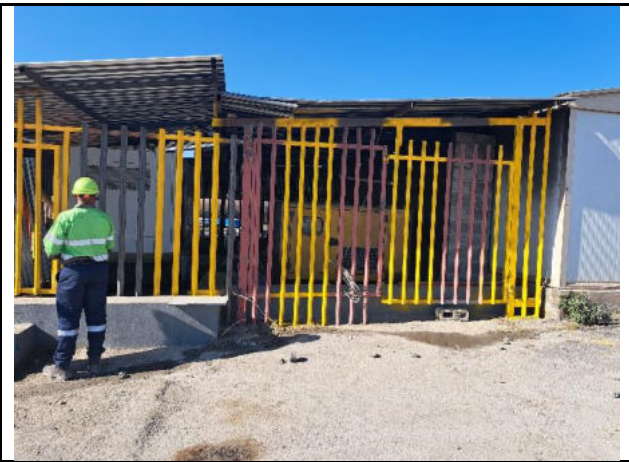
Improvements made to the bund of the generators. The bund must still be cleaned and sealed

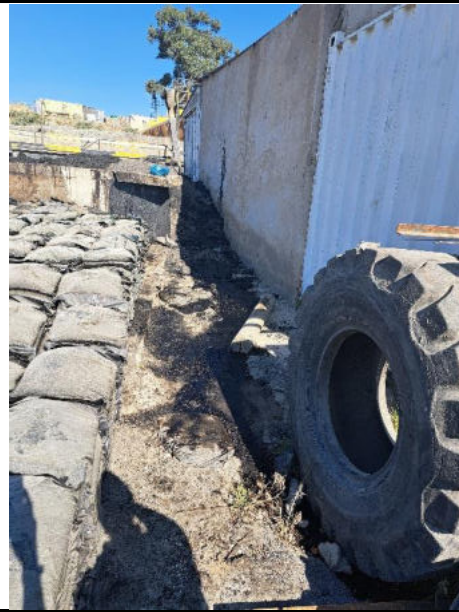
Spills to be cleaned (right picture)

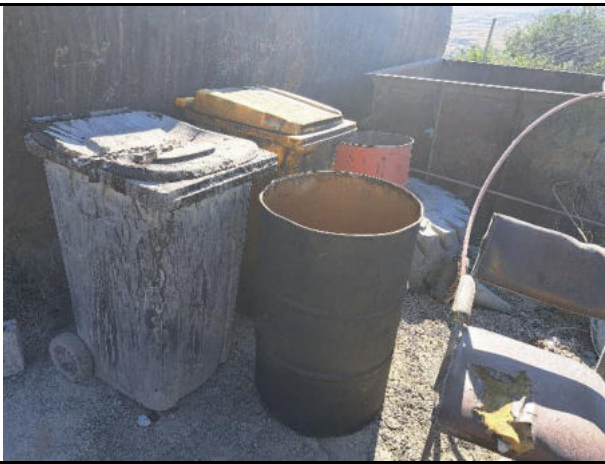
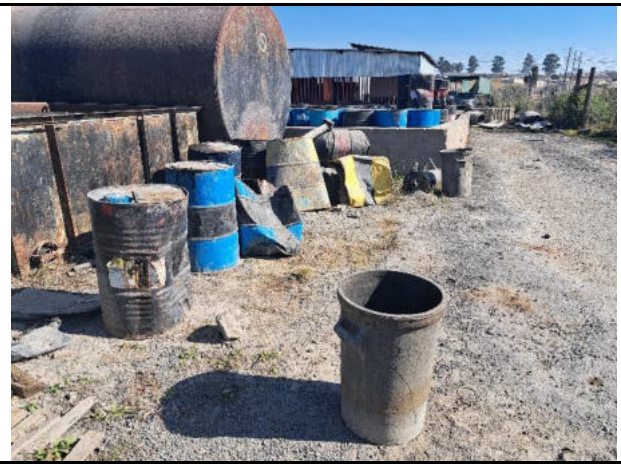
Drums to be moved to bunded areas with impermeable surfaces

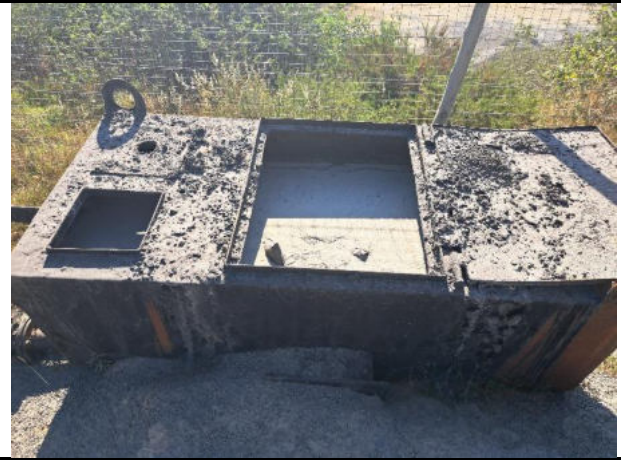
Spills to be cleaned and old container to be removed from site

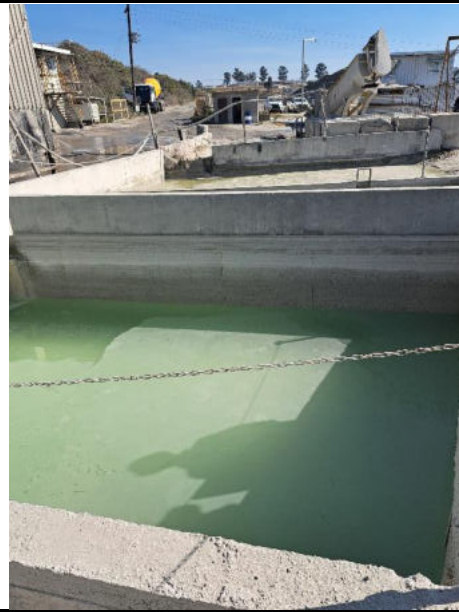
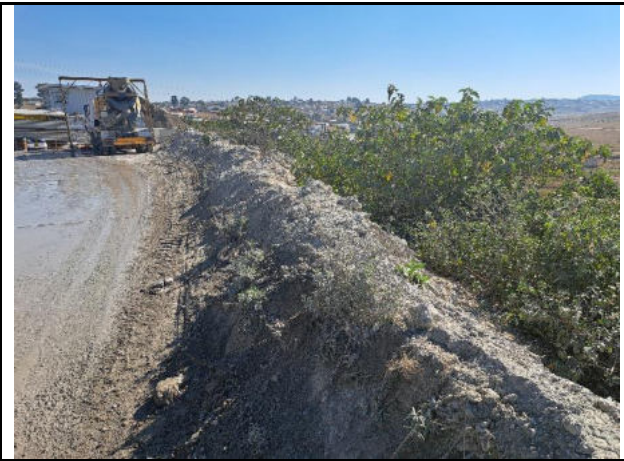
Problem plants to be removed from the berms

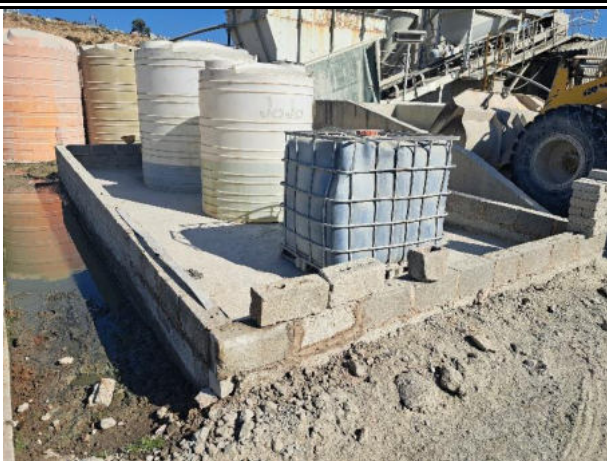
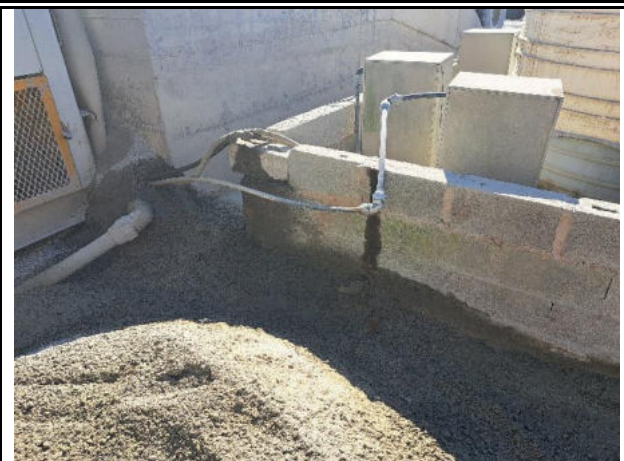
Bunds to be repaired and sealed

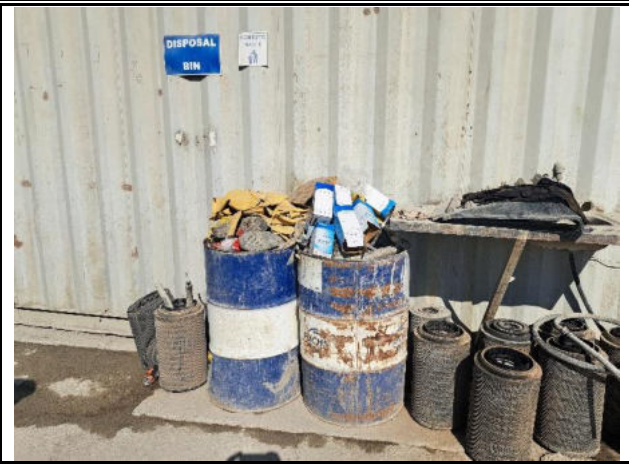
General- and hazardous waste to be kept separate

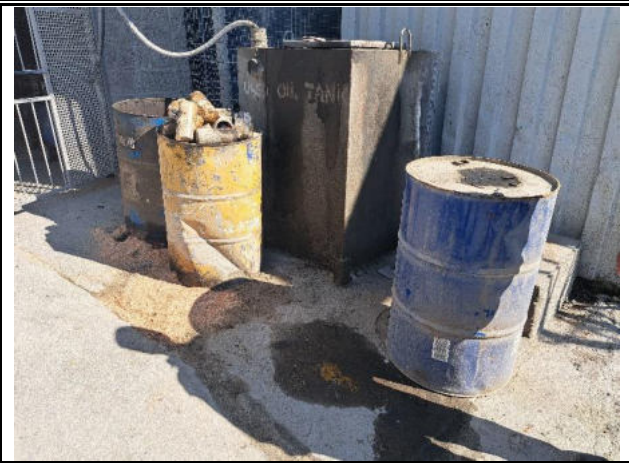
Used oil tank and drums to be placed in a bund

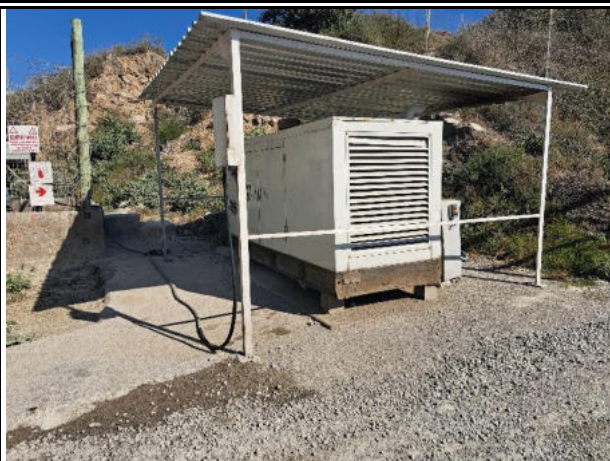
Generator to be placed in a bund

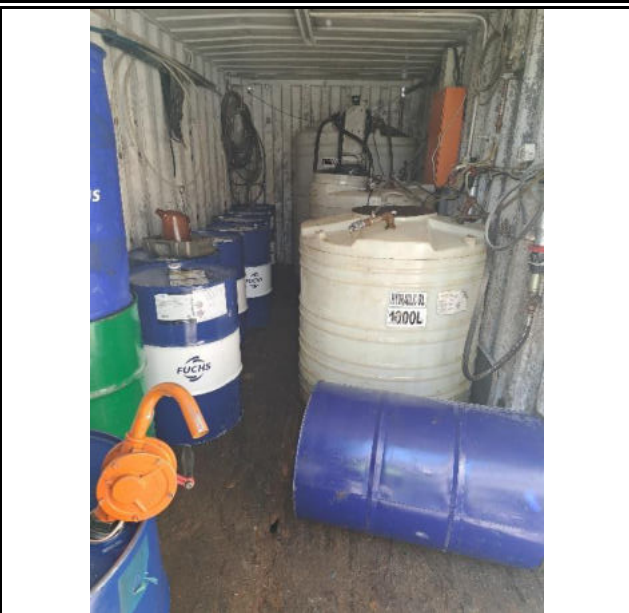
Floor of the oil store to be replaced by an impermeable lining

The oil store (under the offices) must be bunded. Presently the floor of the container allows spills to seep into the soil. Management of the oil store must improve. Further to this, the oil trap at the service pit must still be directed to an oil sump or tank and may not be allowed to drain into the surroundings. All spills caused in this area must be cleaned and the soil must be treated as hazardous waste.

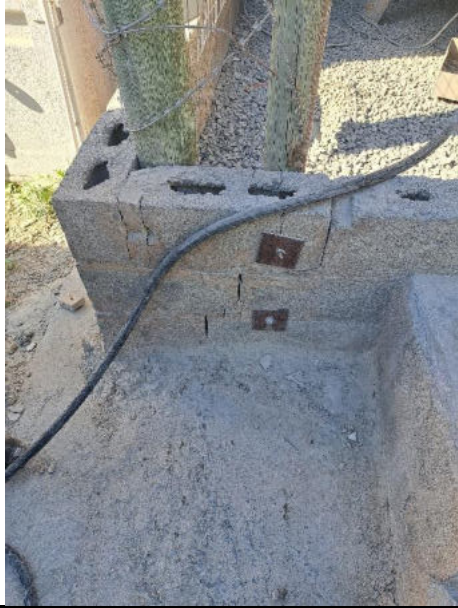
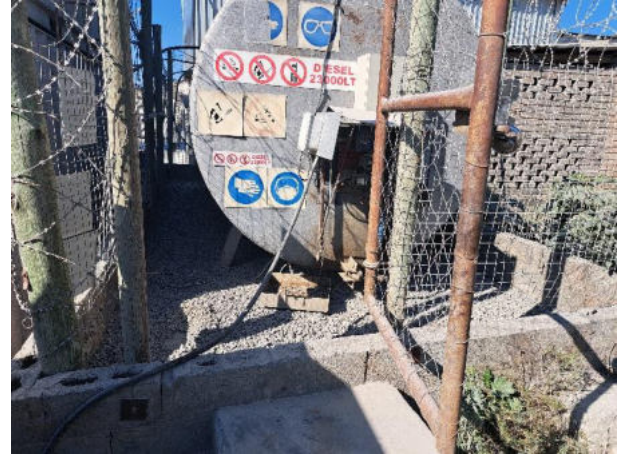
Bunds to be repaired and sealed

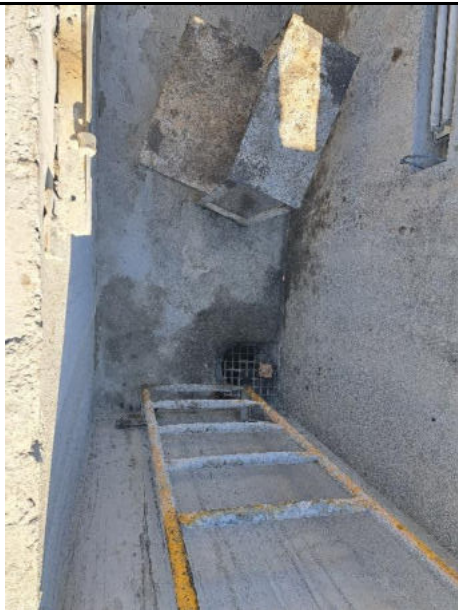
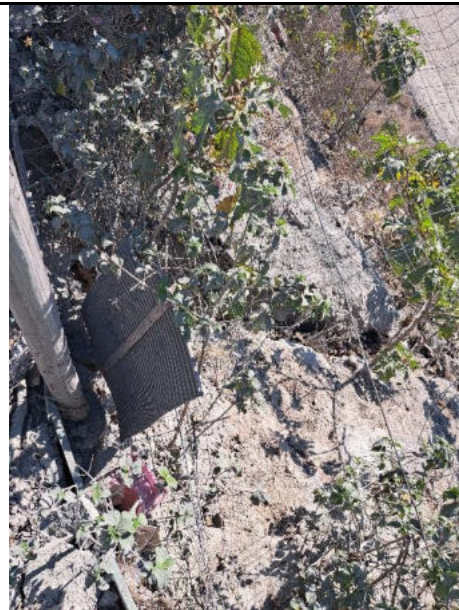
Oil draining from the service pit to be contained and spill to be cleaned
