MTHATHA QUARRY PORTION OF ADMINISTRATIVE AREA NO 11 CALLED ZITATELE, MTHATHA, EASTERN CAPE PROVINCE

ENVIRONMENTAL PERFORMANCE ASSESSMENT / ENVIRONMENTAL AUDIT REPORT

DMRE REFERENCE NUMBER:	EC 30/5/1/2/2/0135 MR
AUDIT PERIOD:	May 2024 – May 2025

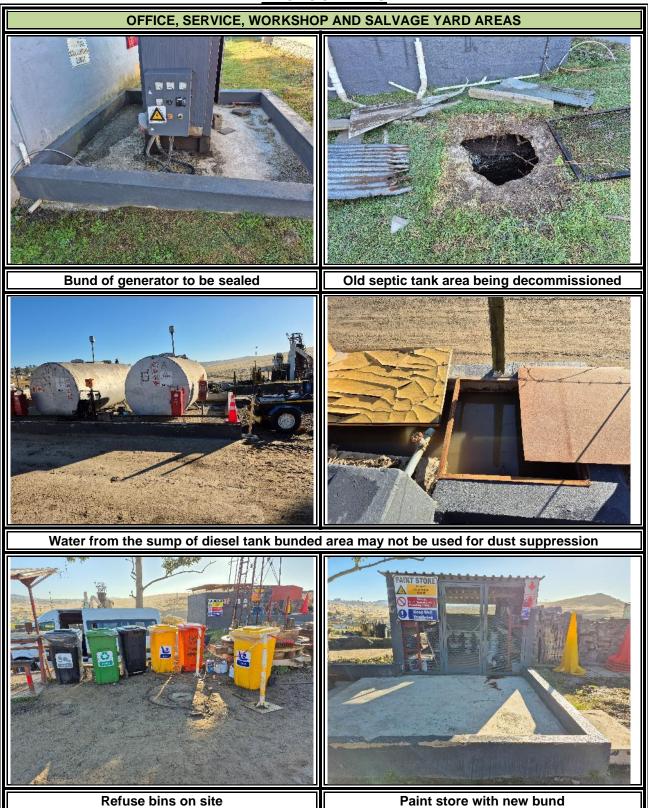
Sump of the used oil storage area must be improved

- 6. Complete and seal all bund walls and prevent the spraying (for dust suppression) of contaminated water from the bunds:
- 7. Add mesh/sieve to the pipe leading from the used oil tank's bund to the sump to keep frogs out;
