**PETRA QUARRY
PORTION 0 OF THE FARM HILLSIDE 2830,
BLOEMFONTEIN, FREE STATE PROVINCE**

ENVIRONMENTAL PERFORMANCE ASSESSMENT / ENVIRONMENTAL AUDIT REPORT

DMRE REFERENCE NUMBER:	FS 30/5/1/2/2/ (10059) MR
AUDIT PERIOD:	August 2023 – June 2024

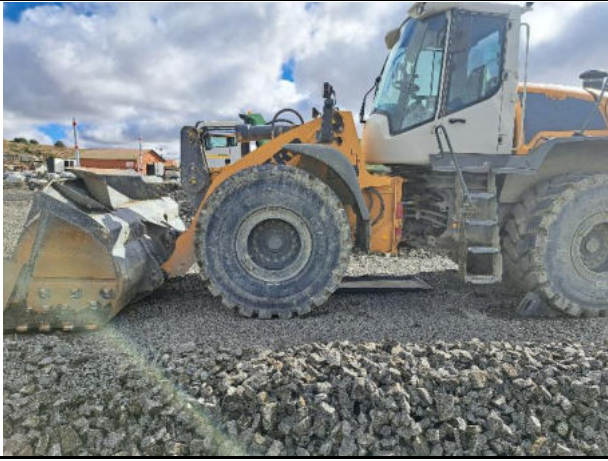
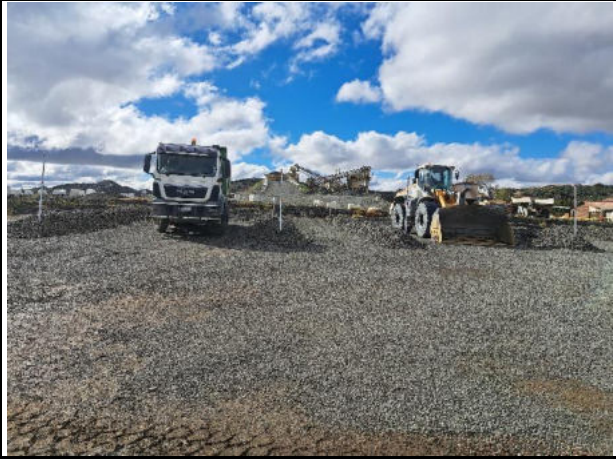
Formal parking bays for trucks and machinery. Drip trays in use.

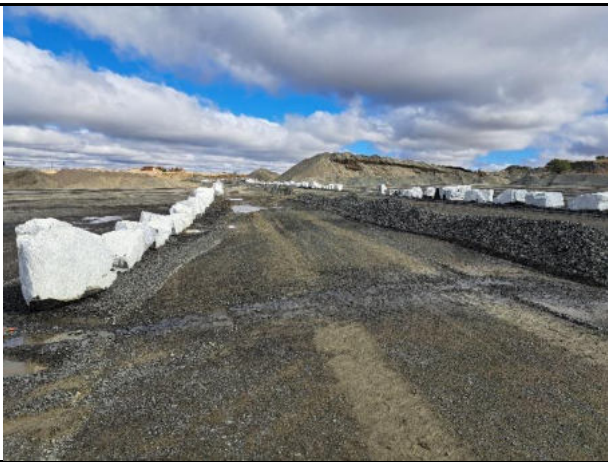
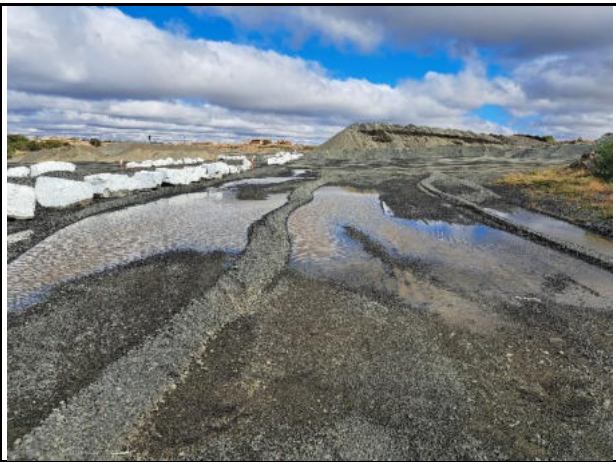
Roadways clearly demarcated

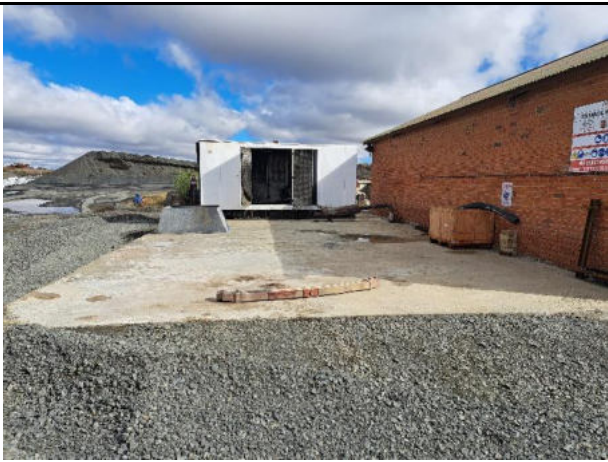
Concrete slab outside workshop

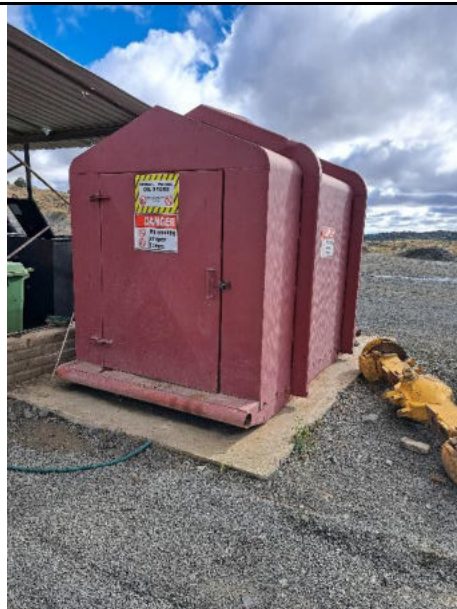
Oil store with build in bund

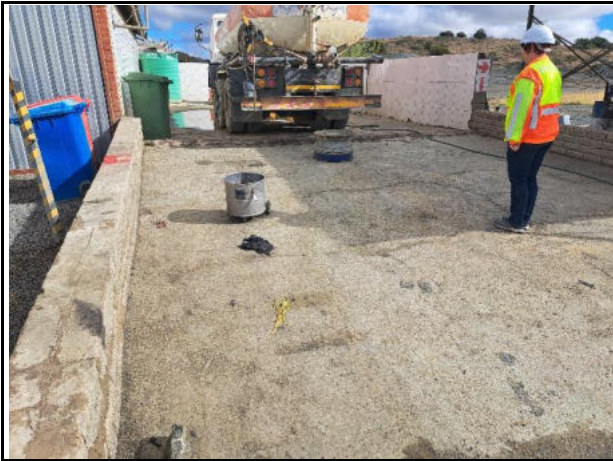
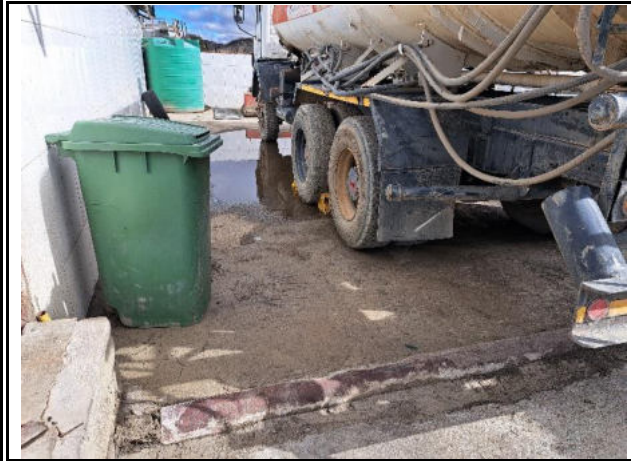
Improved wash bay

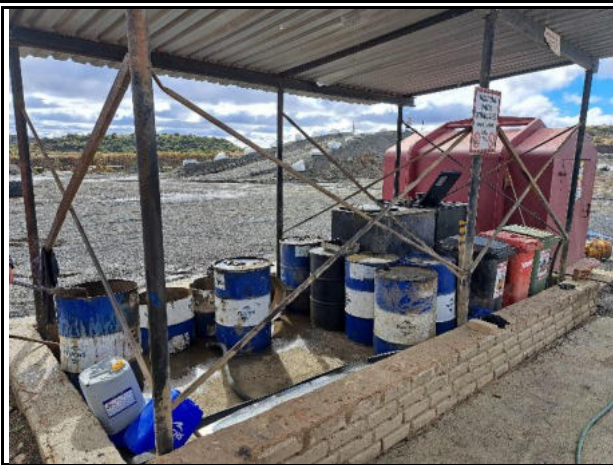
Hazardous waste storage area

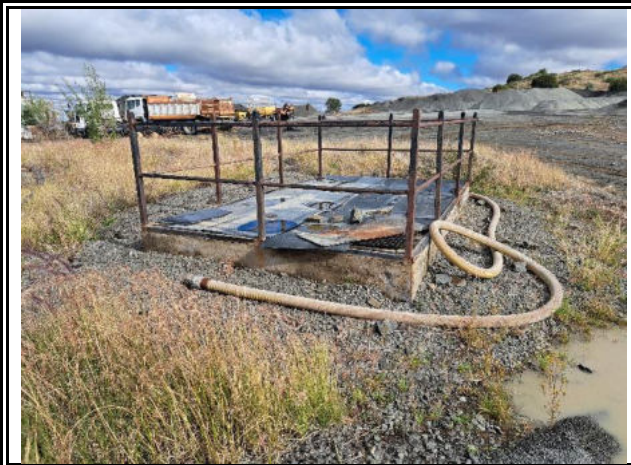
Oil sump

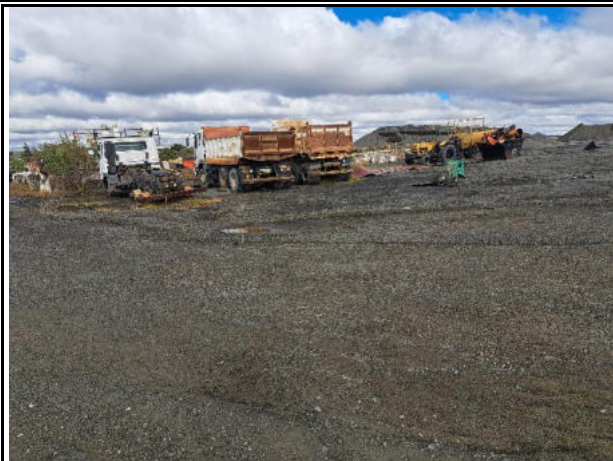
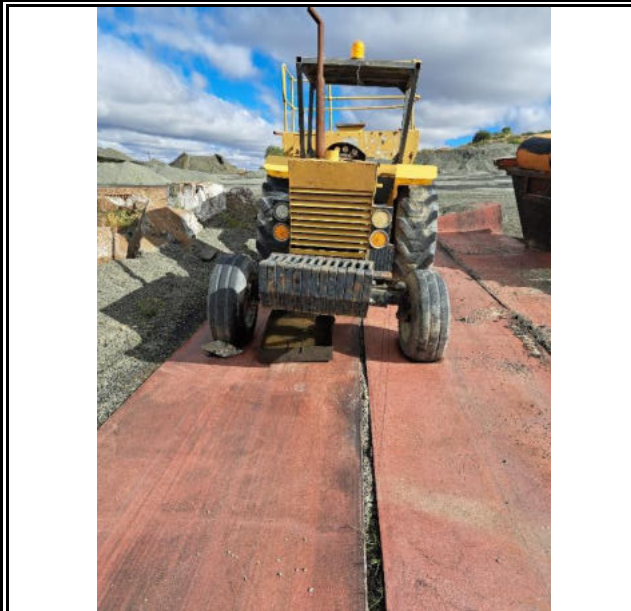
Salvage yard where old conveyor belts are reused

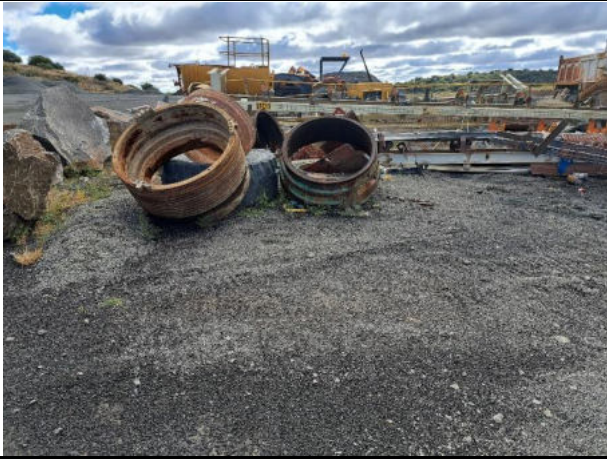
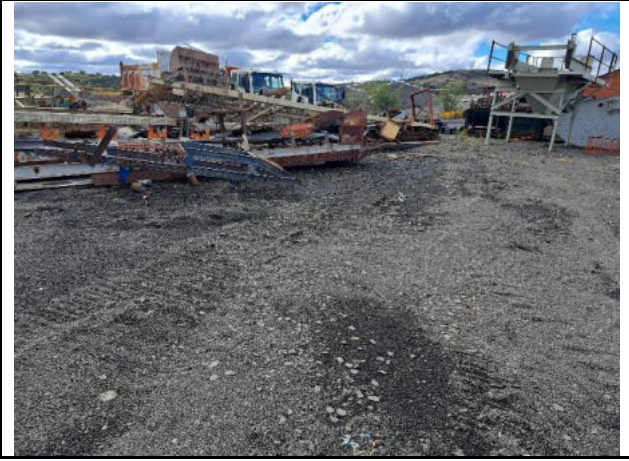
Salvage yard

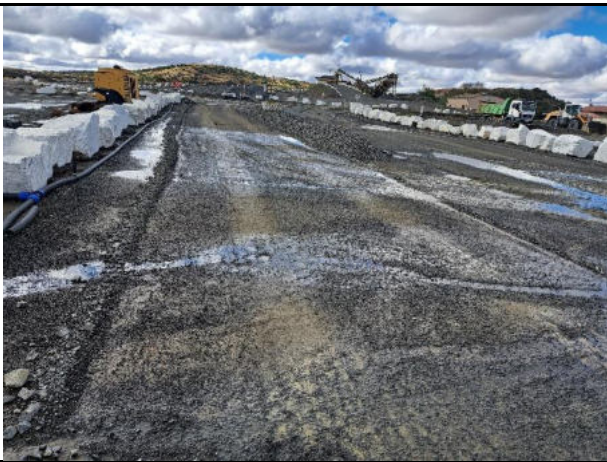
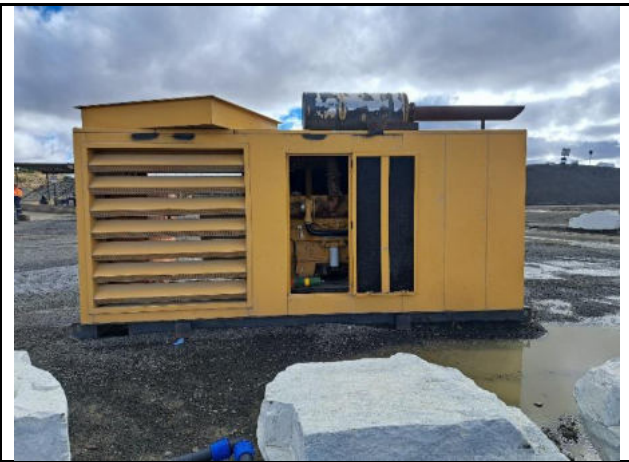
Roadway demarcated with old generator (not in use) adjacent to it

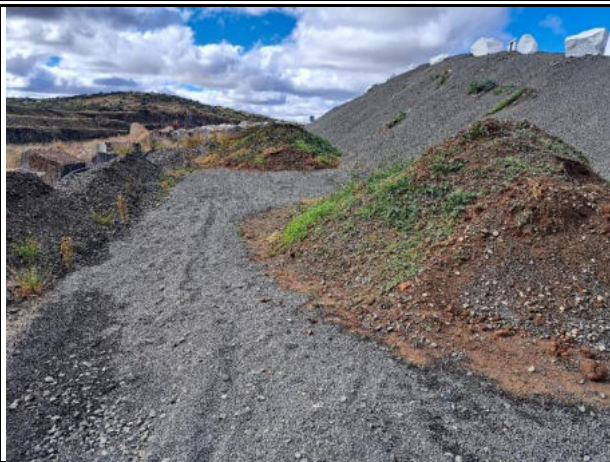
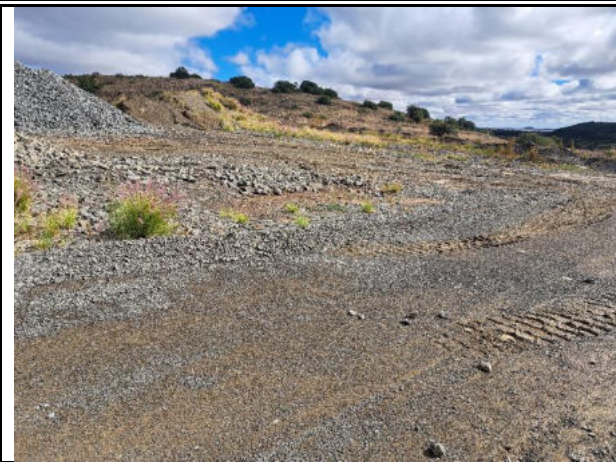
Problem plants removed from stockpiles

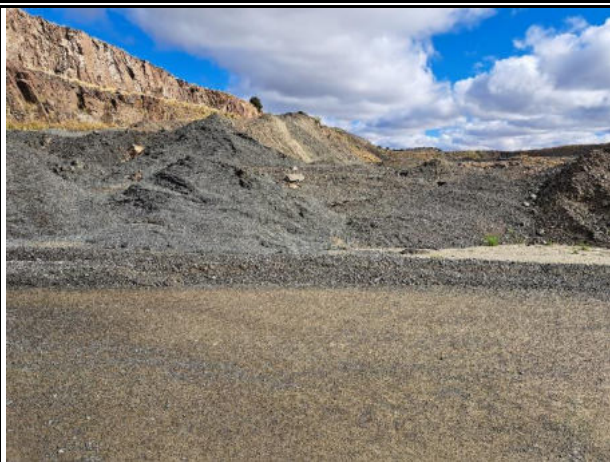
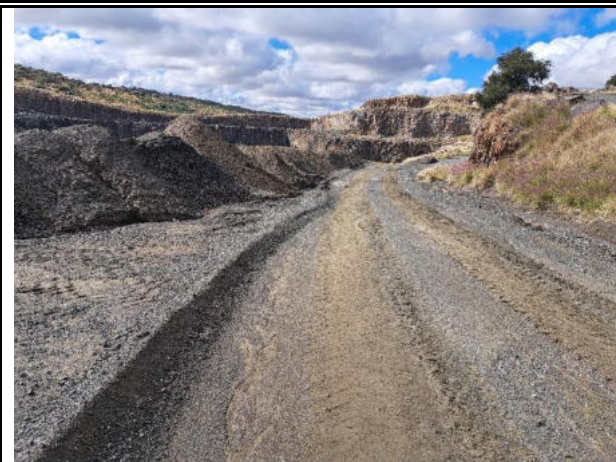
Sediment from the settling ponds used to rehabilitate the quarry

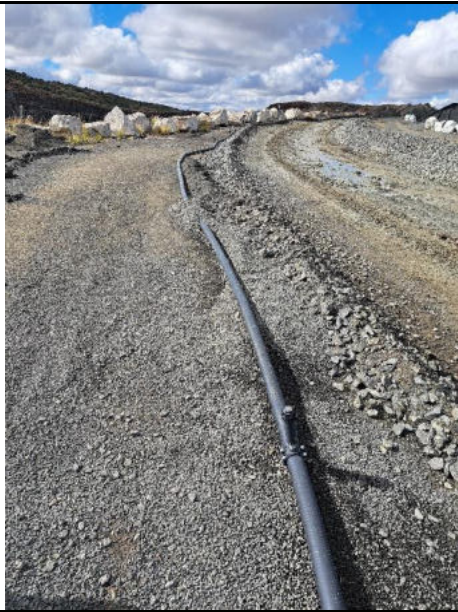
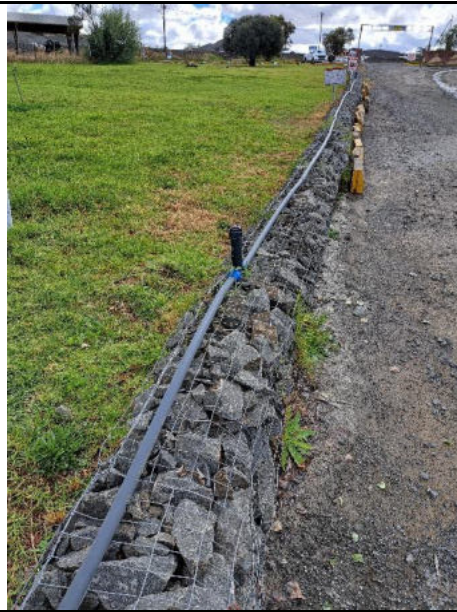
Sprayers installed to lessen dust generation

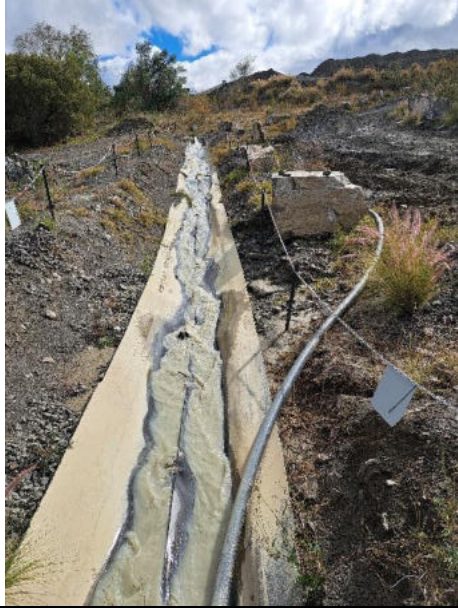
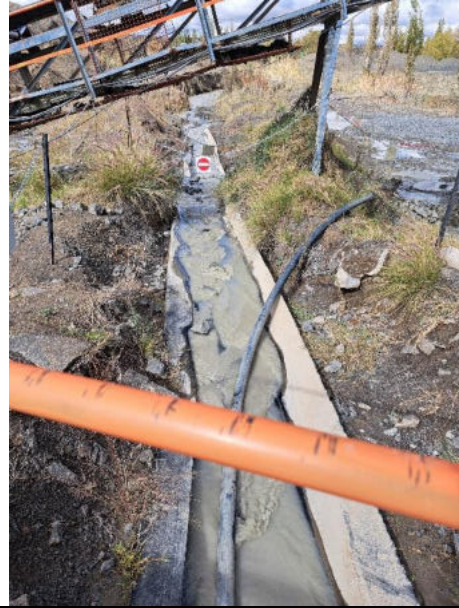
Conveyor belts used to direct the water runoff from the sand plant to the settling ponds

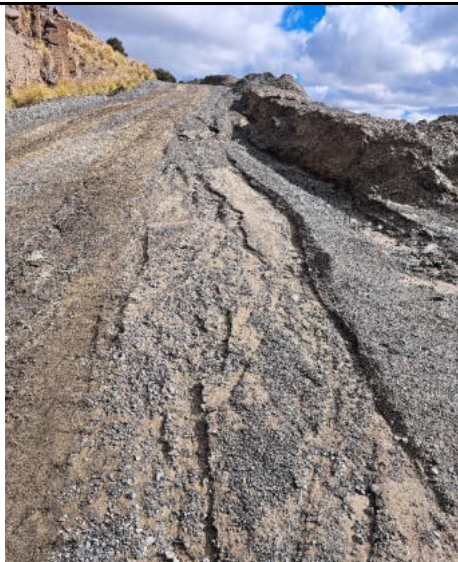
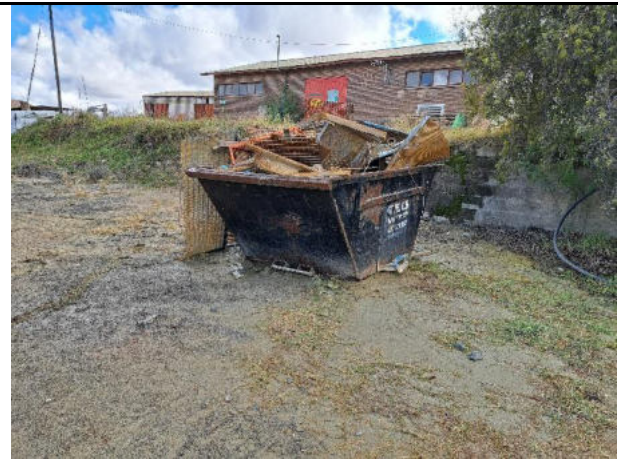
Sheet erosion due to rains – to be reinstated

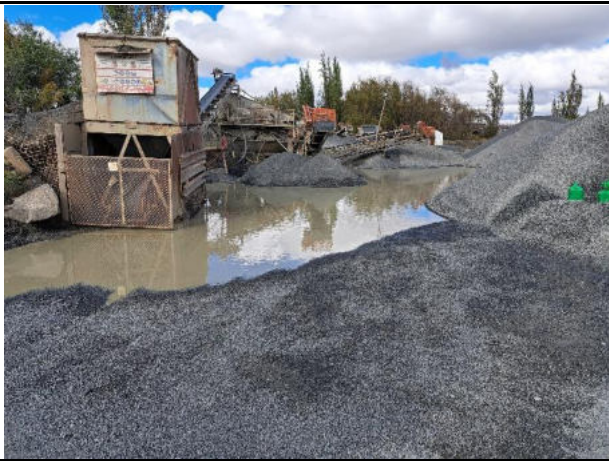
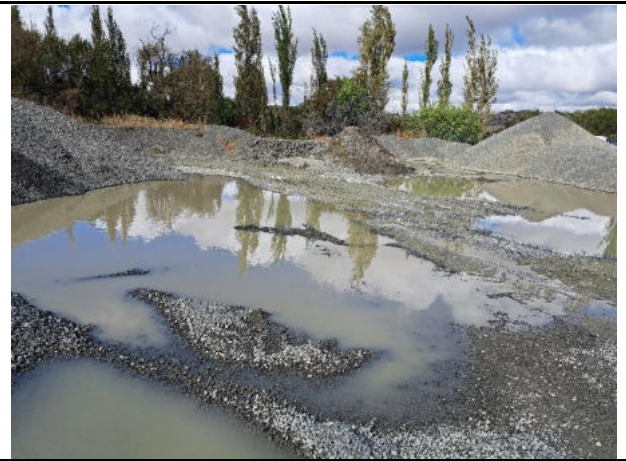
Stagnant water due to rains

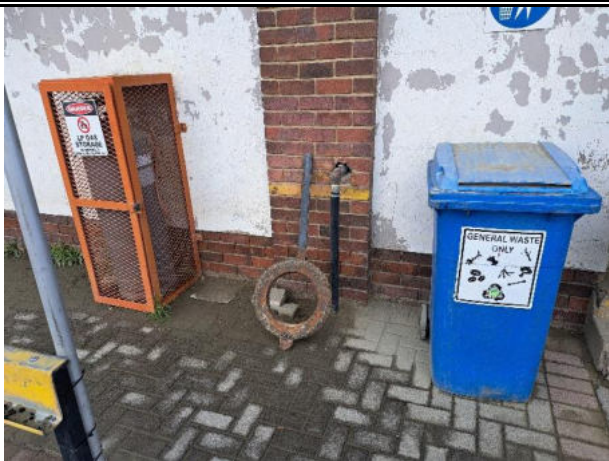
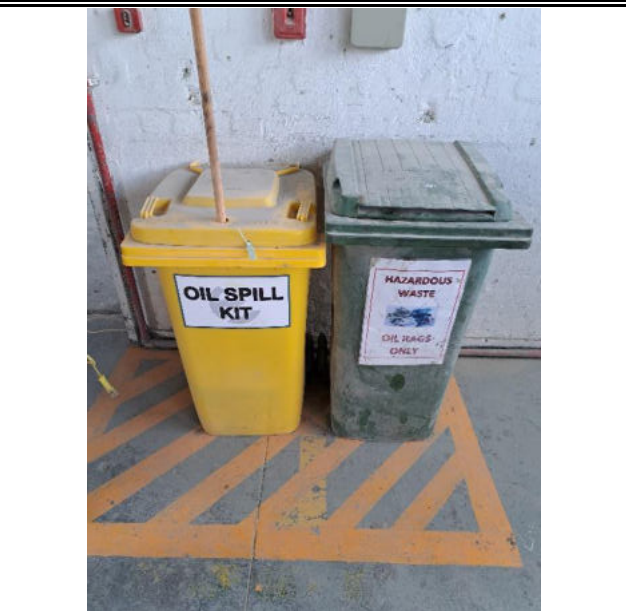
Refuse bins and oil spill kit on site

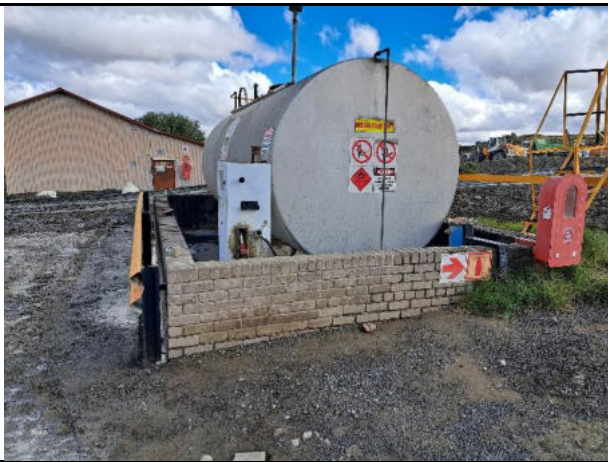
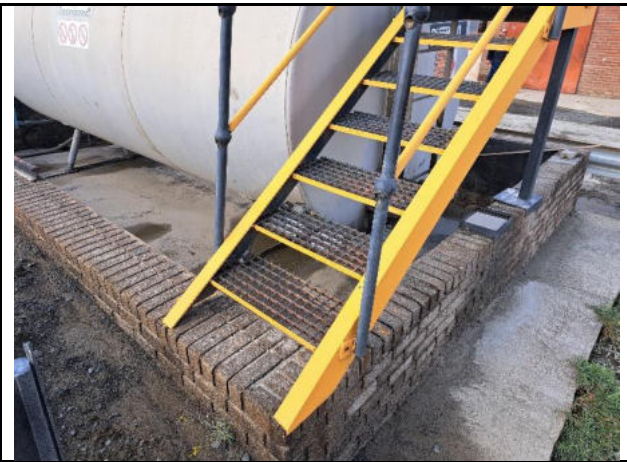
Diesel tank and bund wall

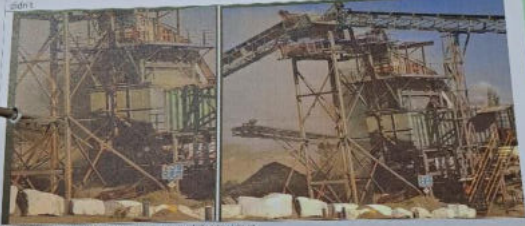
Description:
 Safety officer was on his way to the Primary Plant when the site Excessive Dust Release from the Secondary Plant. Site immediately took a sidestep and reported it to the Summer whatsapp group so that the supervisors can take action. Lebohang Lapote said that he already told the operator to open the water sprayers, not sure why he didn't.

Root Cause – singular issue that caused the incident
 Gross negligence of the plant operator – Reluctance for not opening water sprayers while operating the plant.

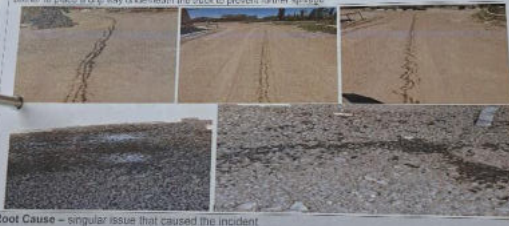
Description:
 On Saturday 20th of January 2024 at 13:15, the safety officer was on the way home when he noticed spills at the entrance gate and followed the spill. At the workshop he asked Edwar Mariani (plant supervisor) if he knew which truck is leaking oil. He said that it's the water truck that's leaking hydraulic oil because of a loose nut and that he will gather the nut. On investigation the safety officer was told that the water truck driver already left at 12:00. He didn't bother to check a dip they underneath the truck to prevent further spillage.

Root Cause – singular issue that caused the incident
 Environmental irresponsible behaviour by operator
