**SAND MINE ON A PORTION OF THE FARM DE  
KLERKSKRAAL 231 IN THE THEUNISSEN DISTRICT,  
FREE STATE PROVINCE**

**ENVIRONMENTAL AUDIT REPORT**

<b>DMR REFERENCE NUMBER:</b>	<b>FS30/5/1/3/2/10207MP</b>
<b>AUDIT PERIOD:</b>	<b>February 2021</b>

<b>Permit Number:</b>	FS30/5/1/3/2/10207MP	<b>Date of Commencement:</b>	November 2019
<b>Site Name:</b>	De Klerkskraal Quarry	<b>Inspection Date:</b>	26 February 2021
<b>Permit Holder:</b>	Blazecor 226 CC	<b>Other Authorisations:</b>	4 March 2017
<b>Report Number:</b>	11

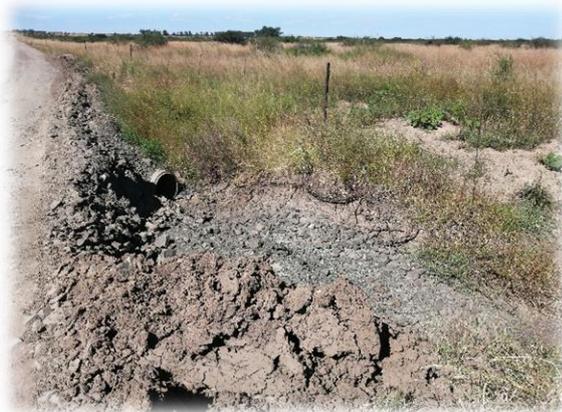
Erosion around the culvert area, channelling stream flow underneath the access road have reappeared. The portion of the river bank around the water pipeline have been subjected to erosion, furthermore, this portion of the bank have been disturbed during maintenance on the pipeline and water pump.

**The culvert that needs to be upgraded**

- a) The culvert system should be upgraded to a larger system, preferably a block culvert, which can be placed, level with the natural flow level of the stream. Erosion structures (earthen berms/rock fill foundations) and dissipaters should be reinstated.

- Areas with erosion within the mining area:
  - *Recommended Mitigation:*
    - a) The culvert system should be upgraded to a larger system, preferably a block culvert, which can be placed, level with the natural flow level of the stream. Erosion structures (earthen berms/rock fill foundations) and dissipaters should be reinstated.

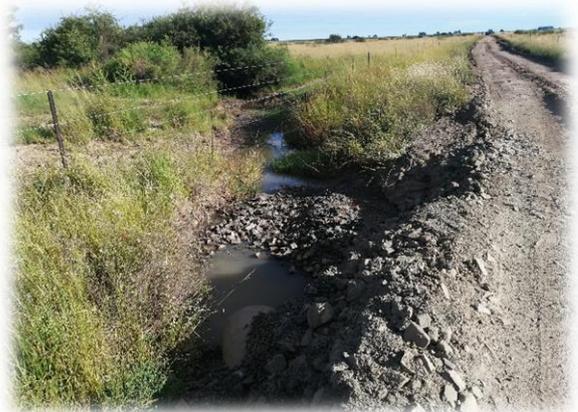
**Damming of water above the culvert indication the inability of the culvert to allow for natural drainage/stream flow.**

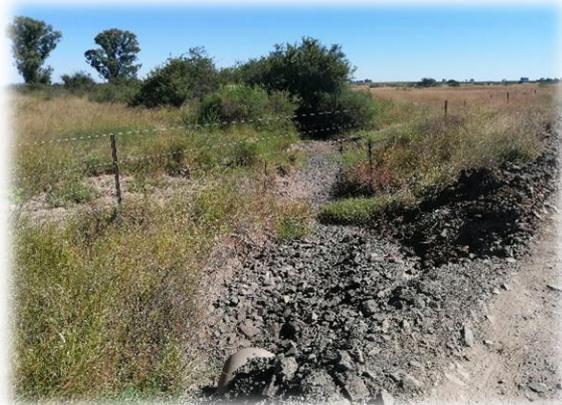
**Most of the erosion prevention structures have been flushed away.**

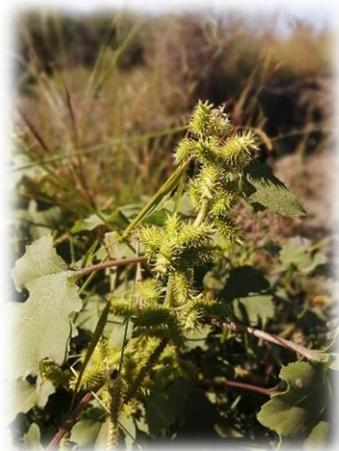
A few Category 1b Alien Invasive Plants, most notably *Datura ferox* (Olieboom) and *Xanthium strumarium* (large cocklebur, kankerroos), have started to establish within the mining footprint and along the access route.

*Xanthium strumarium* (Large cocleblur, kankerroos)

- *Recommended Mitigation:* Within three weeks upon receipt of this report, a walk-through of the mining property should be conducted, wherein all affected (invaded) areas should be identified. These areas should then be cleared of these species with care taken not to allow the dispersal of seeds.

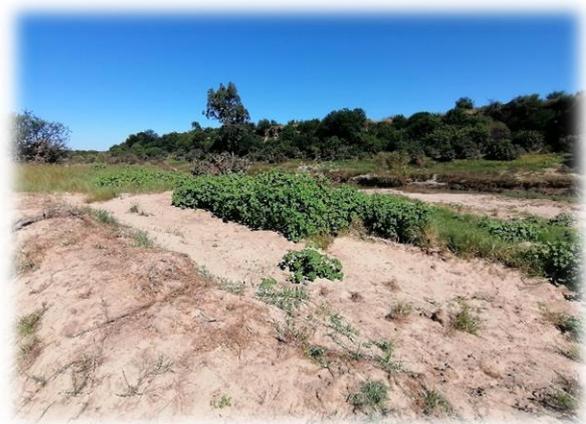
*Xanthium strumarium* (Large cocleblur, kankerroos)

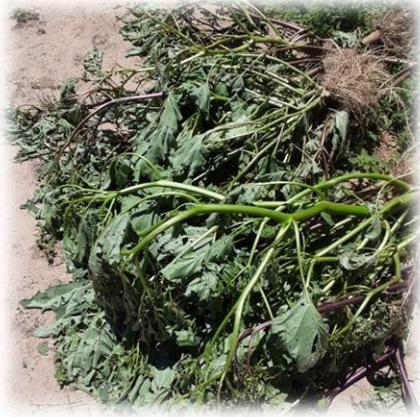
*Some eradication of IAPs have already occurred and is currently in progress.*

Eradication of IAPs (*Datura stramonium*)

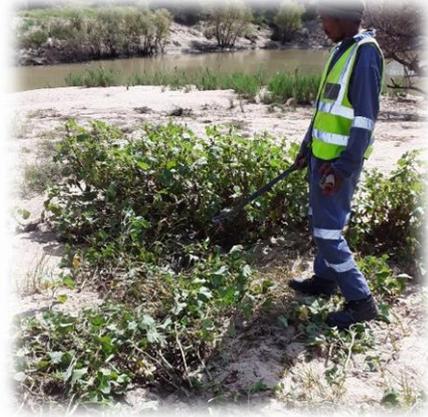
Eradication of IAPs (*Xanthium strumarium*)
