**GRANITE/SYNEITE MINE ON A PORTION OF PORTION 2 AND
REMAINING EXTENT OF THE FARM AROAMS 57, AGGENEYS
NORTHERN CAPE PROVINCE.**

**ENVIRONMENTAL PERFORMANCE
ASSESSMENT REPORT**

REFERENCE NUMBER	NC 30/5/1/3/2/10746 MP
AUDIT PERIOD	MARCH 2025

ENVIRONMENTAL PERFORMANCE ASSESSMENT AROAMS QUARRY- LIME SALES

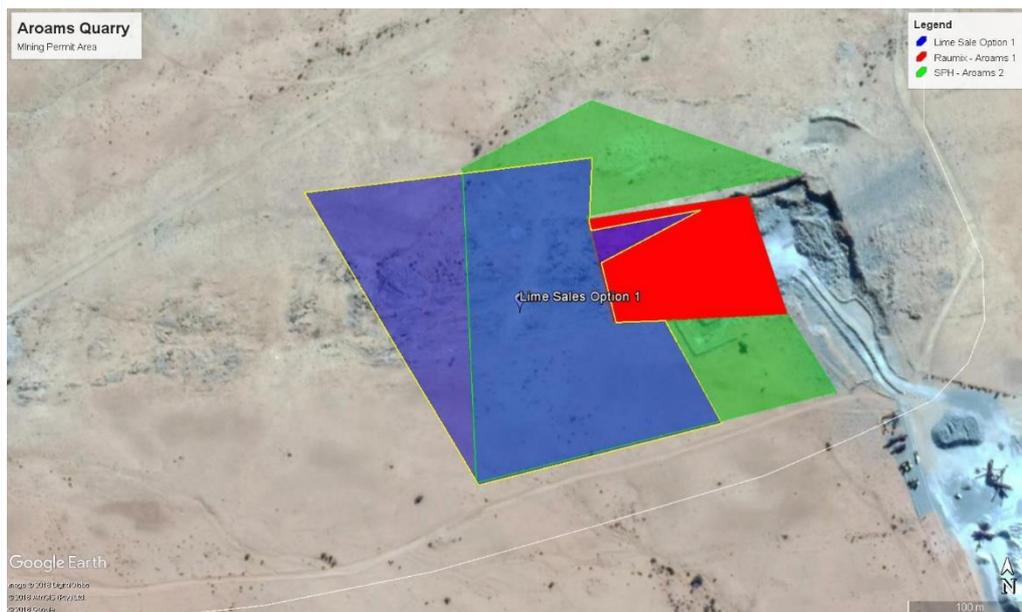
Figure 1: Location of the Lime Sales mining permit 10746MP (blue polygon) that this audit is based on. (Image obtained from Google Earth).

Green area shows the (previous permit held by SPHK) and Red areas shows the (previous permit area held by Raumix). These areas remain unclosed.

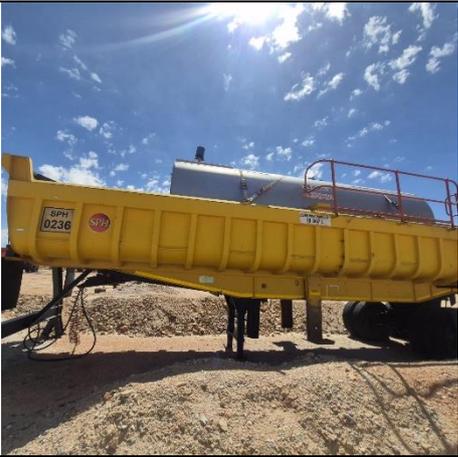
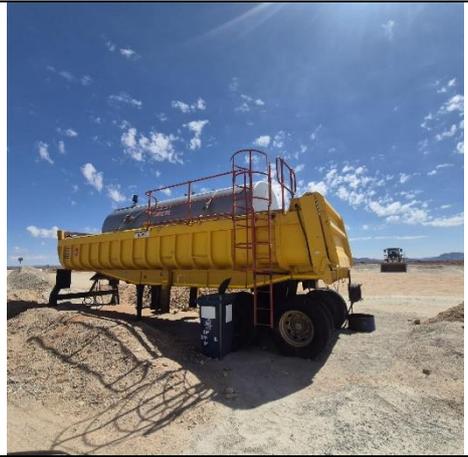
FORMALISED BUND AREA

The generators are fitted with formal bunds with a 110% capacity. No contaminated soil was seen on site. Drip was placed and visible under all stationary vehicles.

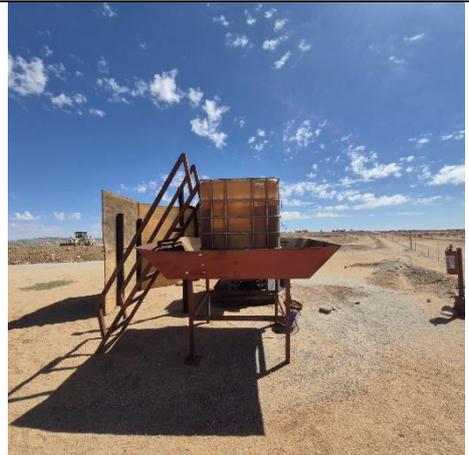
BUNDED OIL TANK

Height of product stockpiles determined based on visibility of site	5	-	Compliant	Due to the remote location of the quarry pit, site visibility is not a major concern. It was recommended to store product heaps at a greater height to reduce the required footprint.
HAZARDOUS CHEMICAL MANAGEMENT (EMPR PG 18)				
Hazardous material stored within a bunded area (110% capacity)	5	-	Compliant	Hazardous materials were stored in bunded areas, which were deemed sufficient at the time of inspection. A designated area was allocated for used oil.
Management of fuel and oil spills	5	-	Compliant	<ul style="list-style-type: none"> Bunded areas of the generators, and diesel tanks are formalised with steel pans.

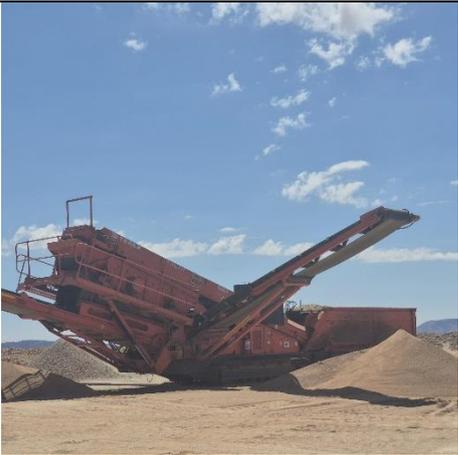
MACHINERY PARKING AREA WITH DRIP TRAYS

DESCRIPTION	COMPLIANCE SCORE	NON-COMPLIANCE SCORE	STATUS	COMMENTS
				<ul style="list-style-type: none"> The use of drip trays under all stationary vehicles is compulsory and is implemented to prevent spillages/dripping equipment contaminating the area.
Drip trays present when refuelling is done outside the service bay	5	-	Compliant	<ul style="list-style-type: none"> Drip trays were present under vehicles. At the time of inspection, no refuelling was done. However, the bowser nozzle was fitted with a drip tray and the surrounding area was visibly clean.
Temporary work bays for emergency repairs must be provided with a concrete floor or lining. Supplied with oil trap.	5	-	Compliant	<ul style="list-style-type: none"> When emergency repairs are needed on site, drip trays are used as a mitigation measure. All major services are done at Aggeneys. The construction of a workshop will take place once the MR is executed, currently the commencement date of the MR has been postponed.

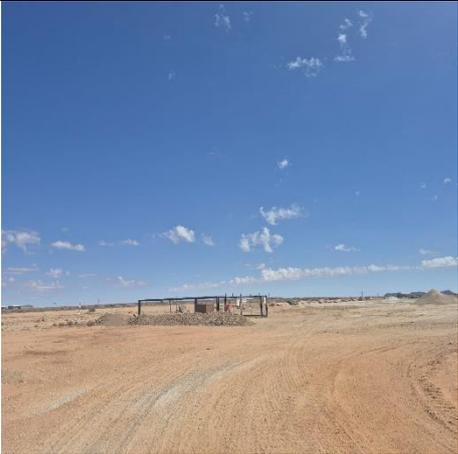
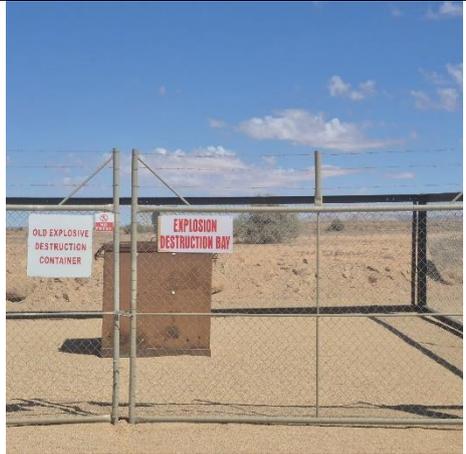
EXPLOSION DESTRUCTION BAY – WITHIN THE MINING PERMIT AREA

As per instruction from Law Enforcement: a designated explosive bay was erected in accordance with the Blasting regulations on an already cleared area within the mining permit area.

Empty explosives cardboard boxes and plastic bags must be over inspected and flattened to ensure that they are clear and free of any explosives and accessories before they are burned after the blast in the designated Burning Bay by the appointed Blaster and must be recorded in writing and kept for a period of three (3) years.

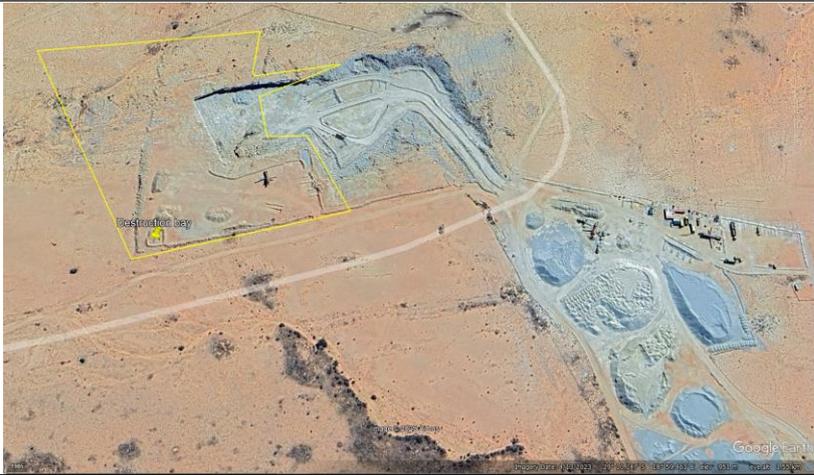
DESCRIPTION	COMPLIANCE SCORE	NON-COMPLIANCE SCORE	STATUS	COMMENTS
Explosives destruction bay	5	-	Compliant	<p>The directive issued by law enforcement: in accordance with blasting, Regulation.</p> <ul style="list-style-type: none"> Empty explosives cardboard boxes and plastic bags must be over inspected and flattened to ensure that they are clear and free of any explosives and accessories before they are burned after the blast in the designated Burning Bay by the appointed Blaster and must be recorded in writing and kept for a period of three (3) years.
MINE AND EQUIPMENT MANAGEMENT (EMPR PG 17)				
Mining area demarcated with visible beacons	5	-	Compliant	The extension area, 10746MP, is clearly marked and visible with white poles.
Mining conducted within approved footprint area	5	-	Compliant	Mining conducted within the demarcated and approved Lime Sales MP 10746Mp, marked in blue in figure 1. The existing processing and stockpile area is still used as per agreement.in the 10040MP area and will not exceed the already disturbed area. An aerial photo in support of activities is included in the photo report.
