PROPOSED MINING OF AGGREGATE ON PORTION 18 (PORTION 2) OF THE FARM LOUTERBRONNEN 250, THEUNISSEN DISTRICT, FREE STATE PROVINCE

ENVIRONMENTAL AUDIT REPORT

DMR REFERENCE NUMBER:	FS 30/5/1/2/2/10040 MR
AUDIT PERIOD:	February 2021

Permit / Right Number:	FS 30/5/1/2/2/10040 MR	Date of Commencement:	15 May 2019
Site Name:	Louterbronnen Aggregate Quarry	Inspection Date:	26 February 2021
Permit / Right Holder:	Vengablox (Pty) Ltd	Other Authorisations:	24 March 2017
Report Number:	12

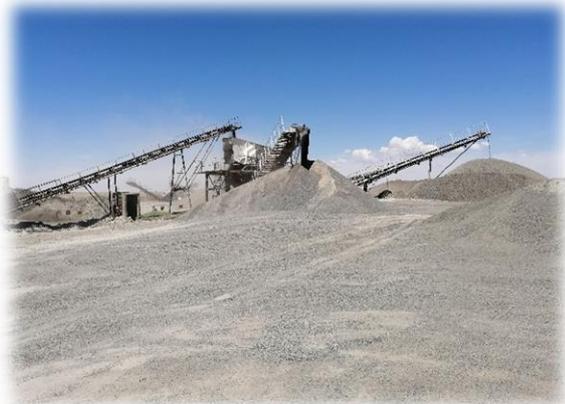
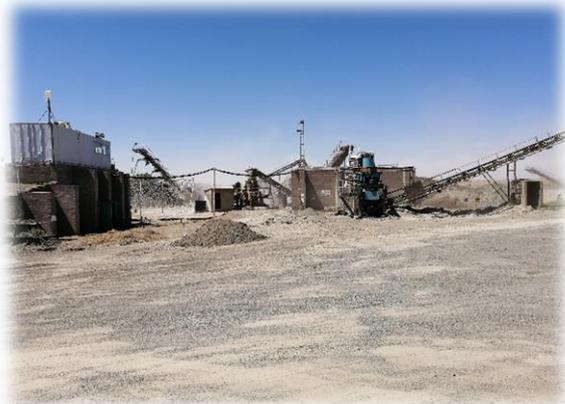
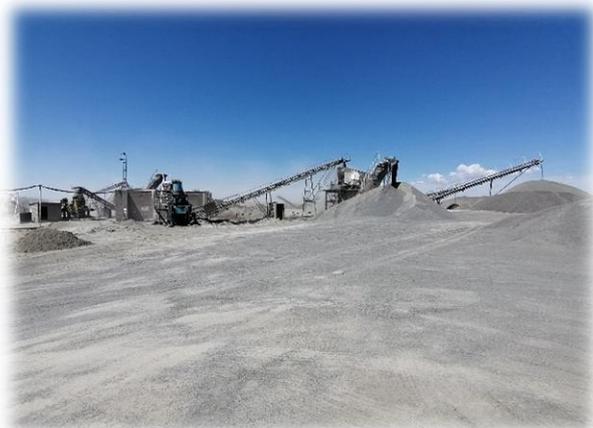
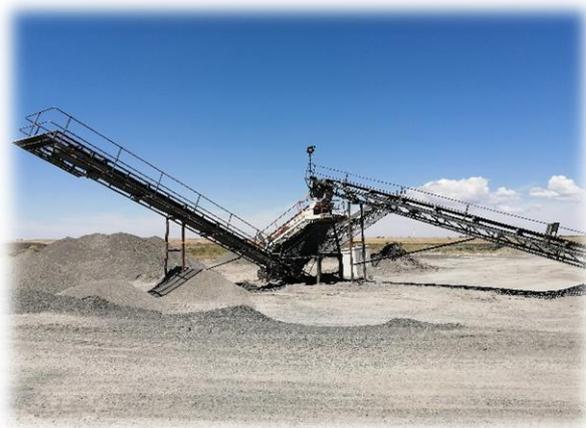
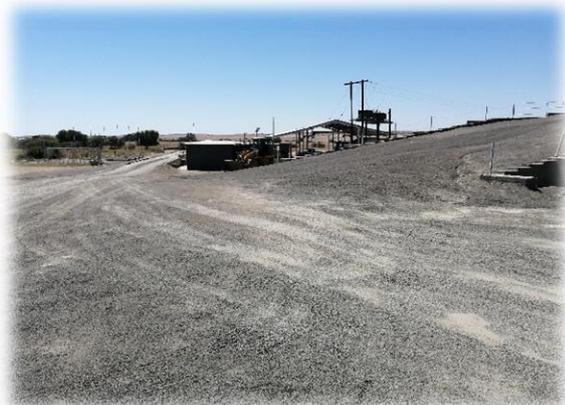
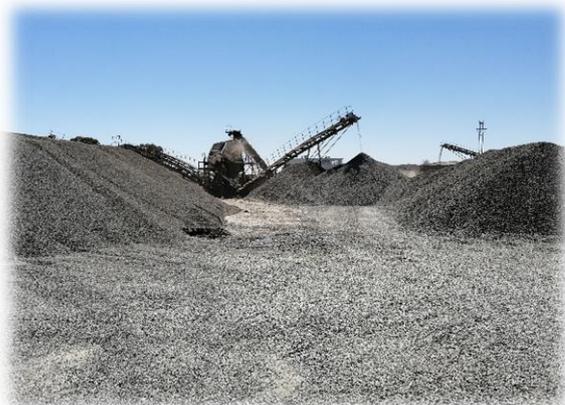
SCREENING AND CRUSHING PLANT

The mine has made notable progress in addressing the amount of dust pollution generated within the mining area, including wetting of access roads, stockpiled material and some of the crushing plants. Wind barriers have also been installed on some of the crushing plants. However, the mine is still in the process of implementing/installing additional dust prevention measures.

- *Recommended Mitigation:* The mitigation of dust generated from the remainder of the processing/crushing plants are still in progress and should be completed as soon as possible.

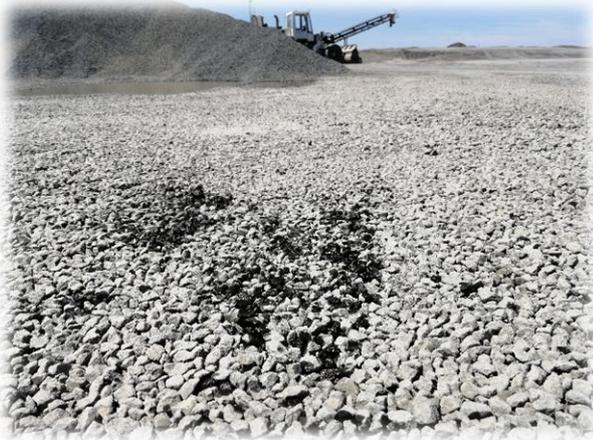
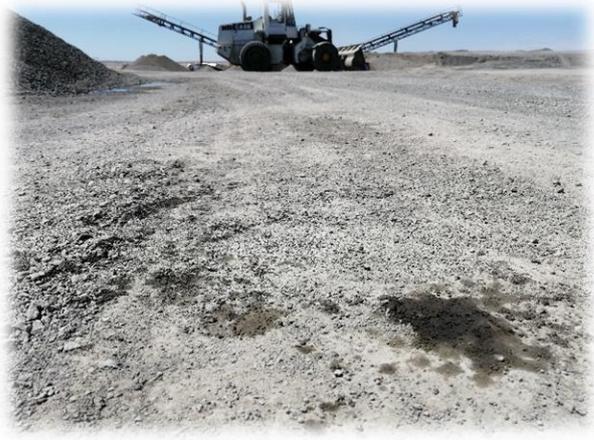
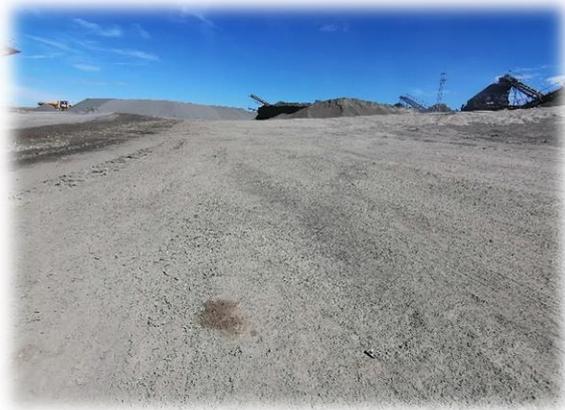
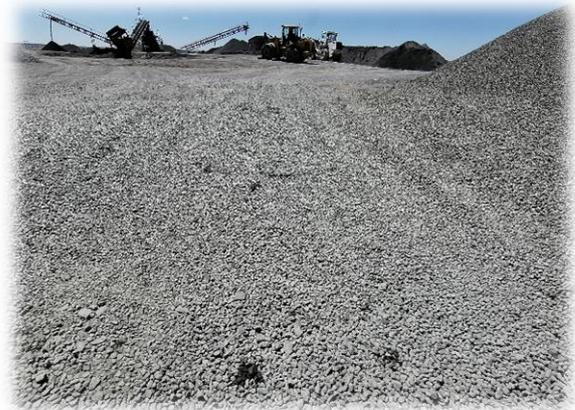
○ Hazardous spills: Even though all spills recorded during the previous month's inspection have been cleaned up numerous new small oil spills have been recorded during this inspection.

- Mine plan to be drawn up by land surveyor.
- Small oil leaks and the responsible mining vehicle: Numerous new small oil spills have been recorded within the mining area, and are the result of an unsound mining vehicle. These oil spills should be cleaned up and

Example of Oil Spill

- *Recommended Mitigation:* The culprit mining vehicles/machinery responsible for the numerous small oil spills should be identified and serviced (made sound).

- *Recommended Mitigation:* More frequent clean up inspections should be considered.

- The small oil spills identified within the mining areas should be cleaned up and stored within the appropriate manner (sealable container within the bunded area for hazardous waste) as soon as possible (before mine closer for the remainder of the year).
- The mining vehicle responsible for the oil spills should be serviced (made safe) as soon as possible.
- Drip trays to be used when refuelling.
- The washbay's sump and oil separator have reached its capacity and should be emptied.

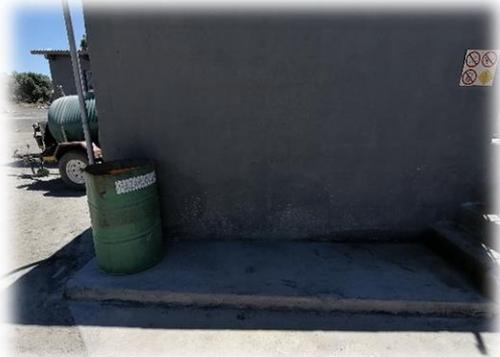
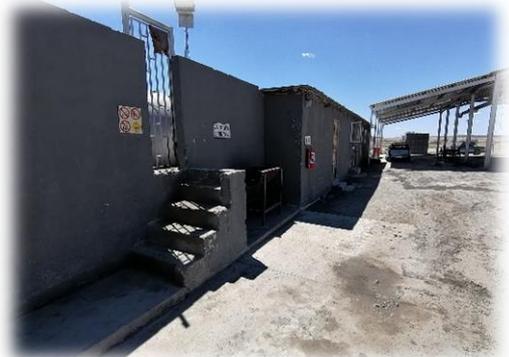
FUEL STORAGE AND REFUELLING AREA

○ Drip trays used when refuelling is done outside the service bay: At the time of the inspection it was noted that drip trays are not used when refuelling with some spillage occurring on bare soil during the refuelling process.

- *Recommended Mitigation:* The use of drip trays during refuelling should be mandatory.

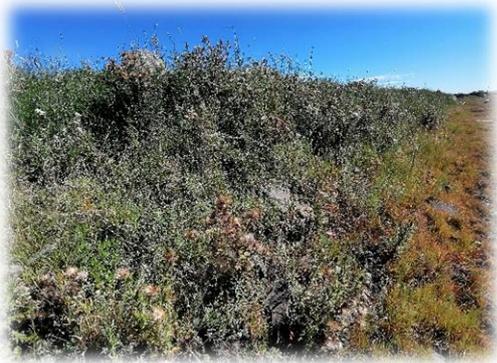
Some Invasive Plants have established on some of the topsoil heaps.

Stockpiled topsoil with numerous IAPs, mainly *Xanthium spinosum*

- *Recommended Mitigation:* Within three weeks upon receipt of this report, a walk-through of the mining property should be conducted, wherein all affected (invaded) areas should be identified. These areas should then be cleared of these species with care taken not to allow the dispersal of seeds. The use of chemical methods is allowed and a few registered chemicals are mentioned below.

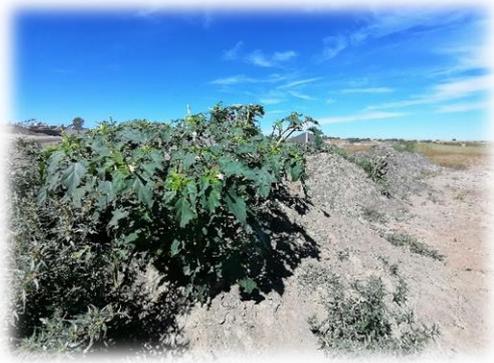
Some Invasive Plants have established on some of these heaps.

Datura stramonium, growing on one of the stockpiled soil heaps

- *Recommended Mitigation:* Within three weeks upon receipt of this report, a walk-through of the mining property should be conducted, wherein all affected (invaded) areas should be identified. These areas should then be cleared of these species with care taken not to allow the dispersal of seeds. The use of chemical methods is allowed and a few registered chemicals are mentioned below.

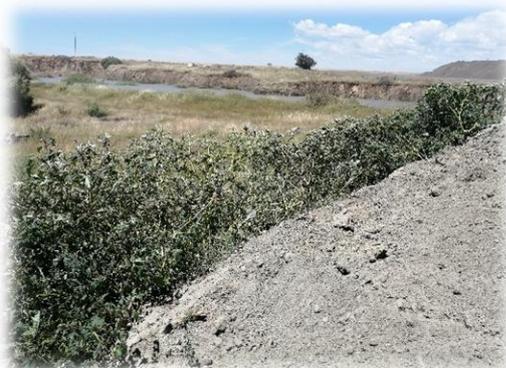
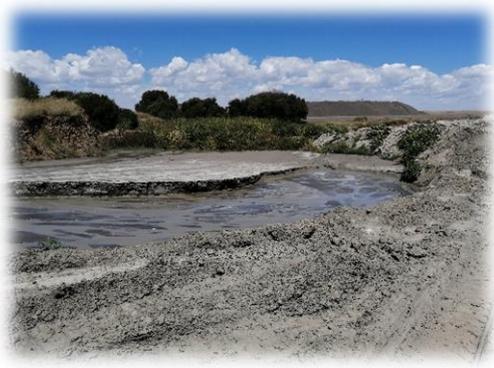
SETTLING POND

Apart from the topsoil and overburden stockpiles some IAPs have established within other areas of the mine.

Note the establishment of the IAP, *Datura stramonium* along the margins of the settling pond.

- *Recommended Mitigation:* See recommended mitigations above (Topsoil Storage & Stockpiled Overburden).

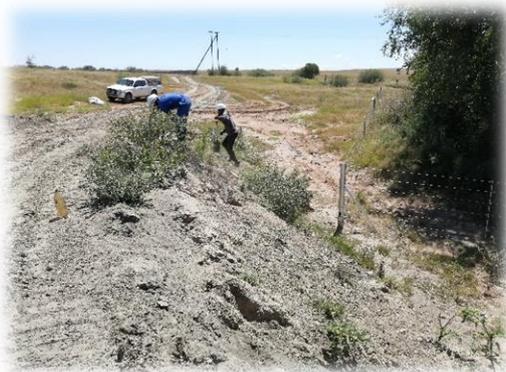
Eradication of *Datura stramonium* in progress.
