**Vegetation and Wetland Assessment for borrow pit Site 1 for the Mulilo Newcastle Wind Energy Facility (WEF) situated near Newcastle in KwaZulu-Natal.**

January 2025

<b>Report Version</b>	Final 1.1		
<b>Title</b>	Vegetation and Wetland Assessment for borrow pit Site 1 for the Mulilo Newcastle Wind Energy Facility (WEF) situated near Newcastle in KwaZulu-Natal.		
<b>Author</b>	DP van Rensburg (Pr.Sci.Nat)

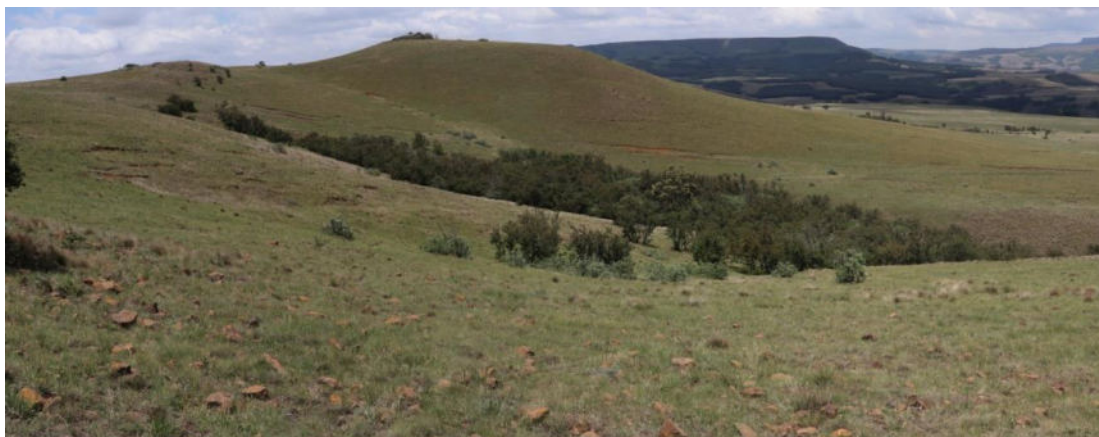
Figure 3: The area is still largely natural, with vegetation dominated by species rich grassland habitats. Note however infestation by invasive *Acacia mearnsii*, along drainage lines.

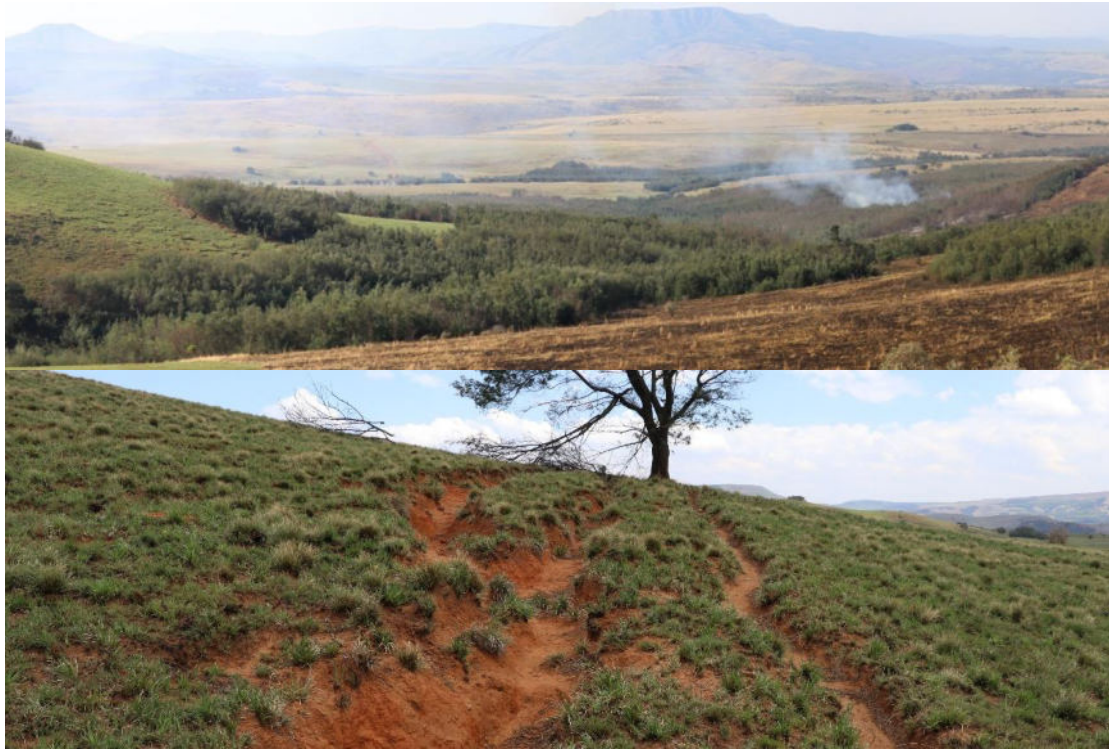
Figure 4: Though the area is still largely natural, significant impacts include quite severe infestation by *Acacia mearnsii* (Top) and significant erosion occurring along livestock tracks and steep slopes (Bottom).

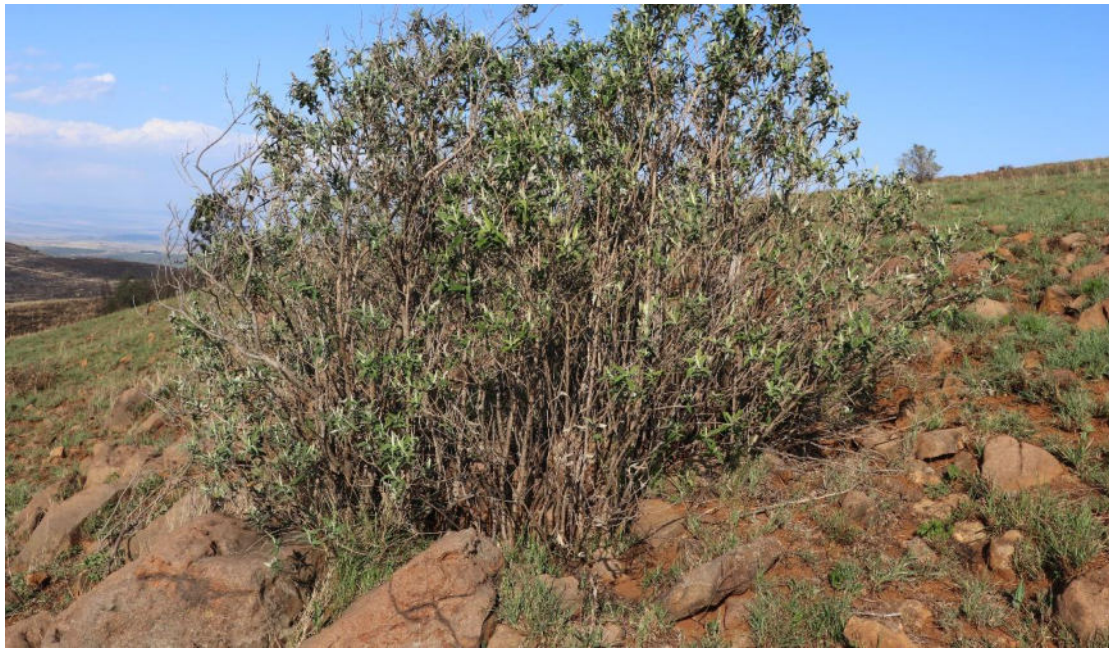
Figure 7: Where surface dolerite boulders occur, these provide a higher diversity of micro-habitats which also promote species diversity on the site.

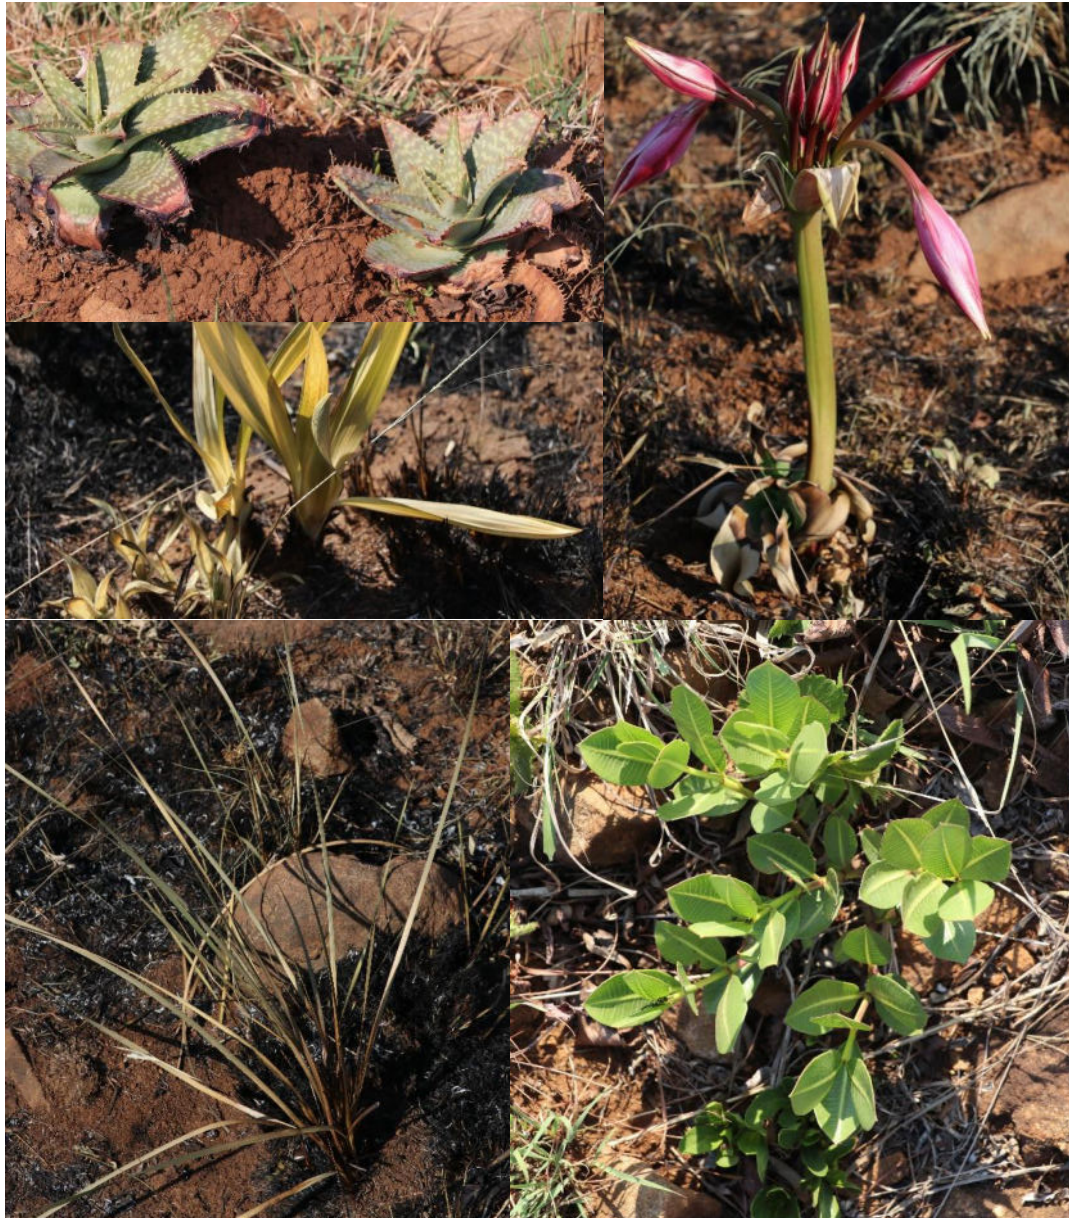
Figure 8: Protected species occurring on the site include, clockwise from top left: *Aloe maculata*, *Crinum macowanii*, *Raphionaceme hirsuta*, *Dierama galpinii* and *Schizocarpus nervosus*. It should be noted that these may also be quite difficult to identify at some certain times of the year, especially during the dormant winter season.

- Numerous protected plant species have been identified **Site 1** (Appendix B). These include the protected succulent and geophytic species, *Gladiolus ecklonii*, *Raphionacme hirsuta*, *Dierama galpinii*, *Aloe maculata*, *Schizocarpus nervosus* and *Crinum macowanii*. Where development will affect these species, the necessary permits should be obtained and a significant proportion of these transplanted to adjacent areas where they will remain unaffected.

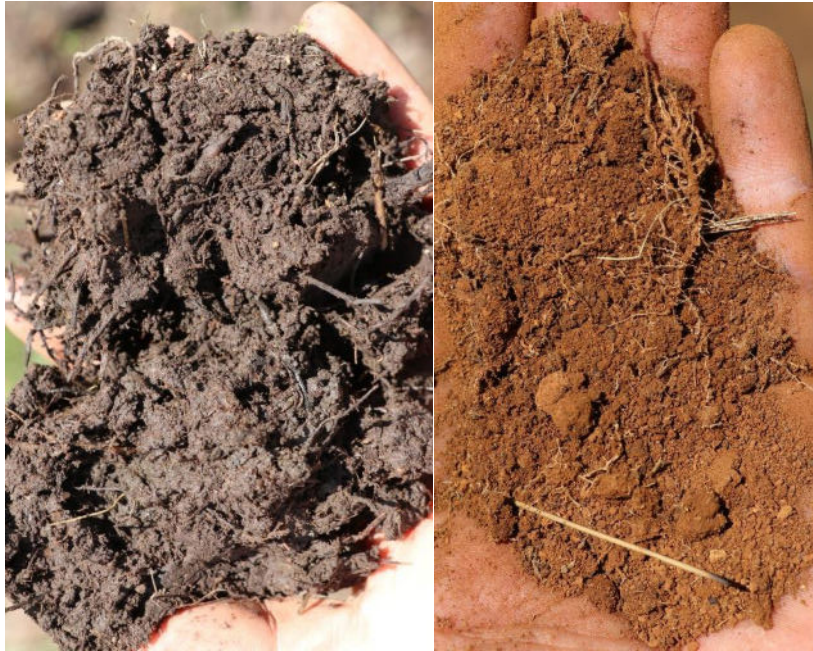
Figure 10: Soils within seepage areas (left) contain a high clay content and are easily differentiated from surrounding terrestrial soils with high sand content, no clay content and large percentage gravel. This conclusively confirms the presence of wetland conditions. However, there is a gradual transition between these soils and the border between wetland and terrestrial is also gradual and not clearly defined.

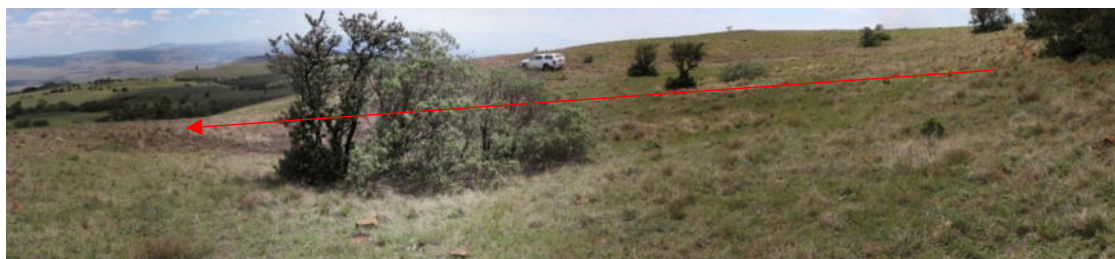
Figure 11: The seepage wetlands are situated along a prominent slope which results in unidirectional, but diffuse flows.

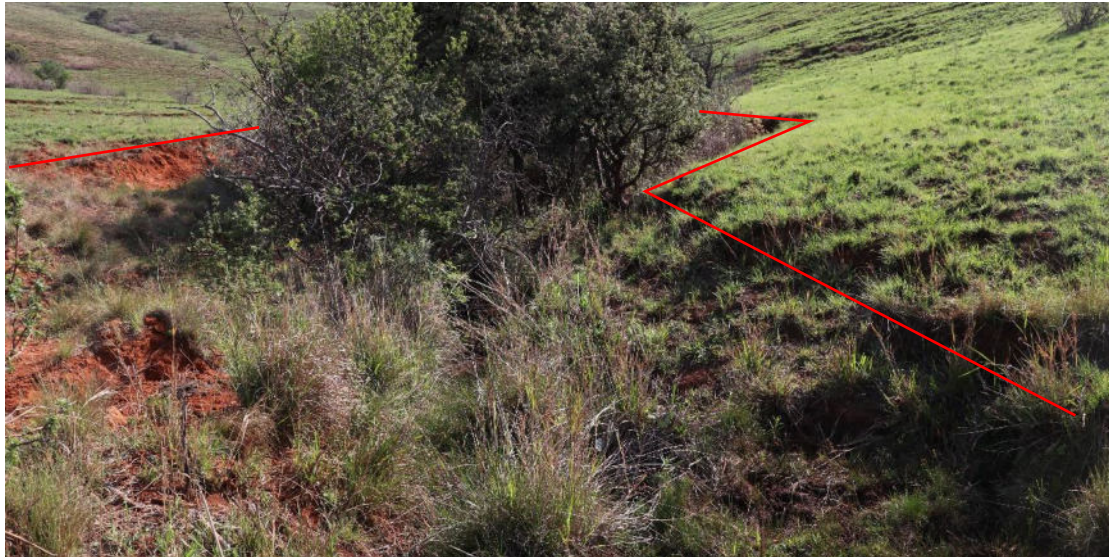
Figure 12: Smaller mountain streams and drainage lines form a clear channel, with defined banks (red), clearly draining via concentrated flow as opposed to diffuse flows.

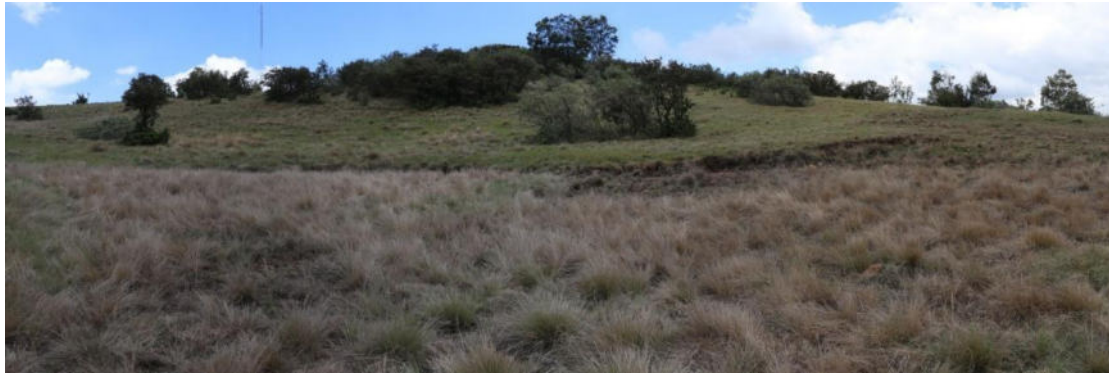
Figure 13: View of a head-cut forming at one of the seepage wetlands on the plateau. This will likely continue to increase over time and will progressively destabilise the wetland system.

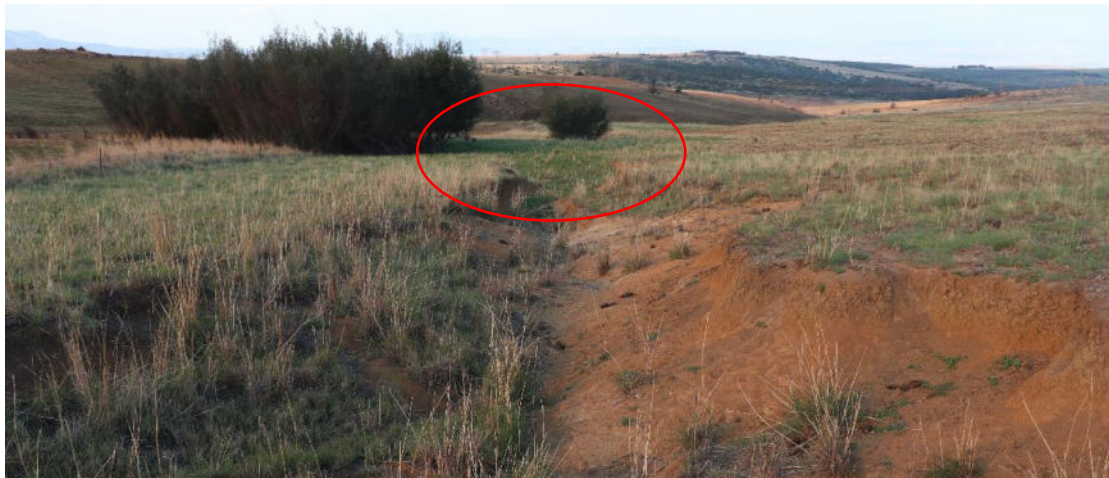
Figure 14: View of another seepage wetland (red), where head-cut erosion has progressed considerably and will eventually result in gulley formation. This is clearly resulting in significant impacts on the wetland.

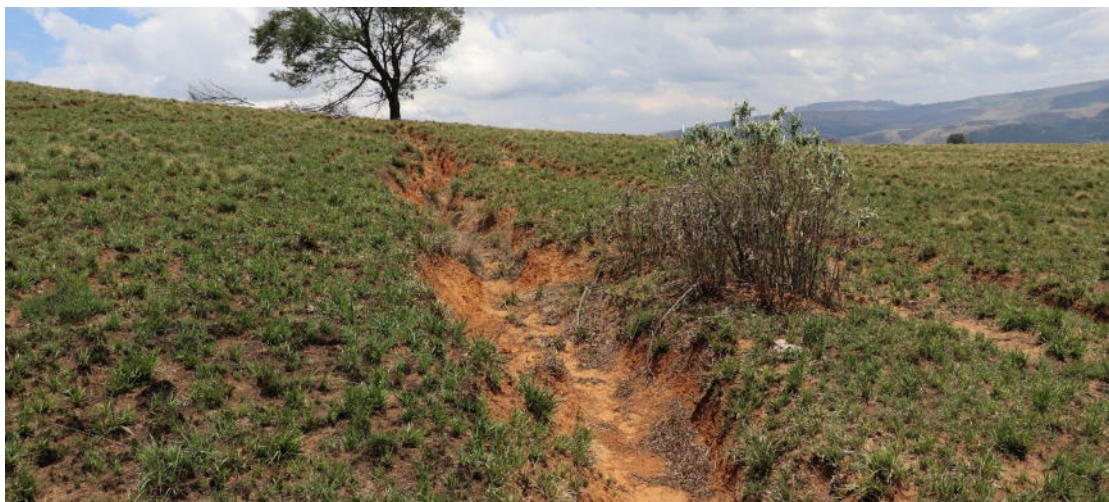
Figure 15: Within the catchment, erosion along tracks is also prominent and will still contribute to impacts on the surrounding wetlands.

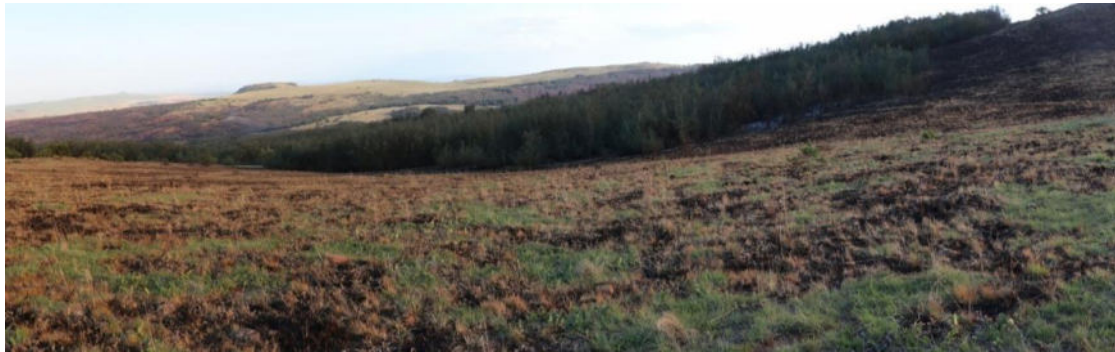
Figure 16: Infestations by *Acacia mearnsii* are substantial in several areas.

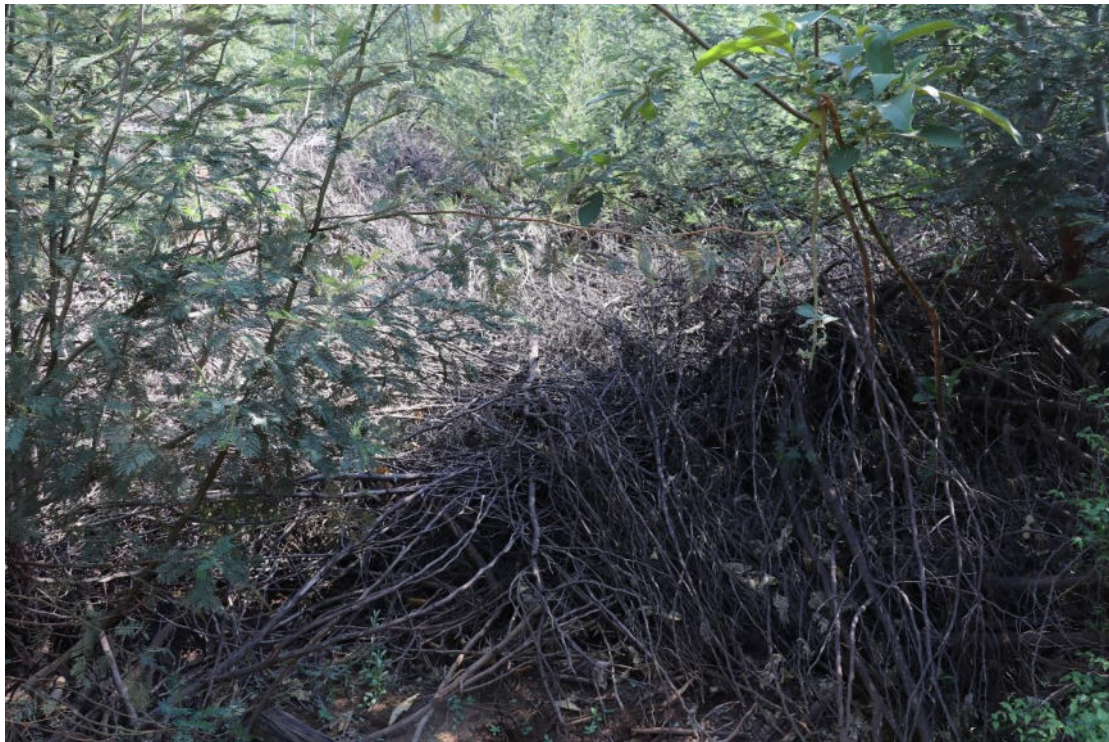
Figure 17: Within these infested areas and within watercourses, the natural biodiversity is low to almost absent, while the understorey is also devoid of vegetation. The stream system has clearly become choked with debris.

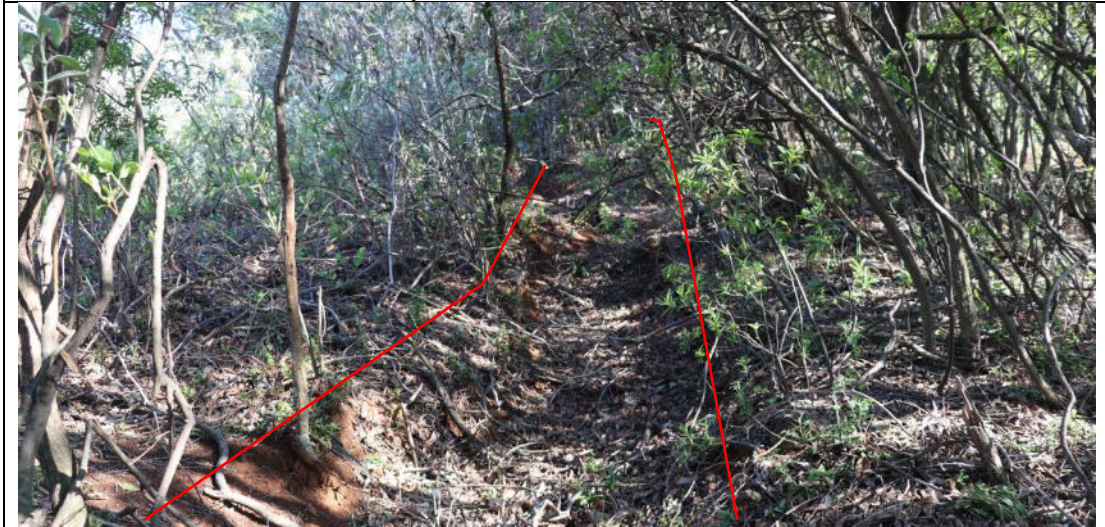
The drainage lines are very small but retain a defined channel (red).

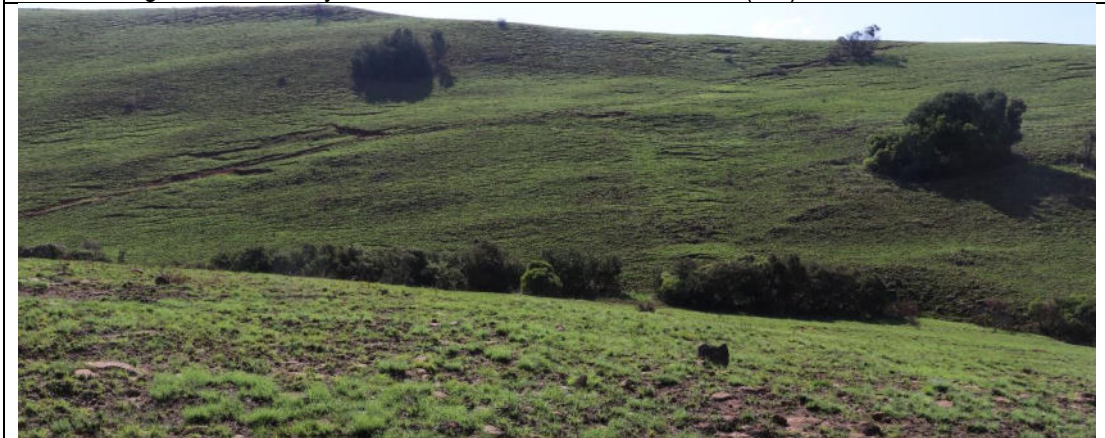
The stream system is larger though still a small system. Note the narrow floodplain with trees also being prominent along the stream.

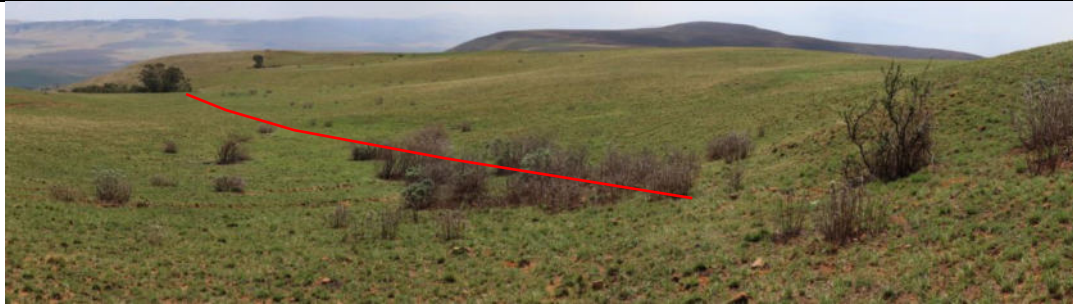
The northern seepage wetland is not very prominent but can be discerned by vegetation and forming a shallow depression along the slope.

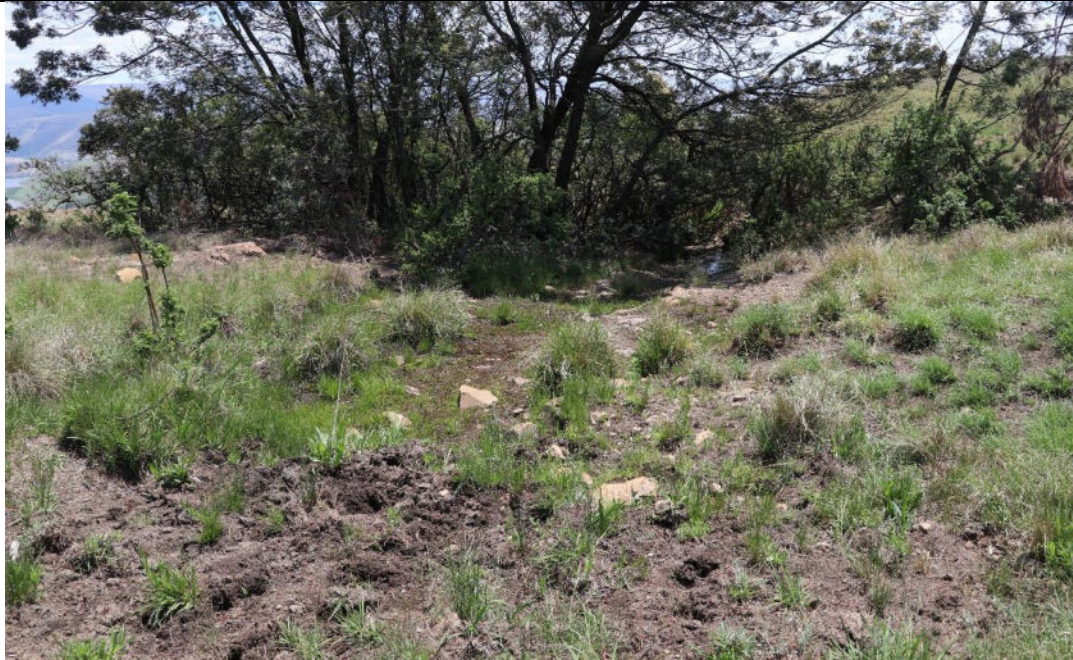
Where the northern seepage wetland drains into the mountain stream system, wetland conditions become much more pronounced.

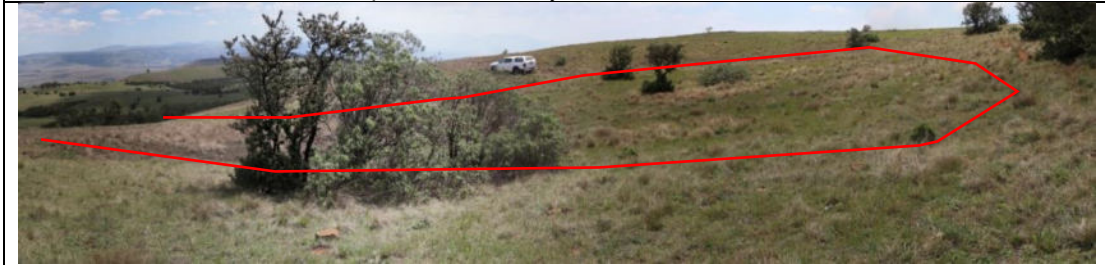
The main seepage wetland is fairly prominent and drains toward the west where it flows into a prominent mountain stream.

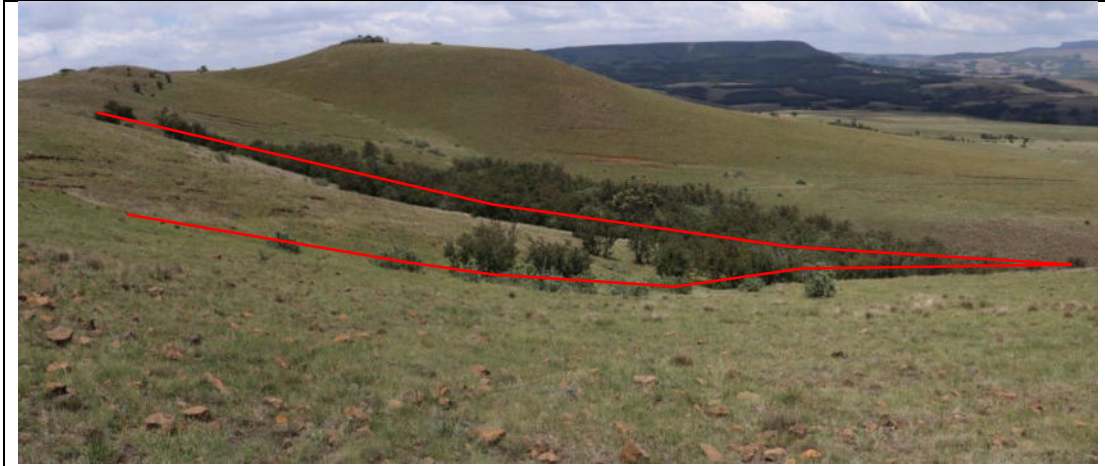
Several drainage lines also originate in the surrounding area and are likely to be affected indirectly by the borrow pit development.

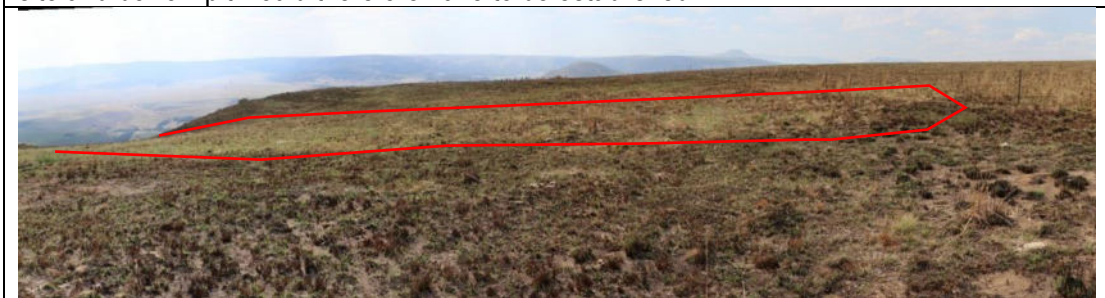
The seepage wetland is small but clearly present and drains from east to west.

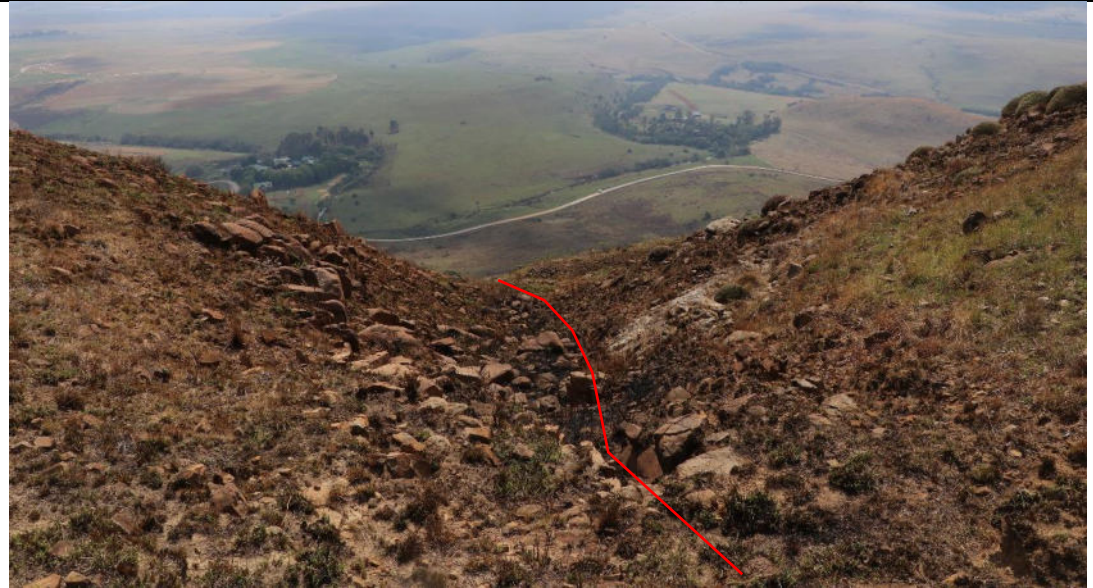
The seepage wetland drains into a small drainage line along a very steep slope.

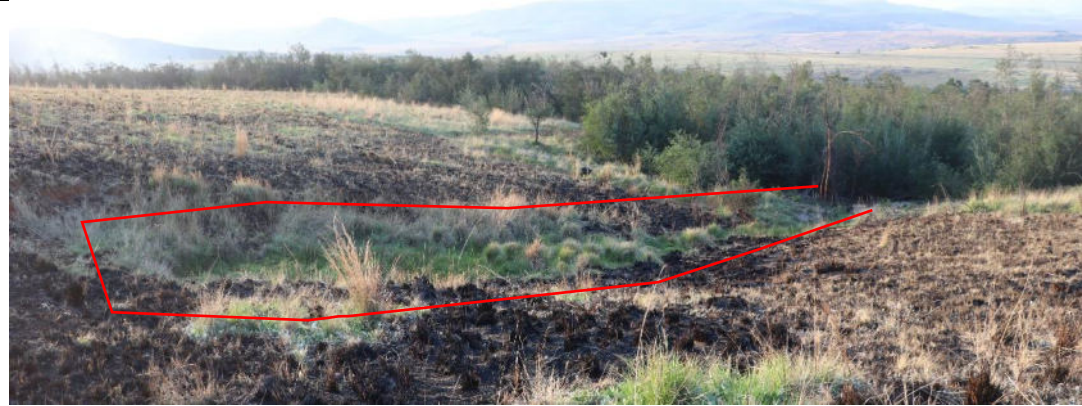
Seepage wetlands are generally not prominent, the seepage to the west of the site being the most prominent of all.

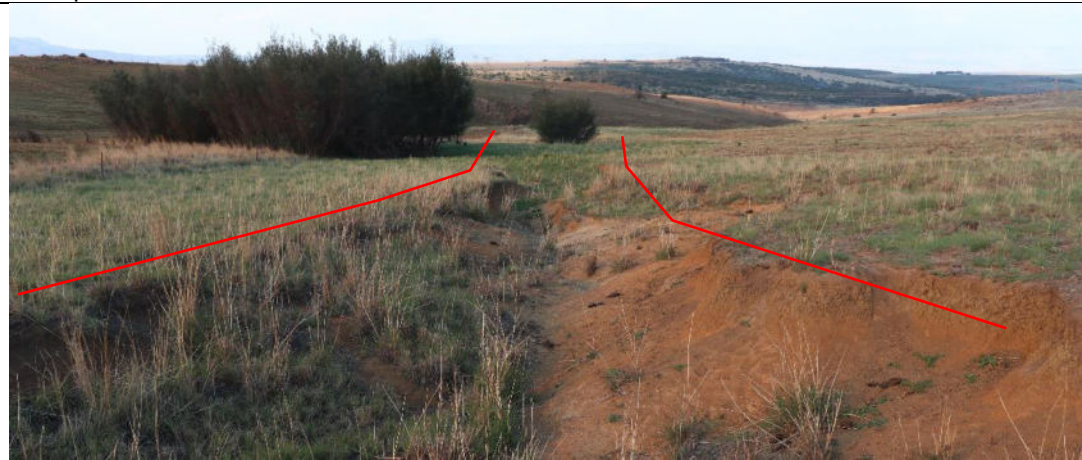
The northern seepage is not well defined, though drainage along it is clearly visible. Note also significant erosion taking place here.

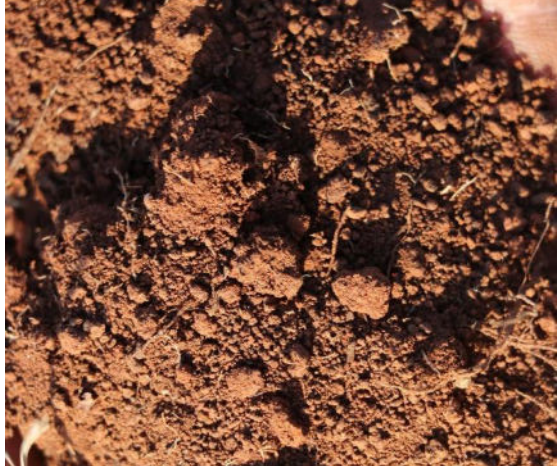
<p>Soil sample taken in the surrounding terrestrial habitat at Site 5.</p> <p>Soils have a reddish colour, without any grey matrix, clay content or distinctive mottling and are clearly devoid of wetland conditions. This should contrast starkly against wetland soils.</p>

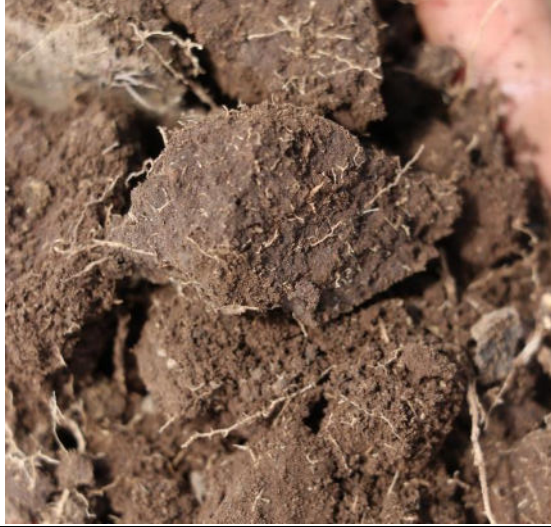
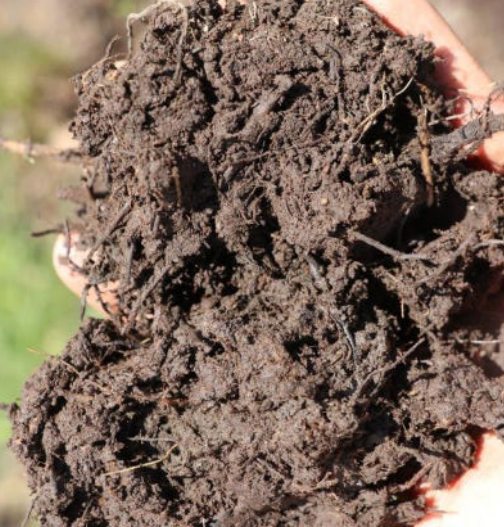
Table 3: Soil samples taken within the seepage wetlands at Site 2 (S 27.662949°, E 29.792269°).

<p>Soil sample taken within the upper section of the seepage wetland along the north of the site. Note a high clay content and grey matrix but mottling not being prominent. Wetland conditions are therefore not prominent, considered as indicative of a temporary zone of wetness, but still contrast clearly with surrounding terrestrial soils (Table 1).</p>	<p>Soil sample taken within the lower section of the seepage wetland along the north of the site. Soils have a prominent grey matrix, high clay and organic matter content and clearly indicate the presence of wetland conditions.</p>

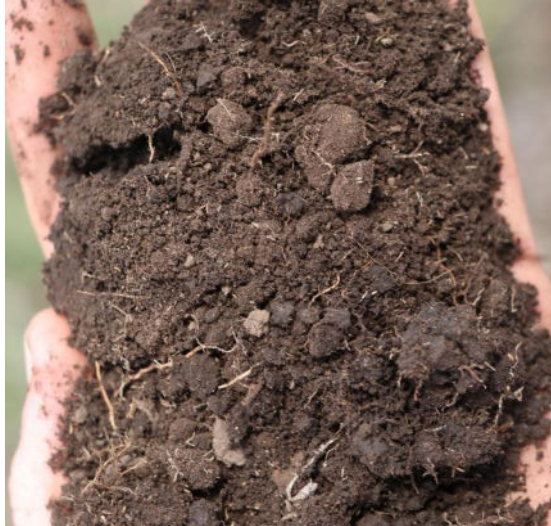
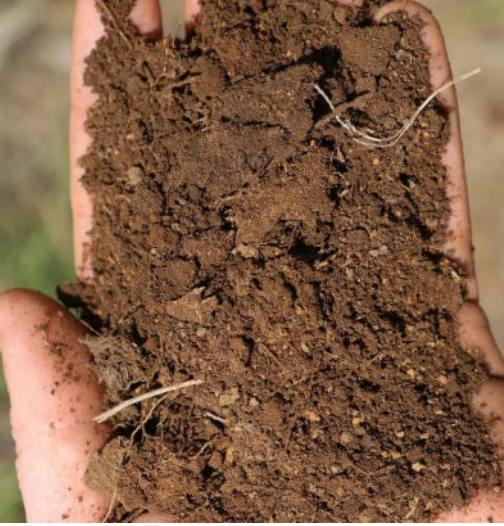
Table 4: Soil samples taken at sample sites within the seepage wetland on the site and surrounding drainage lines at Site 3 (S 27.675914°, E 29.798682°).

<p>Soil sample taken within the seepage wetland situated on the site. Note a high clay and organic matter content and grey matrix but mottling not being prominent. Wetland conditions are therefore not prominent, though still clearly present and also contrast clearly with surrounding terrestrial soils (Table 1).</p>	<p>Soil sample taken in the small drainage line to the south of the site. Soils do not contain any prominent soil wetness indicators and wetland conditions are not considered as conclusively present. However, note the dark colouration and higher clay content which clearly contrast with terrestrial soils (Table 1) and the drainage line is clearly still a watercourse system.</p>

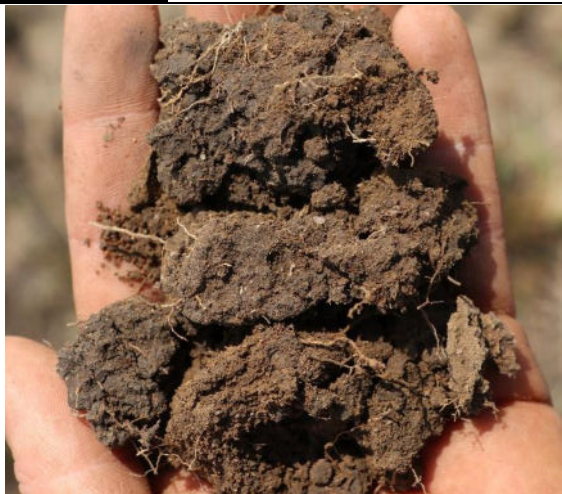
Table 5: Soil samples taken at sample sites within the seepage wetland at Site 4 (S 27.646613°, E 29.785577°).

<p>Soil sample taken within the seepage wetland to the west of the site. Note a high clay and organic matter content and grey matrix with mottling being visible. Wetland conditions are therefore clearly present and also contrast clearly with surrounding terrestrial soils (Table 1).</p>

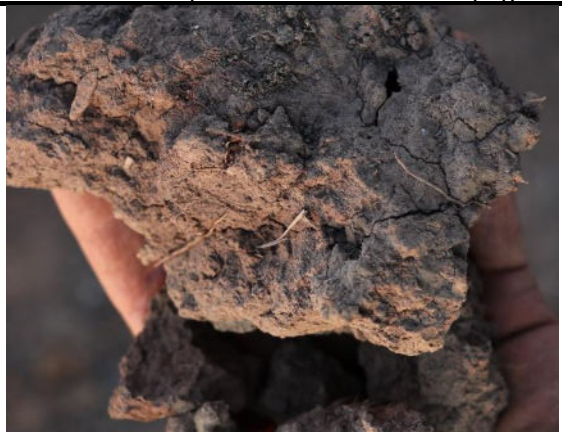
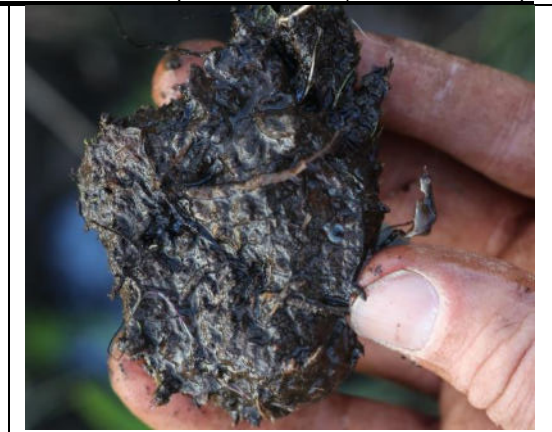
<p>Soil sample taken within the seepage wetland to the north of the site. Note a high clay content and grey matrix but mottling not being prominent. Wetland conditions are therefore not prominent, considered as indicative of a temporary zone of wetness, but still contrast clearly with surrounding terrestrial soils (Table 1).</p>	<p>Soil sample taken within the seepage wetland to the west of the site. Soils have a prominent grey matrix, high clay and organic matter content and clearly indicate the presence of wetland conditions.</p>
