CONSTRUCTION OF AN ASPHALT PLANT ON PORTION 8 OF FARM 1098, HOOGGEKRAAL, DURBANVILLE, WESTERN CAPE PROVINCE.

ENVIRONMENTAL AUDIT REPORT

| AUDIT PERIOD: | March 2021 |

| Report number: | 5 -Final report based on only construction of new plant | | |

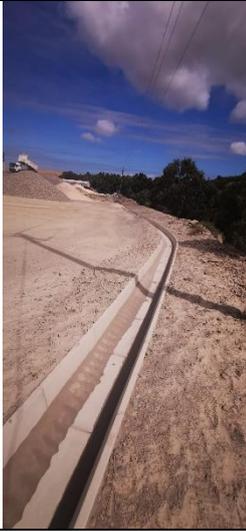
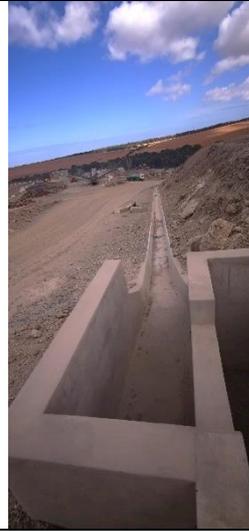
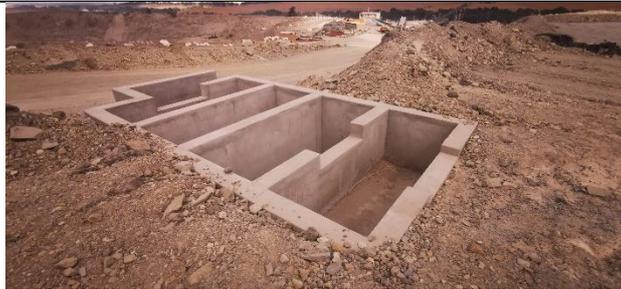
STORMWATER CHANNELS , OIL TRAP

| DESCRIPTION | COMPLIANCE SCORE | NON-COMPLIANCE SCORE | STATUS | COMMENTS |
|---|---|---|---|---|
| Storm water created on site must be slowed by constructing berms/channels perpendicular to the water flow to prevent erosion. | 5 | - | Compliant | Berms and Channels are all in place. |
| If a workshop or washing bay is constructed at the asphalt plant the effluent must pass through an oil trap and treated before released into the natural environment. | 5 | - | Compliant | Oil trap completed clear photographs included in photo report.. |

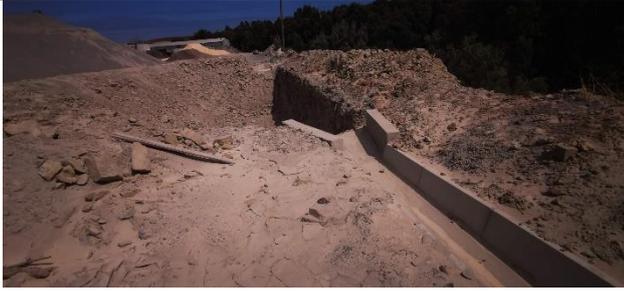
1ST RETENTION POND

| DESCRIPTION | COMPLIANCE SCORE | NON-COMPLIANCE SCORE | STATUS | COMMENTS |
|---|---|---|---|---|
| Stormwater created on site must be guided into water retention ponds be monitored and treated if necessary , before being released. | 5 | - | Compliant | Retention ponds completed, photographs included in photo report. |

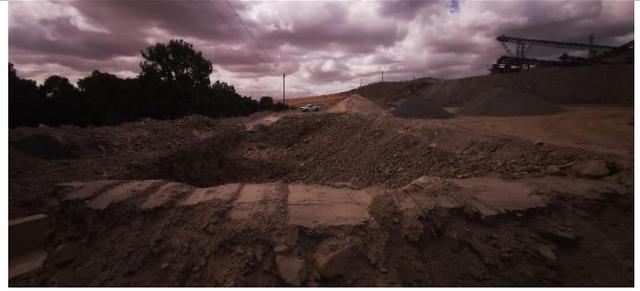
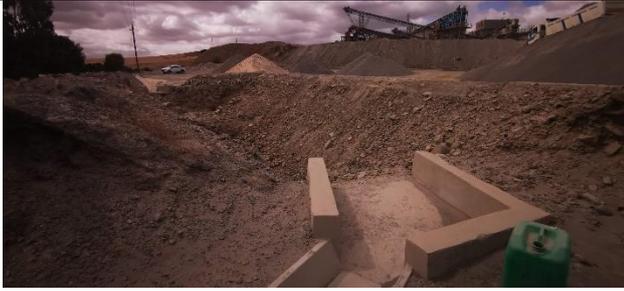
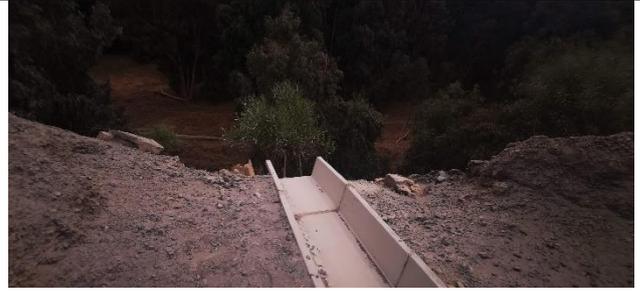
2ND RETENTION POND

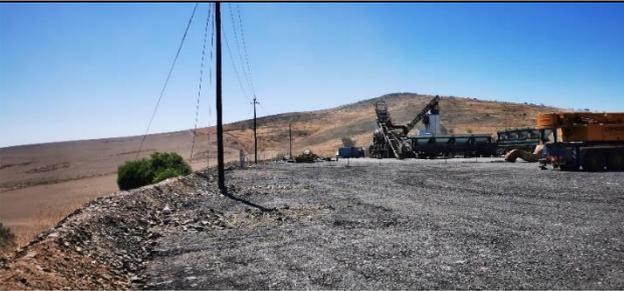
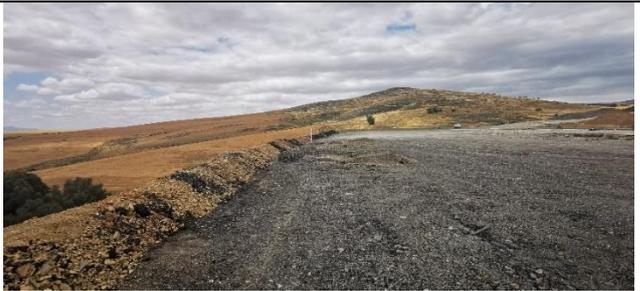
BERMS SURROUNDING CONSTRUCTION AREA

| DESCRIPTION | COMPLIANCE SCORE | NON-COMPLIANCE SCORE | STATUS | COMMENTS |
|---|---|---|---|---|
| Berms must be constructed on perimeter of site to prevent dirty water entering and exiting the site. | 5 | - | Compliant | Berms were neatly constructed around the site. |

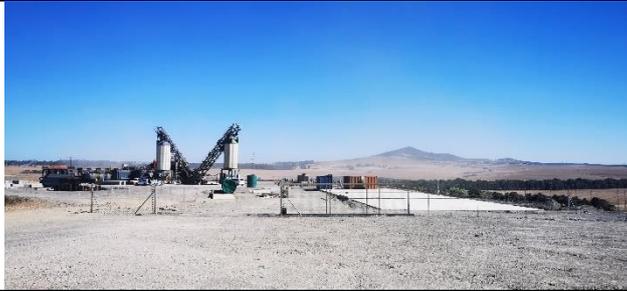
NEW NATIONAL ASPHALT PLANT AREA

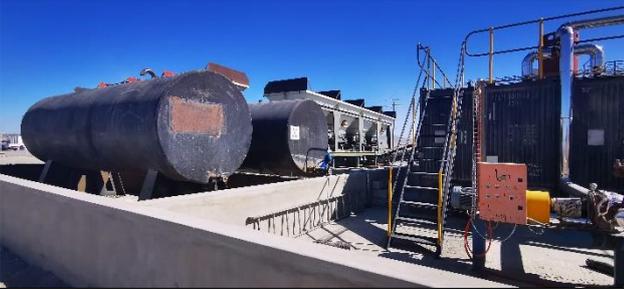
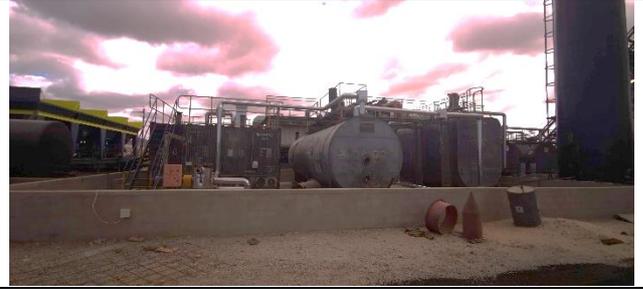
CONCRETE FLOOR AREA READY FOR OFFICE, LABORATORY AND CHEMICAL TOILETS

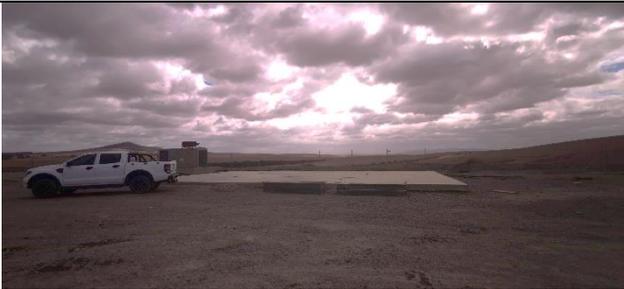
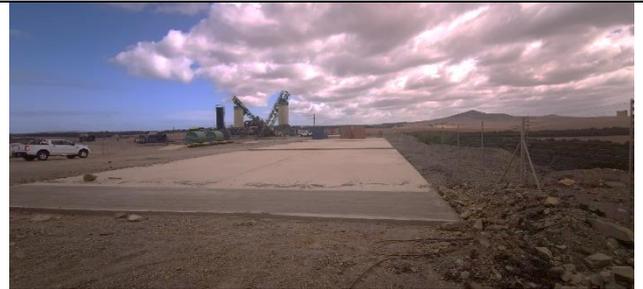
ROADS COMPACTED WITH ASPHALT

| DESCRIPTION | COMPLIANCE SCORE | NON-COMPLIANCE SCORE | STATUS | COMMENTS |
|---|---|---|---|---|
| Areas should be compacted/paved to prevent leaching of dangerous goods into sub-soils | 5 | - | Compliant | The approved and fenced area has been compacted with recycled asphalt. |

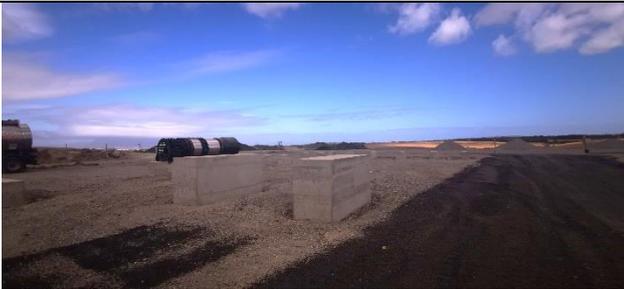
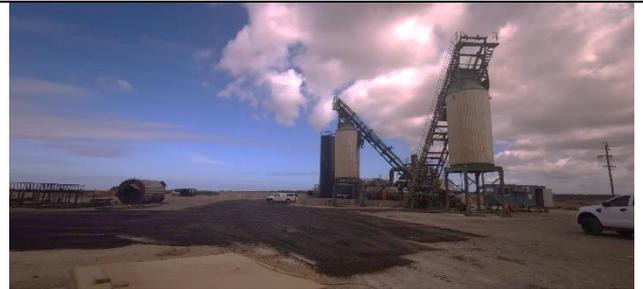
1ST WEIGHBRIDGE

2ND WEIGHBRIDGE – WILL BE INSTALLED WHEN OPERATION STOPS AT PREVIOUS PLANT

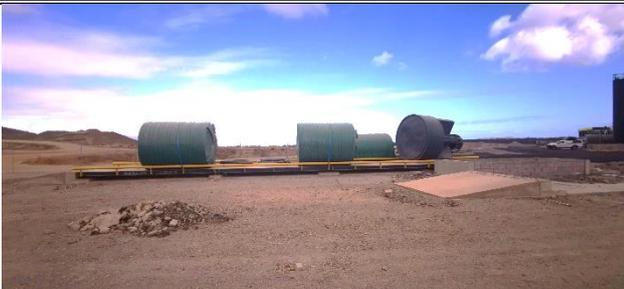
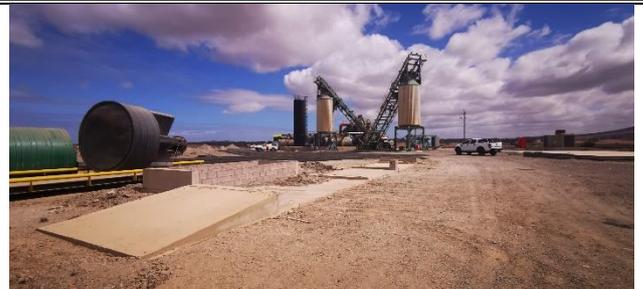
DIESEL AND PARAFIN CONTAINERS BUNDED

| DESCRIPTION | COMPLIANCE SCORE | NON-COMPLIANCE SCORE | STATUS | COMMENTS |
|---|---|---|---|---|
| Storage of dangerous goods should be banded, either with permanent or temporary banded storage facility. | 5 | - | Compliant | The concrete flooring has been installed and bund walls are in place. Currently no dangerous goods are stored. |

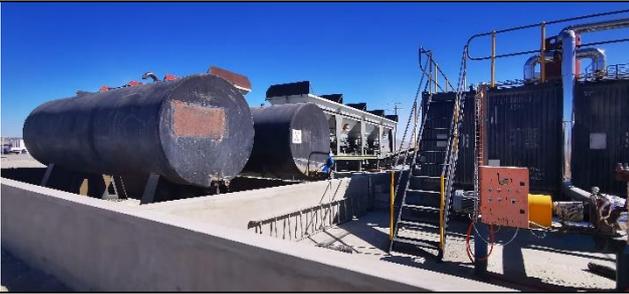
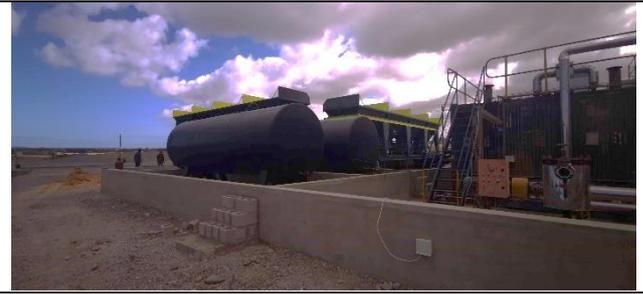
PROOF GENERAL WASTE AND OIL SPILL KIT BINS PLACED ON SITE

| DESCRIPTION | COMPLIANCE SCORE | NON-COMPLIANCE SCORE | STATUS | COMMENTS |
|---|---|---|---|---|
| Separate bins should be marked for specific waste. | 5 | - | Compliant | No Hazardous waste is generated during construction phase. Two general waste bins and oil spill kit bin is placed on site and cleaned regularly by Averda. |

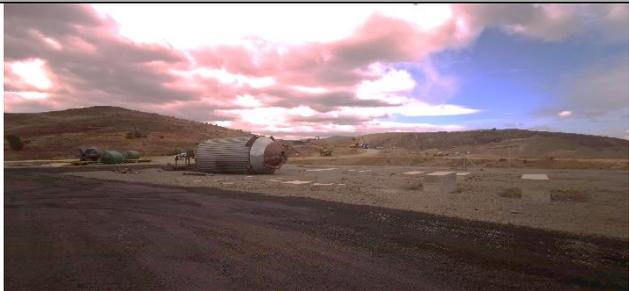
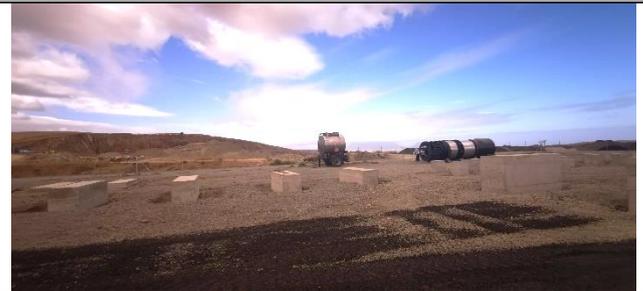
WATER TRUCK WETTING ACCESS ROADS FOR DUST SUPPRESSION

| DESCRIPTION | COMPLIANCE SCORE | NON-COMPLIANCE SCORE | STATUS | COMMENTS |
|---|---|---|---|---|
| Access road and site surface should be regularly wetted to prevent excessive dust. | 5 | - | Compliant | A water truck is used for dust suppression on the entire Portlands Quarry Access roads. |
