**KIMBERLEY QUARRY**  
**PORTION 39 OF THE FARM SPIJTFONTEIN NO 122,**  
**KIMBERLEY, NORTHERN CAPE PROVINCE**

**ENVIRONMENTAL PERFORMANCE ASSESSMENT /**  
**ENVIRONMENTAL AUDIT REPORT**

<b>DMRE REFERENCE NUMBER:</b>	<b>NC 30/5/1/2/2/0287 MR</b>
<b>AUDIT PERIOD:</b>	<b>April 2022 – May 2024</b>

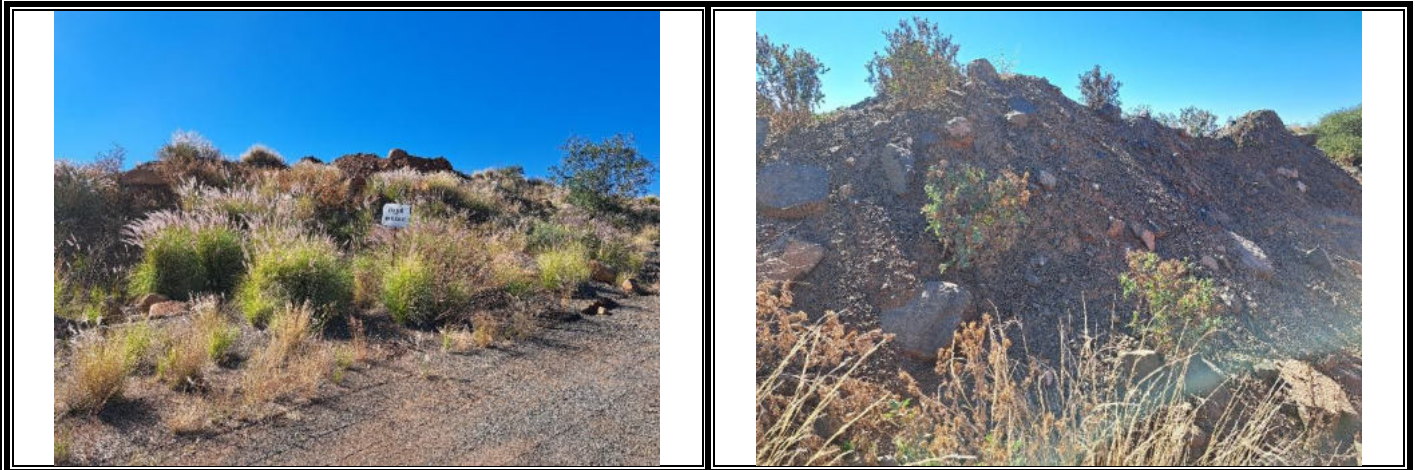
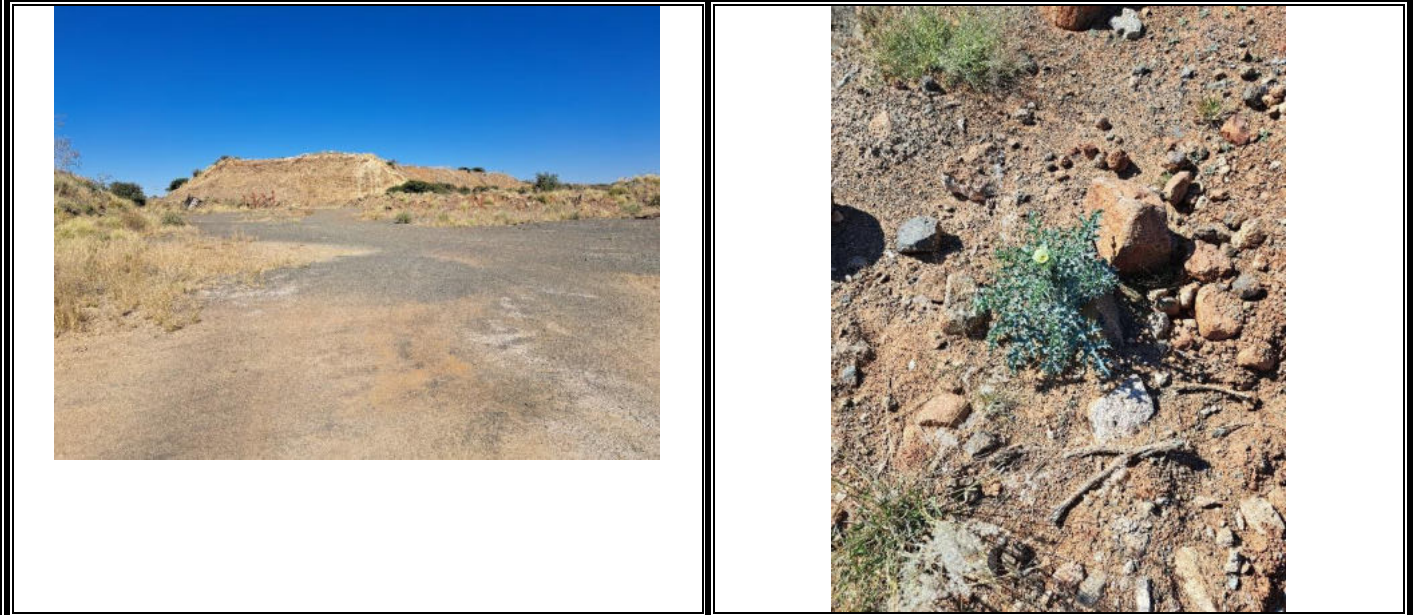
**Invader plants to be removed from the overburden and topsoil stockpiles**

The mine must establish a site specific management plan and the removal and control of invasive plant species must be intensified. Control of the problem plants is a continuous management action, and as discussed, should be extended to include the following species:

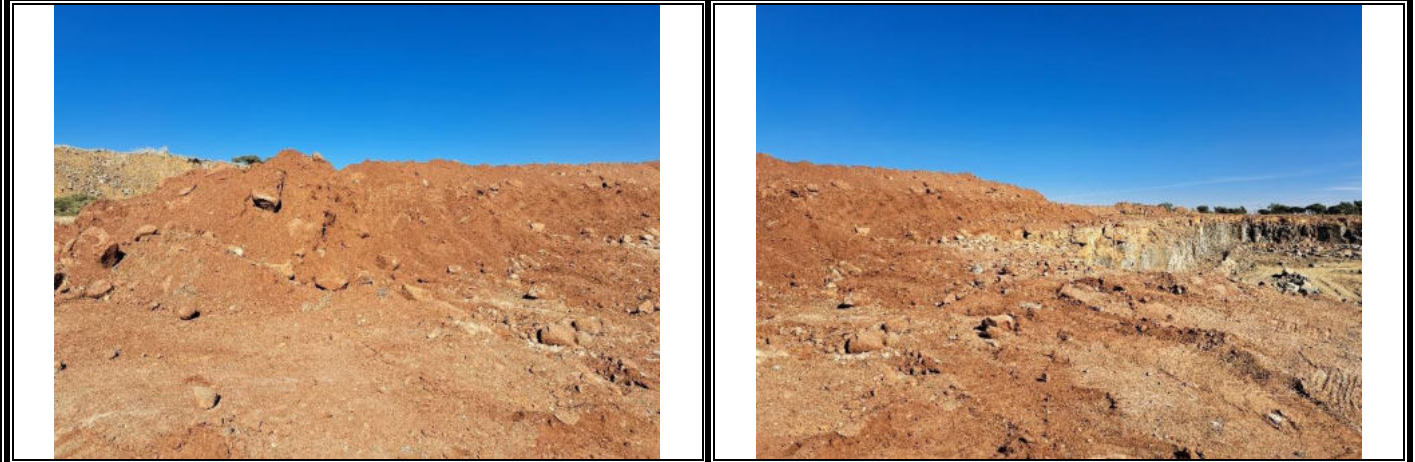
**Soil removed from the quarry extension area**

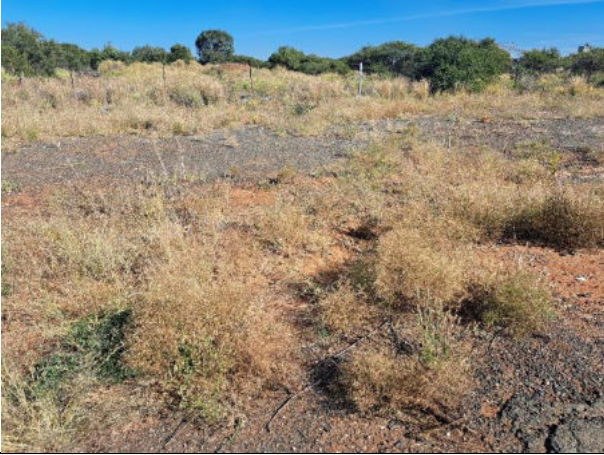
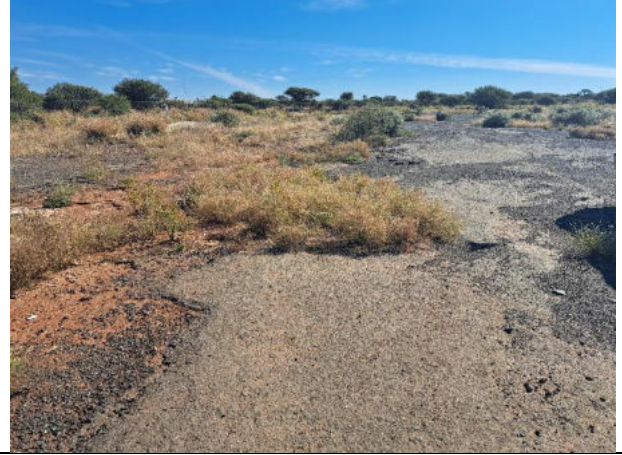
**Old asphalt yard now used as salvage yard**

The area previously used as asphalt yard has since been used as salvage yard by the mine. As mentioned earlier, various hydrocarbon spills and problem plants were noted in this area. All equipment that contains hydrocarbons must either be removed from site or be fitted with drip trays of adequate size. All hydrocarbon spills must be cleaned, and the soil must be treated as hazardous waste.

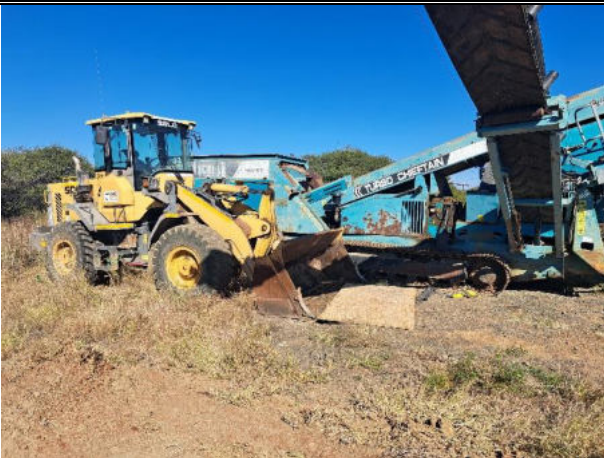
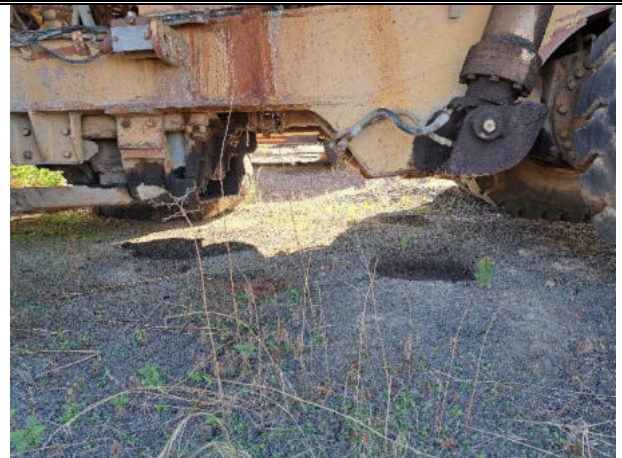
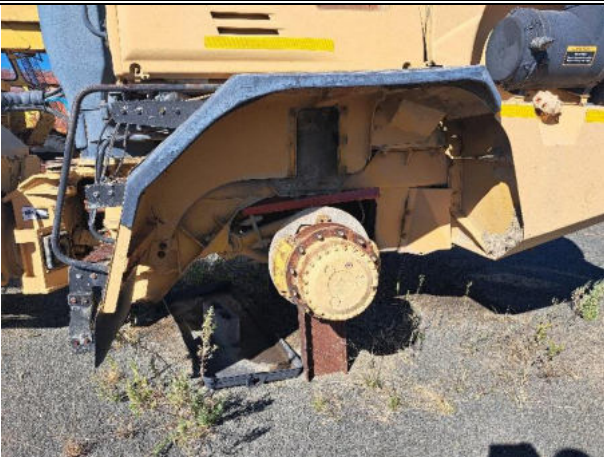
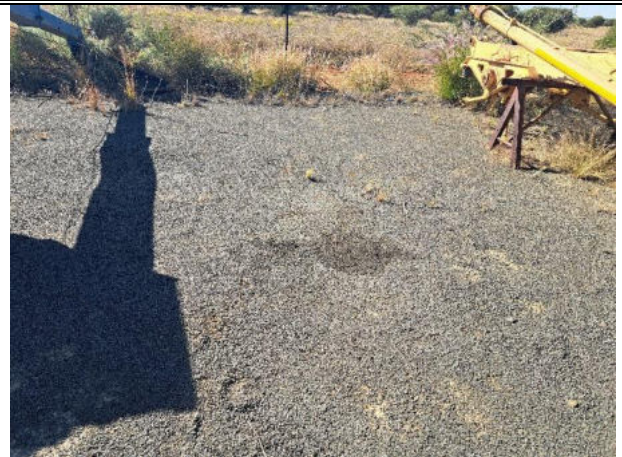
**Drip trays to be placed under leaking equipment and spills to be cleaned**

As stated earlier, site management must ensure that all drip trays used on site is sealed and cleaned regularly. Rainwater that accumulates in the drip trays must be discarded as waste water into the sump at the wash bay.

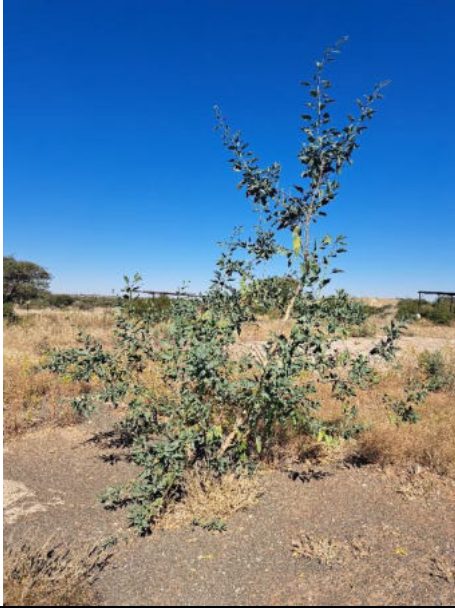
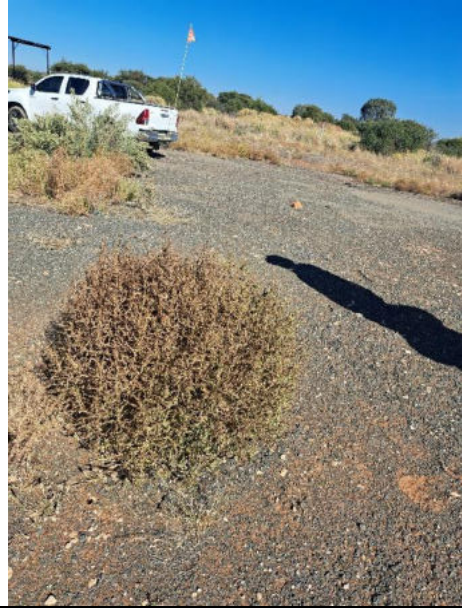
**Invader plants to be removed**

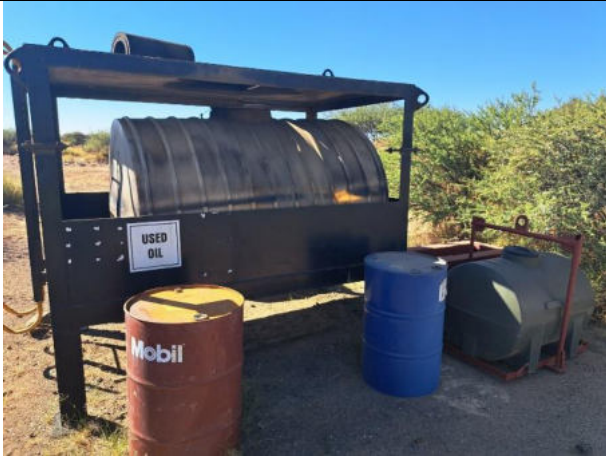
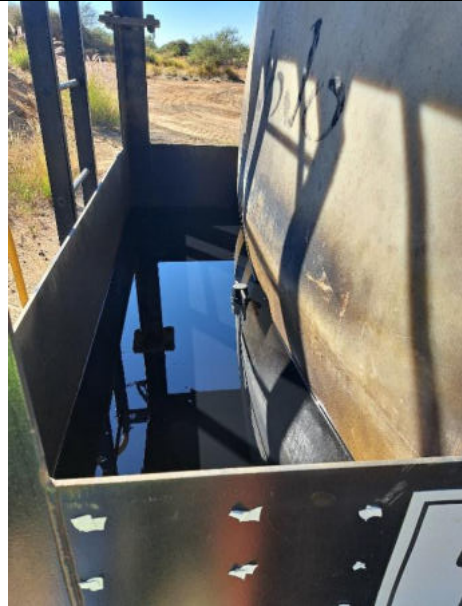
**Used oil to be removed from the old B&E yard**

The area previously used by B&E for the temporary crushing and screening of material, must be cleaned and all unwanted equipment, tools, vehicles and products must be removed. It is important that all the hydrocarbons should either be removed from site or stored in a bunded area with adequate capacity and impermeable surface. The oil that accumulated in the bund of the used oil tank must be removed from site and all the drip trays must continuously be emptied to prevent secondary spills.

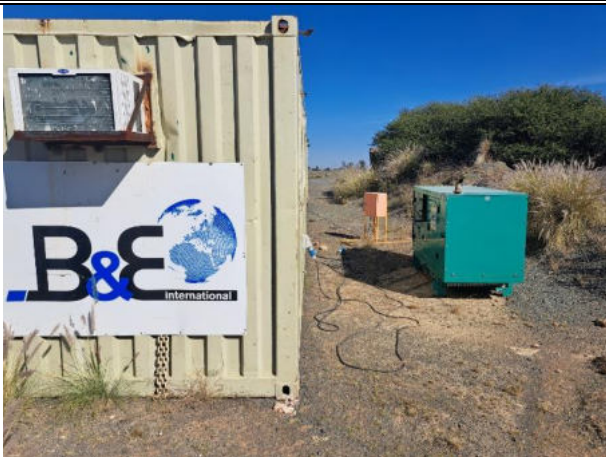
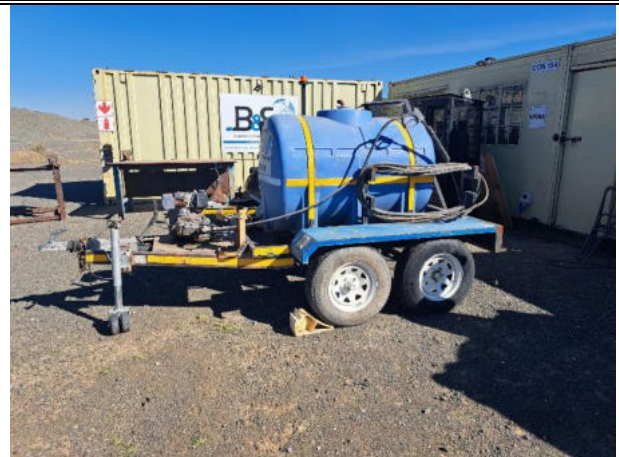
**Drip trays and/or bunds to be added. Alternatively the equipment must be removed from site**

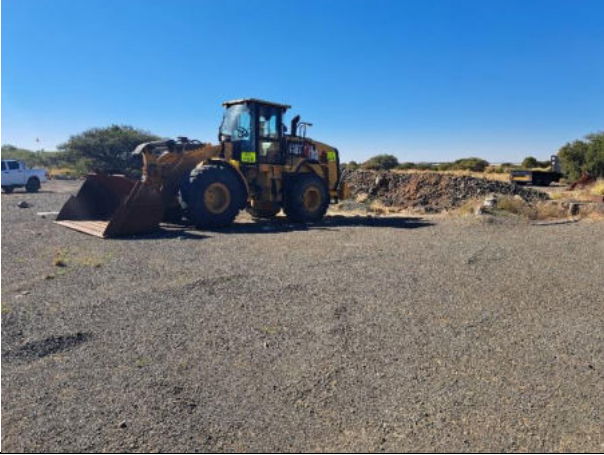
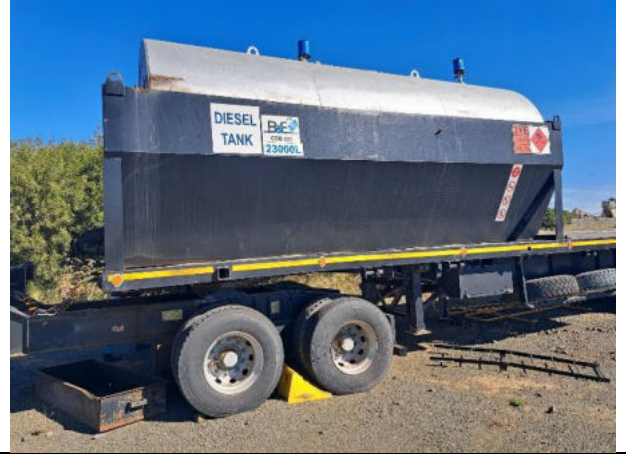
**Equipment to be removed from site if no longer needed**

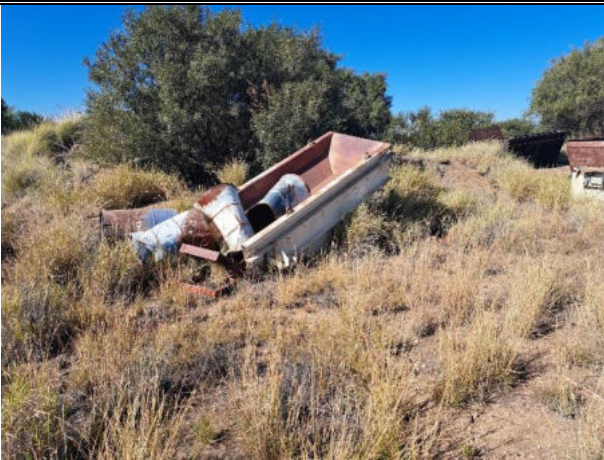
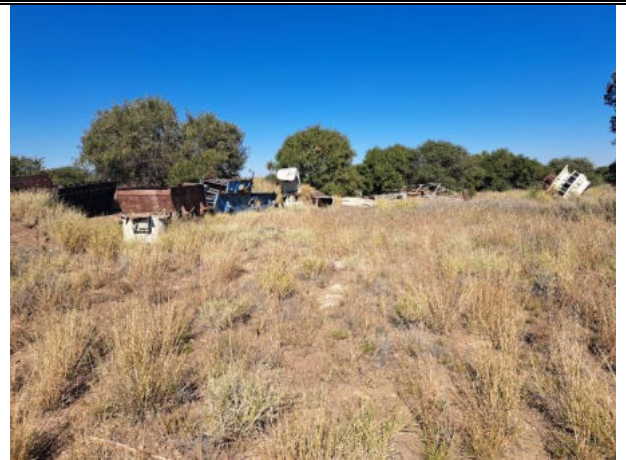
**Unwanted equipment to be removed from the mining area**

7. Remove all unwanted metal, equipment from site;
8. Repair, seal and confirm the capacity of all the bund walls;
9. Place bund walls around the generators;

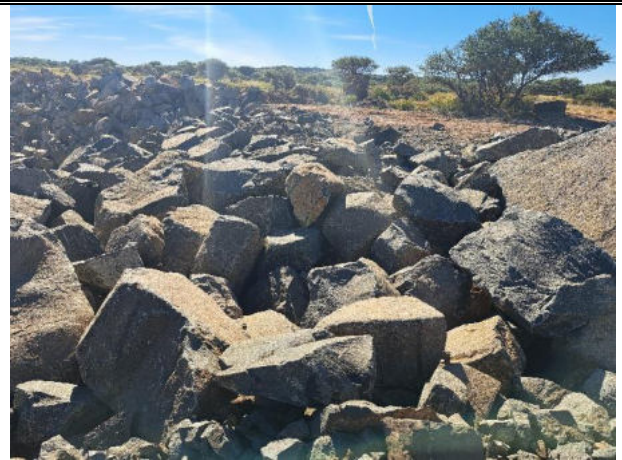
**Oversize rocks used to backfill a part of the old quarry**

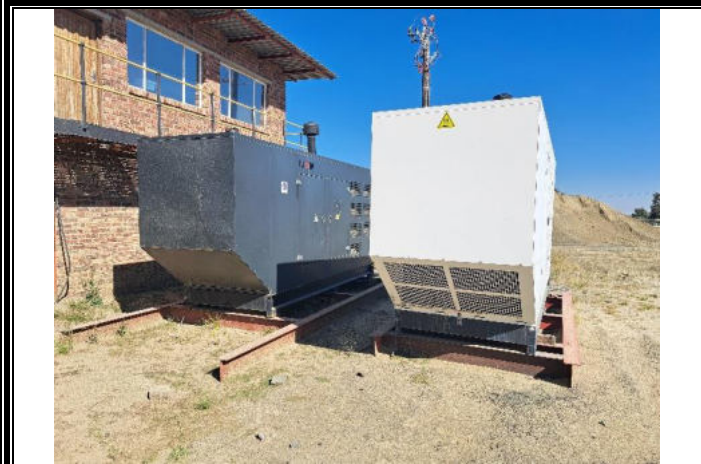
**Bund to be installed around generators**

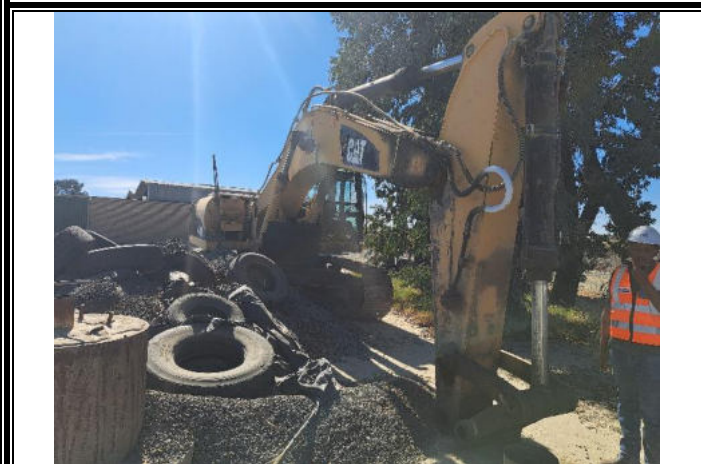
**Machine to be repaired and/or removed from site.  
Spills to be cleaned**

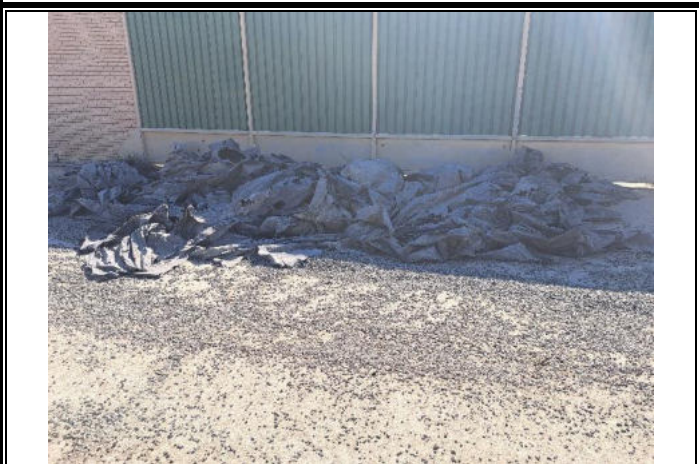
**Old bags/plastic to be removed from site**

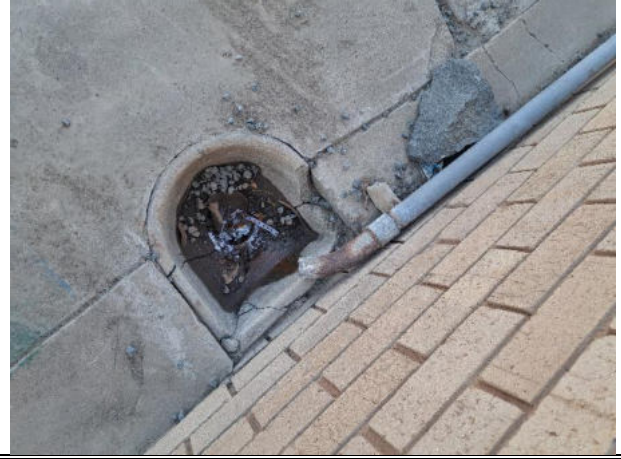
**Drain to be cleaned**

The drains of all basins must be kept operational, and the blockage noted on the day of the audit must be rectified.

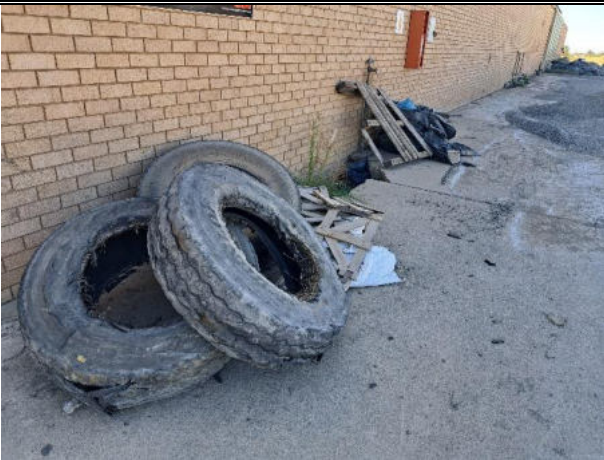
**Unwanted materials to be removed from site**

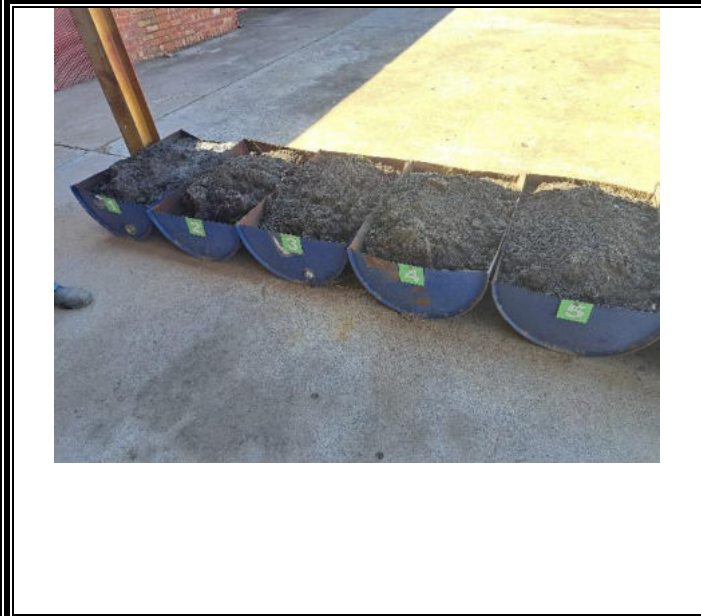
**Soil to be remediated**

Further to the above, if the mine implements the bioremediation of contaminated soil, the “cleaned” soil must be tested for hydrocarbons before it is returned to the environment. Management must be able to proof that the soil is clean, and that the remediation process was successful before the soil is reused. This proof must be filed for auditing purposes. Site management should consider the use of a degreasing agent such as Oilcap prior to the remediation of the soil as this will significantly reduce the time needed to clean the soil.

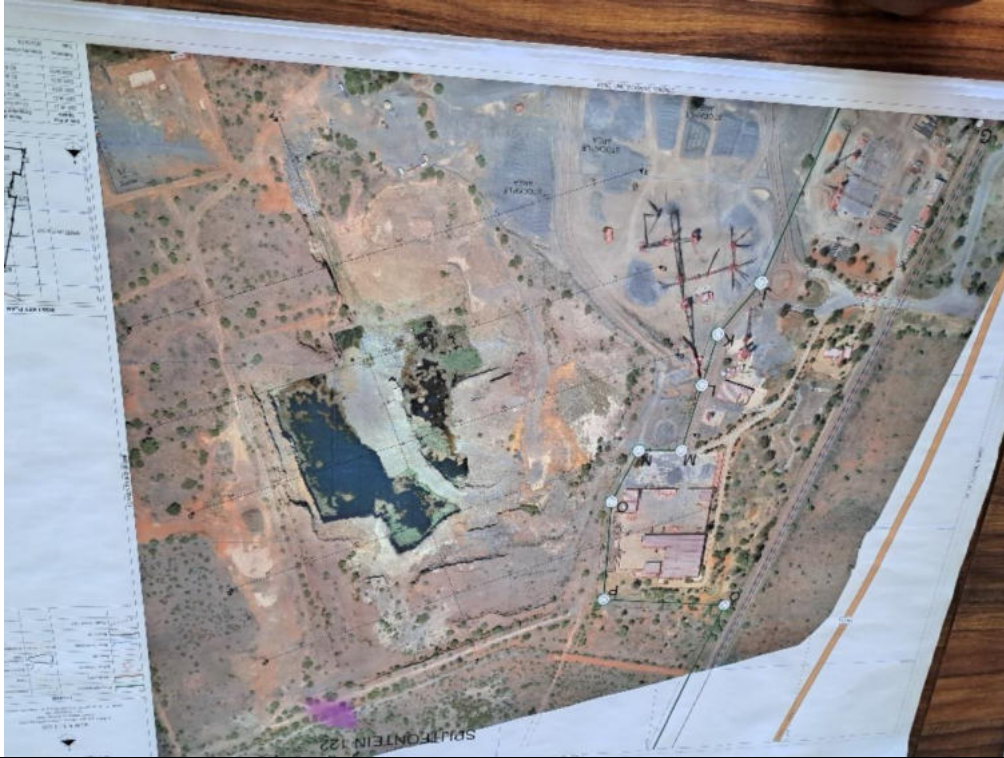
**Boundaries of the mine plan to be confirmed**

As mentioned earlier, it appears as if the mining boundary indicated on the 2024 mine plan differs from the approved area. Site management must confirm the mine boundaries and ensure the correct boundaries appear on the mine plan.
