MTHATHA QUARRY PORTION OF ADMINISTRATIVE AREA NO 11 CALLED ZITATELE, MTHATHA, EASTERN CAPE PROVINCE

ENVIRONMENTAL PERFORMANCE ASSESSMENT / ENVIRONMENTAL AUDIT REPORT

DMRE REFERENCE NUMBER:	EC 30/5/1/2/2/0135 MR
AUDIT PERIOD:	August 2023 – May 2024

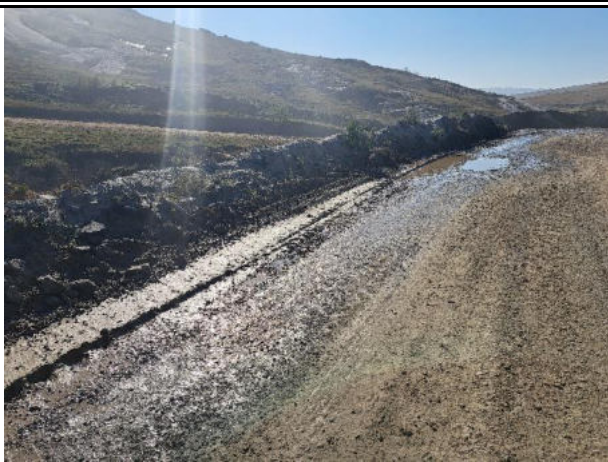
Stormwater berm below the processing plant

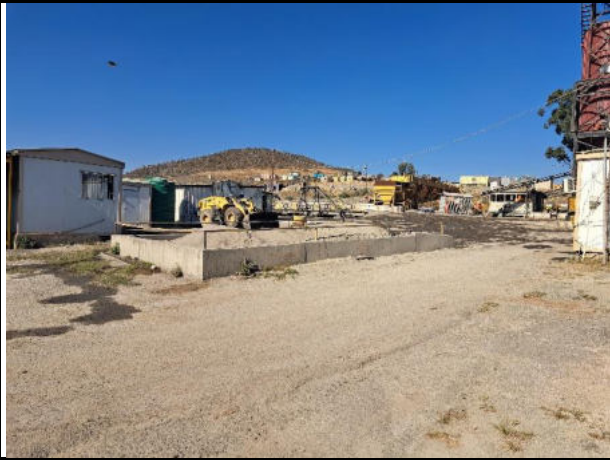
New bund to contain dust material

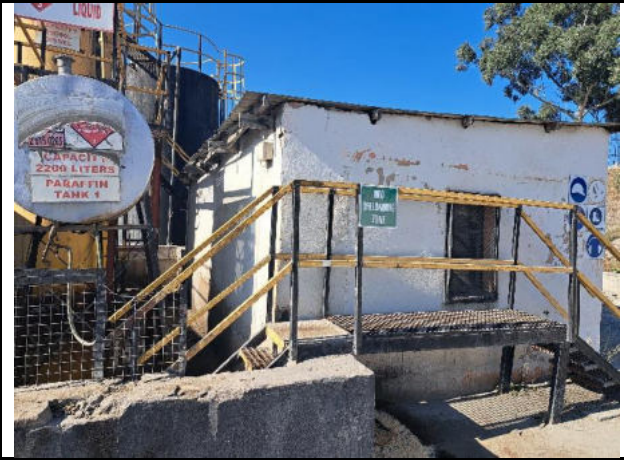
Improvements to bunded area

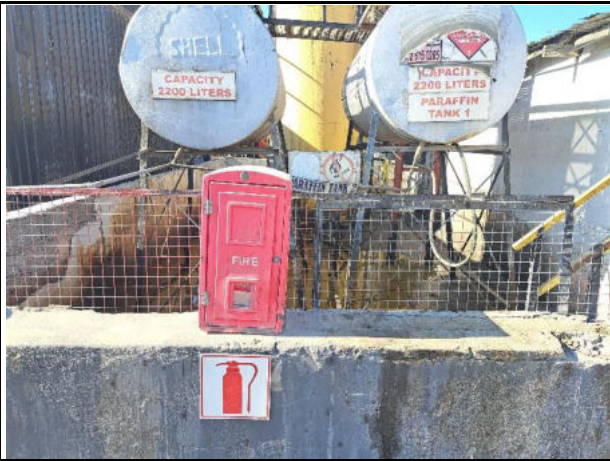
Fire extinguisher on site

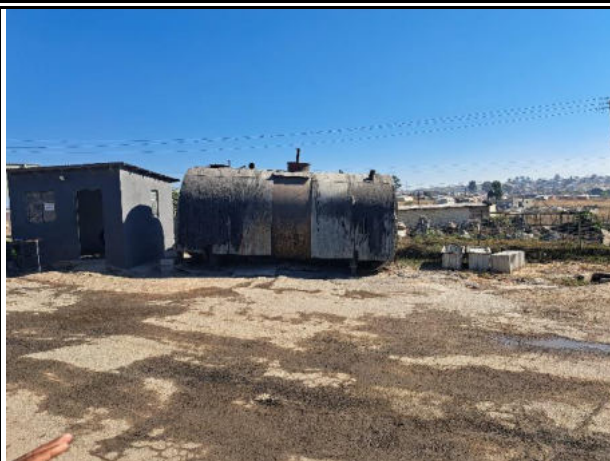
Old tankers being removed from site

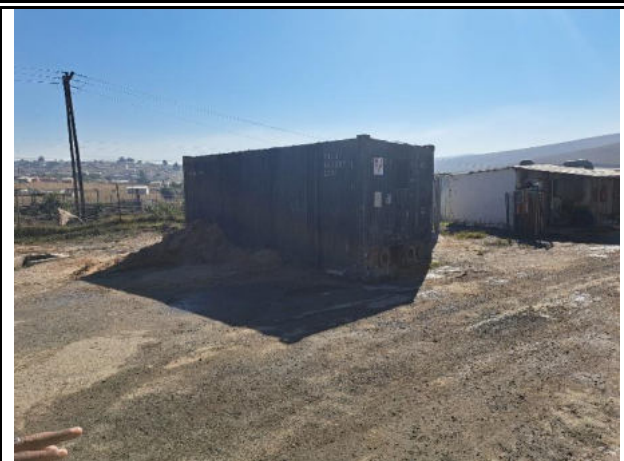
Dust suppression implemented

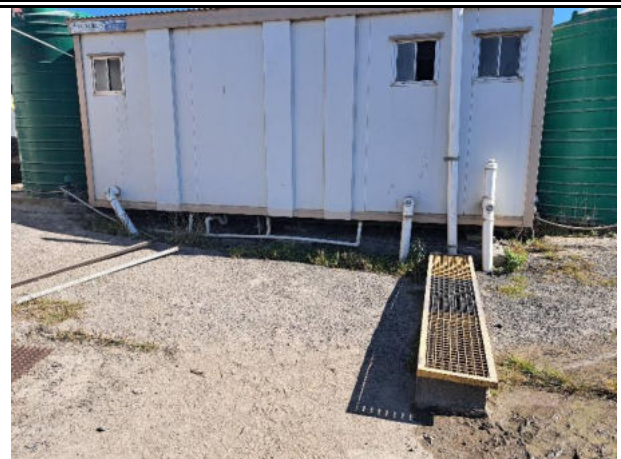
Septic tank cleaned since previous audit
