**SAND MINE ON A PORTION OF THE FARM DE  
KLERKSKRAAL 231 IN THE THEUNISSEN DISTRICT,  
FREE STATE PROVINCE**

**ENVIRONMENTAL AUDIT REPORT**

<b>DMR REFERENCE NUMBER:</b>	<b>FS30/5/1/3/2/10207MP</b>
<b>AUDIT PERIOD:</b>	<b>February 2021</b>

<b>Permit Number:</b>	FS30/5/1/3/2/10207MP	<b>Date of Commencement:</b>	November 2019
<b>Site Name:</b>	De Klerkskraal Quarry	<b>Inspection Date:</b>	26 February 2021
<b>Permit Holder:</b>	Blazecor 226 CC	<b>Other Authorisations:</b>	4 March 2017
<b>Report Number:</b>	11

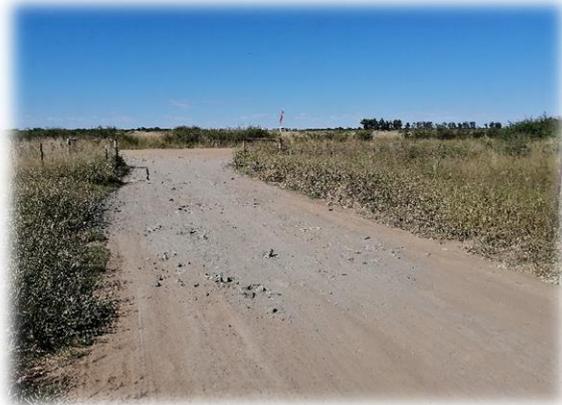
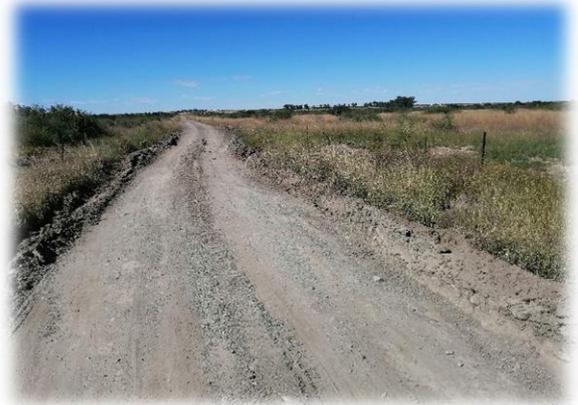
**MINING ACCESS ROAD**

**The culvert that needs to be upgraded**

- a) The culvert system should be upgraded to a larger system, preferably a block culvert, which can be placed, level with the natural flow level of the stream. Erosion structures (earthen berms/rock fill foundations) and dissipaters should be reinstated.

- Areas with erosion within the mining area:
  - *Recommended Mitigation:*
    - a) The culvert system should be upgraded to a larger system, preferably a block culvert, which can be placed, level with the natural flow level of the stream. Erosion structures (earthen berms/rock fill foundations) and dissipaters should be reinstated.

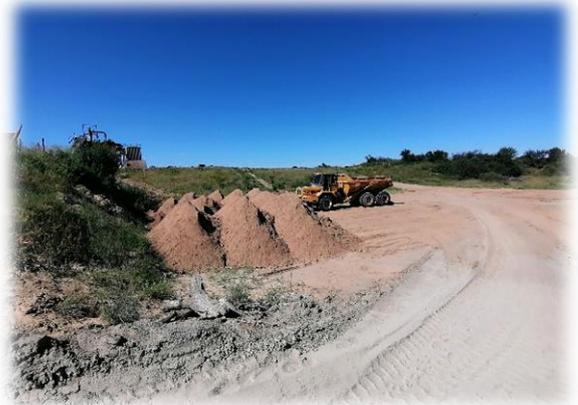
**Most of the erosion prevention structures have been flushed away.**
