MTHATHA QUARRY PORTION OF ADMINISTRATIVE AREA NO 11 CALLED ZITATELE, MTHATHA, EASTERN CAPE PROVINCE

ENVIRONMENTAL PERFORMANCE ASSESSMENT / ENVIRONMENTAL AUDIT REPORT

DMRE REFERENCE NUMBER:	EC 30/5/1/2/2/0135 MR
AUDIT PERIOD:	August 2023 – May 2024

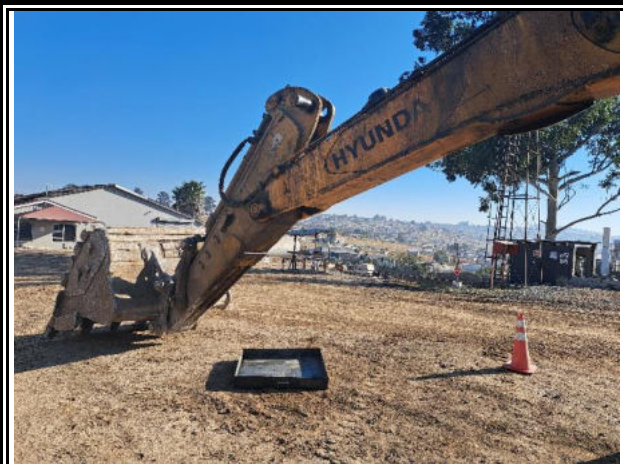
Drip tray in use

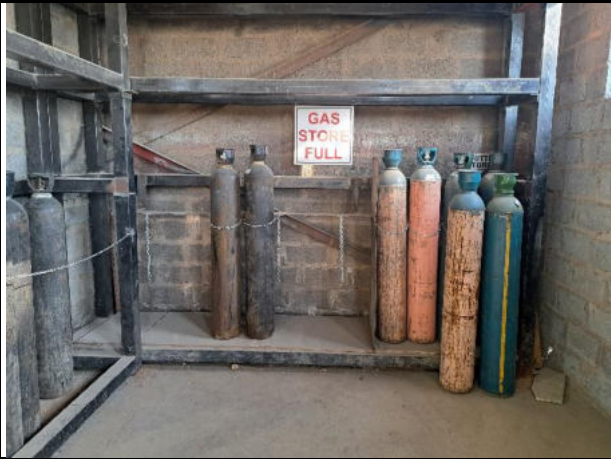
Gas bottles neatly stored

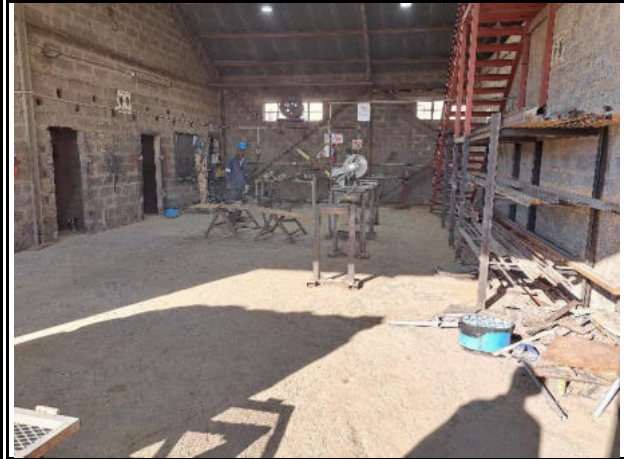
Workshop neatly managed

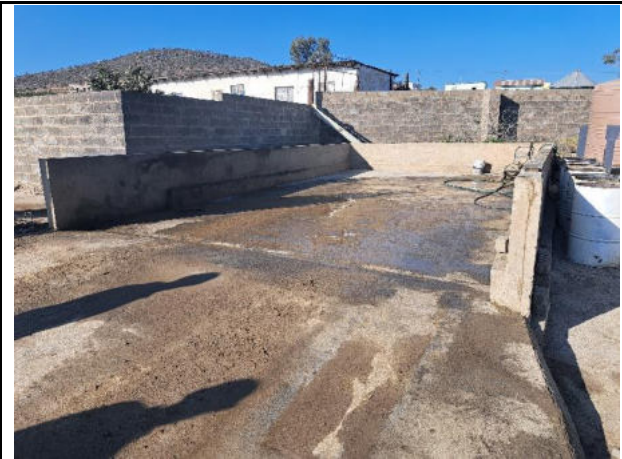
Wash bay neatly managed

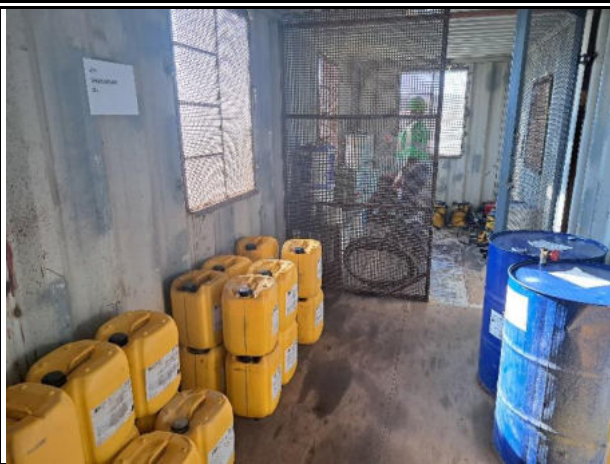
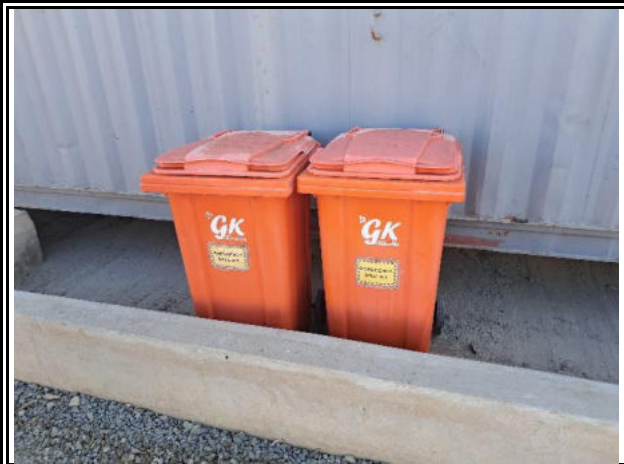
Oil store with oil spill kits

The oil store (under the offices) must be bunded. Presently the floor of the container allows spills to seep into the soil. Management of the oil store must improve. Further to this, the oil trap at the service pit must still be directed to an oil sump or tank and may not be allowed to drain into the surroundings. All spills caused in this area must be cleaned and the soil must be treated as hazardous waste.

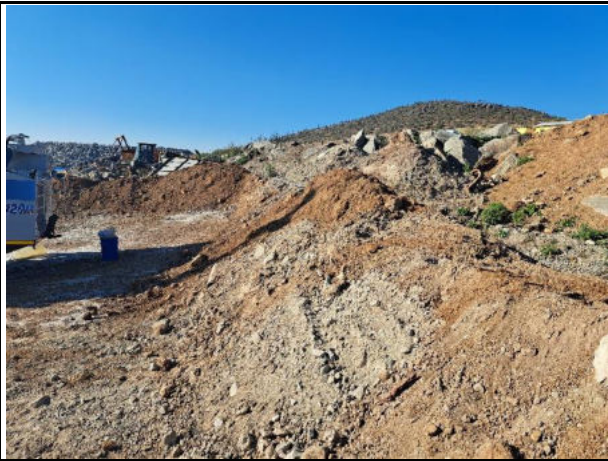
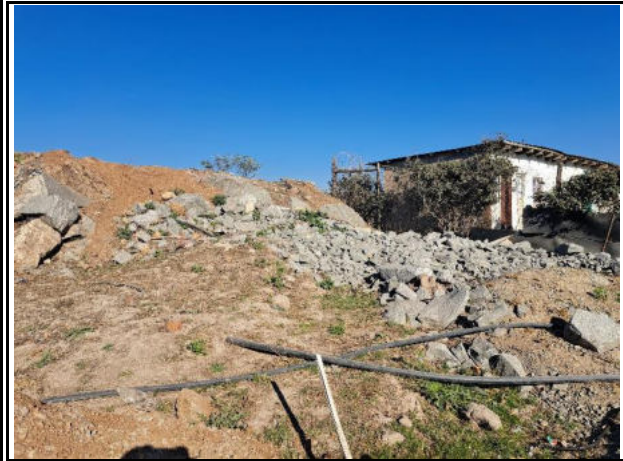
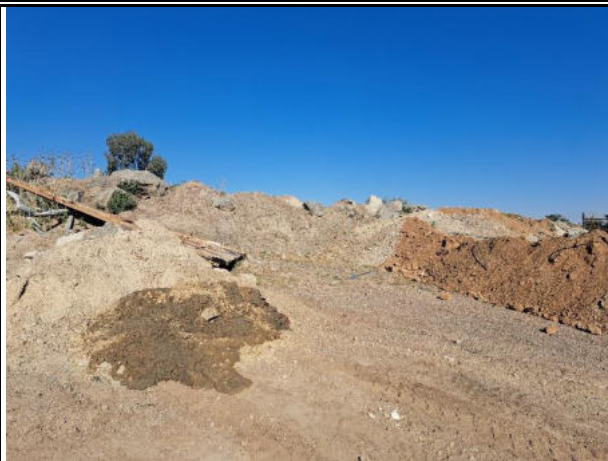
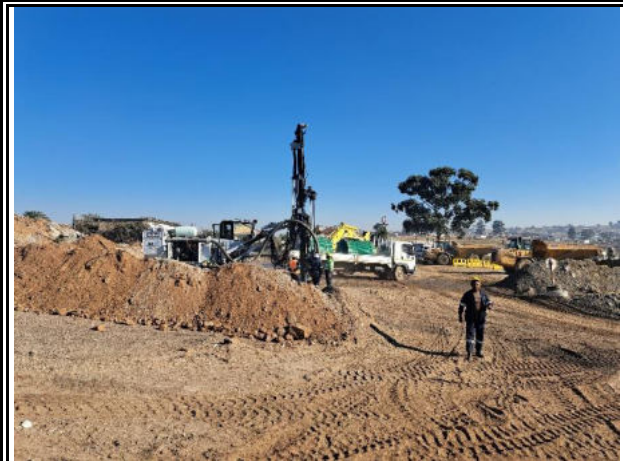
Litter and problem plants removed from the berms along the salvage yard

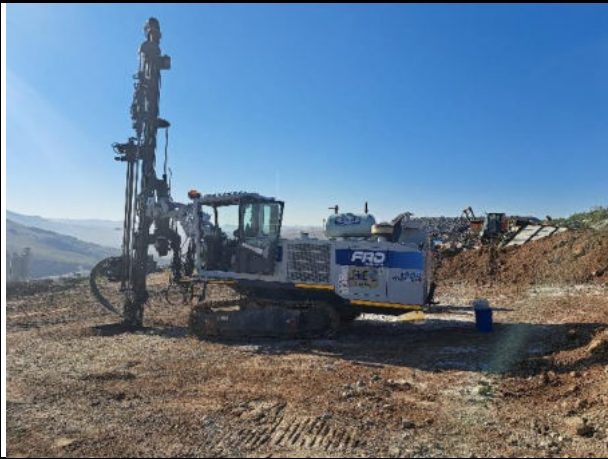
Spills to be cleaned and drip trays of adequate size to be used

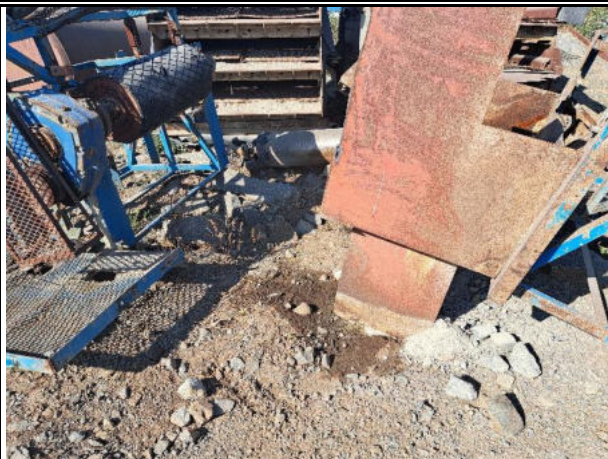
Equipment causing hydrocarbon spills to be removed from the salvage yard and spills to be cleaned

All equipment that may cause hydrocarbon spills must be removed from the salvage yard to banded areas with impermeable surfaces.

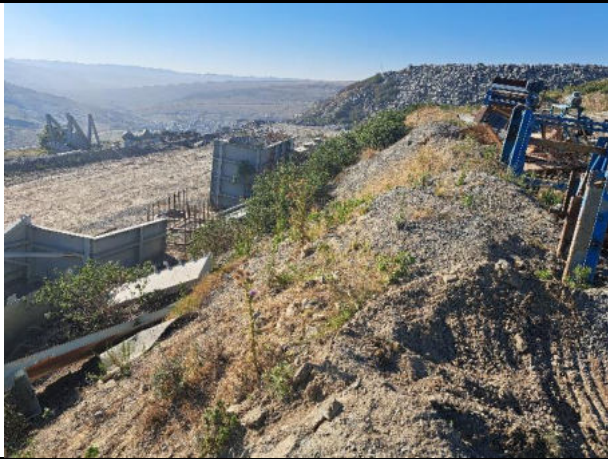
Problem plants (Lantana) to be removed from berms

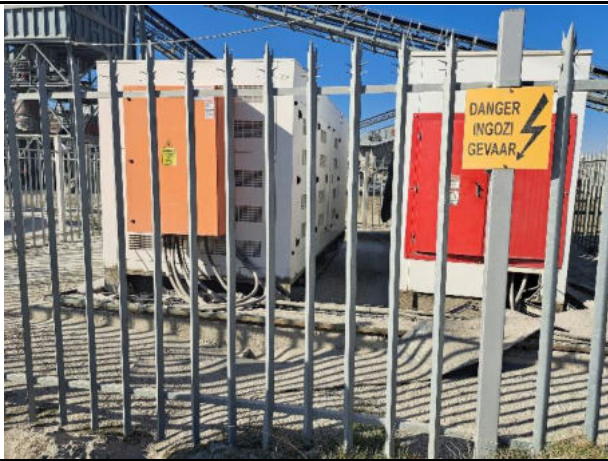
Generators to be fitted with bund walls

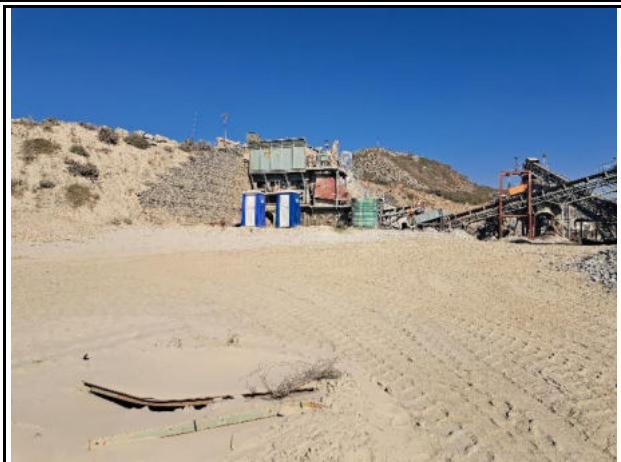
Chemical toilets at the processing plant

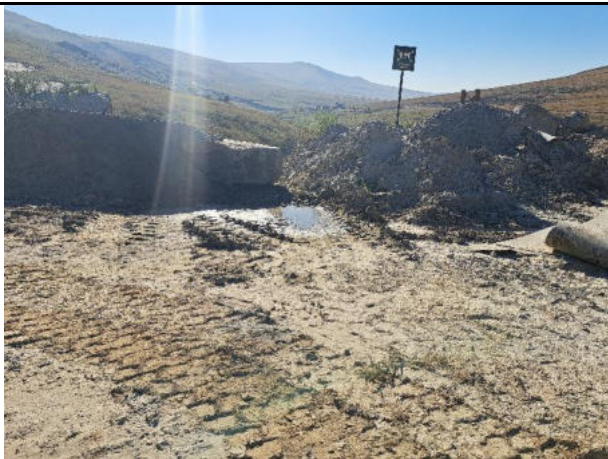
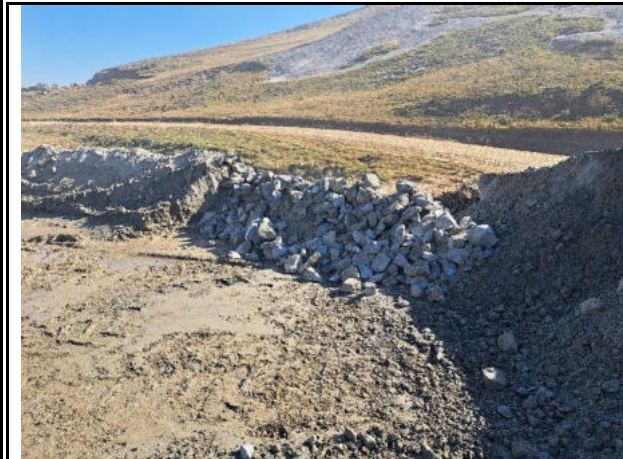
Gabion stone added to berms that acts as sediment trap

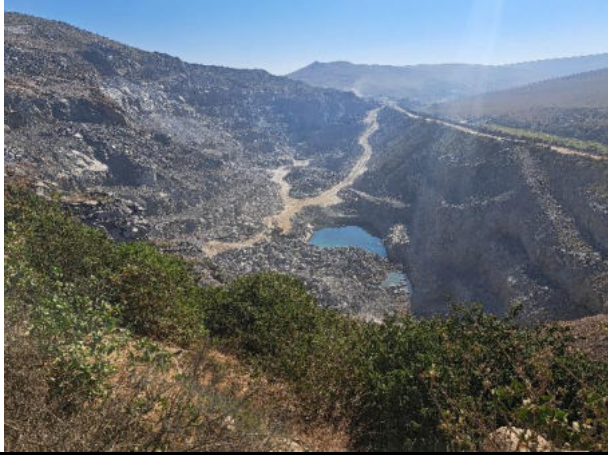
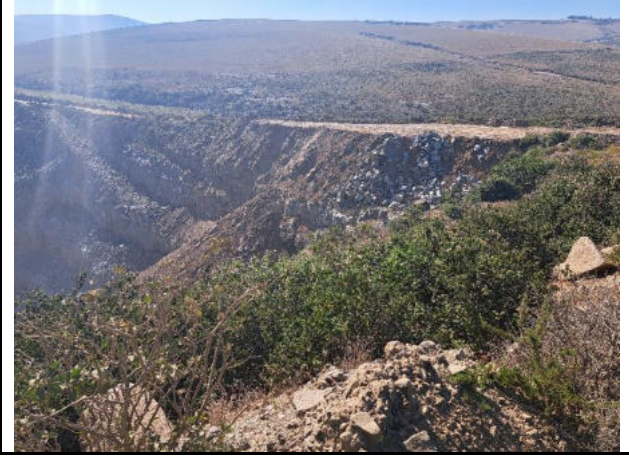
Quarry pit with progressive rehabilitation visible in right picture

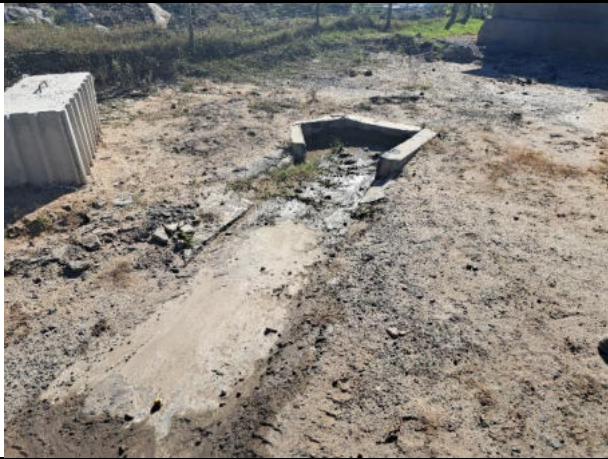
Stormwater drainage to be controlled on site

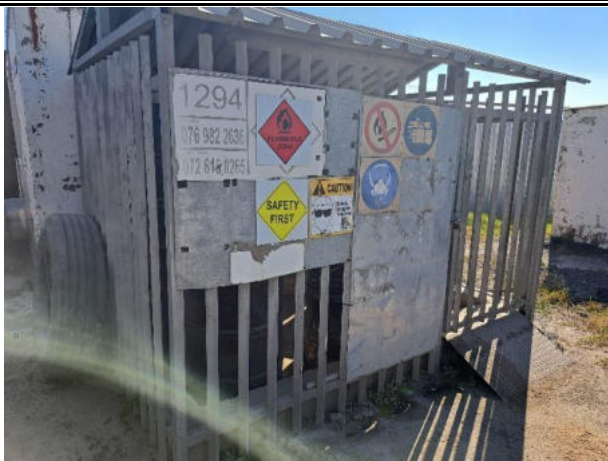
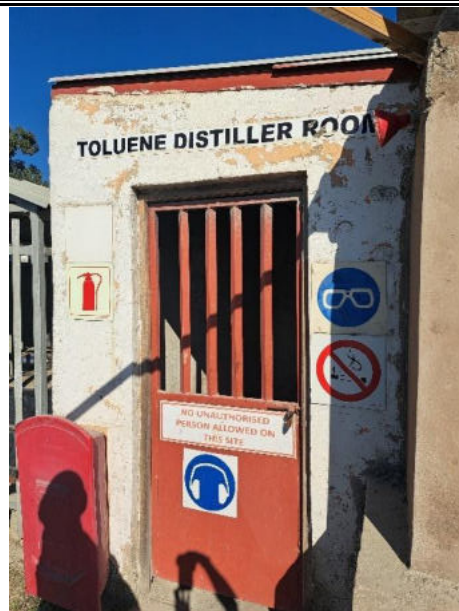
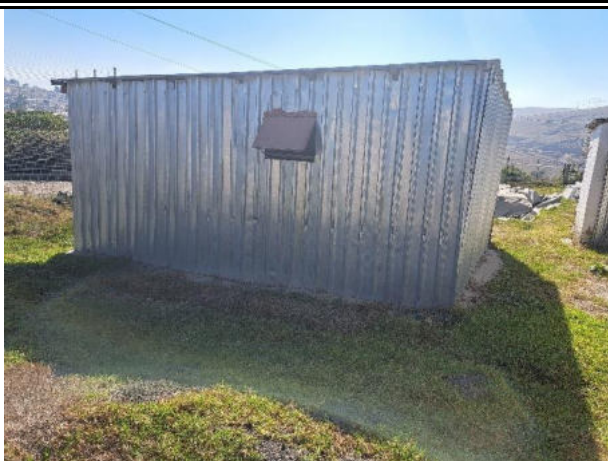
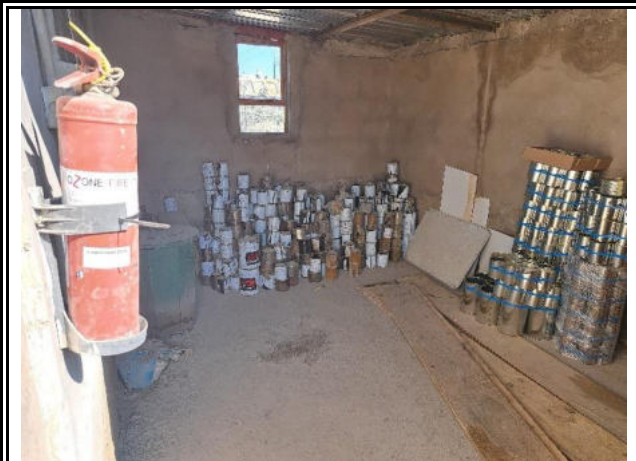
Bunds to be improved

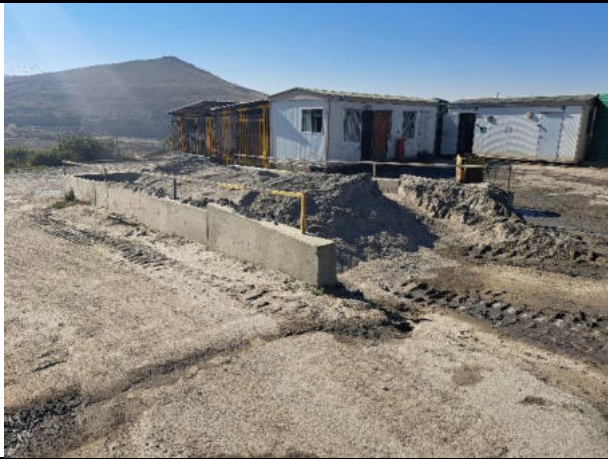
Improvements made to the bund of the generators. The bund must still be cleaned and sealed

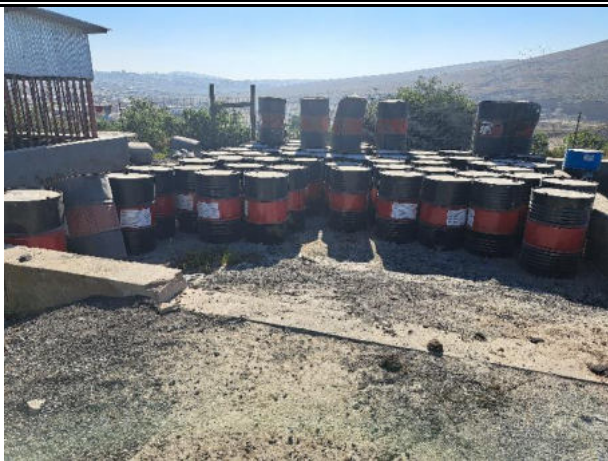
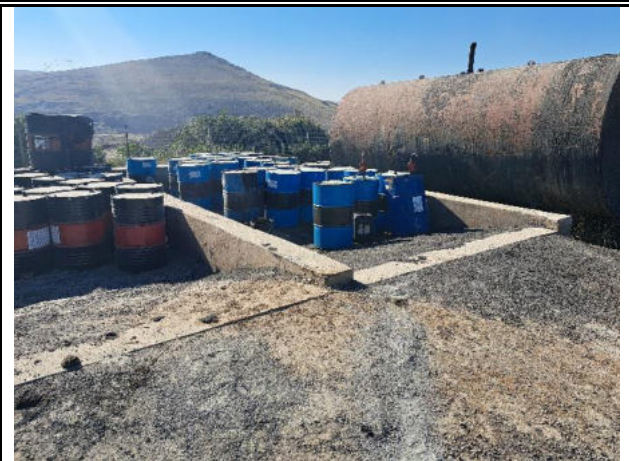
Bitumen products contained to a bunded area

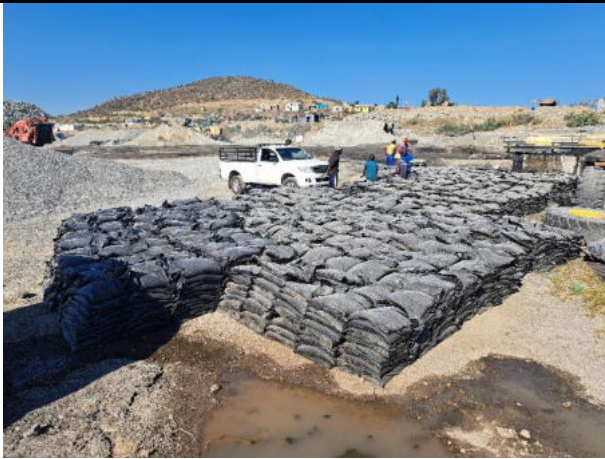
Spills to be cleaned (right picture)

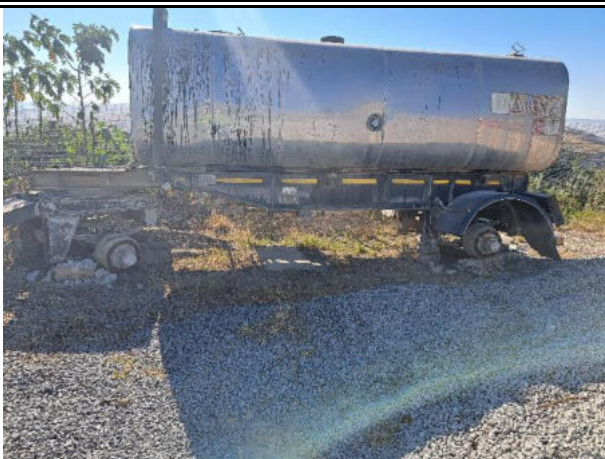
Tanker to be removed from site

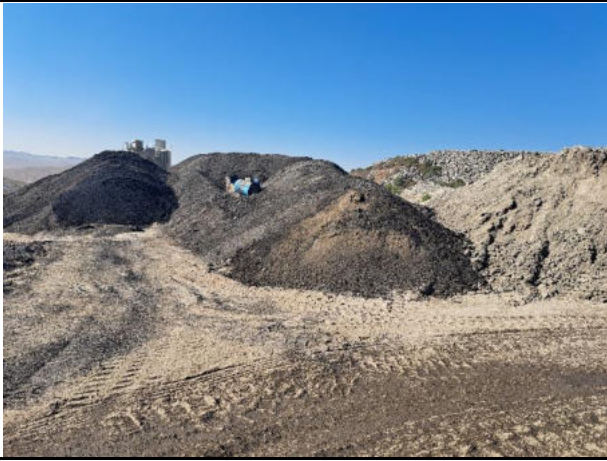
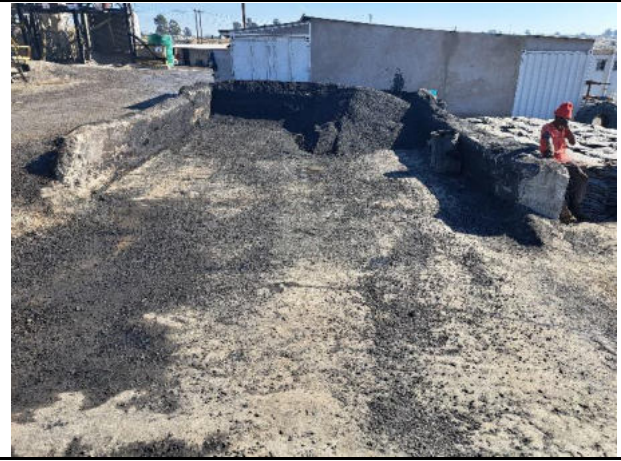
Old bitumen and contaminated soil contained to be reused in asphalt process

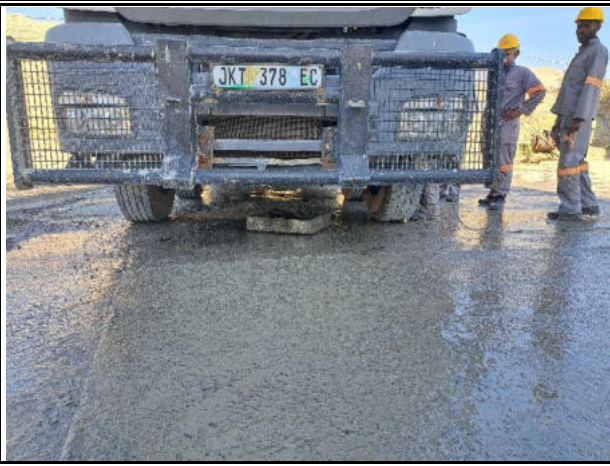
Drip trays in use

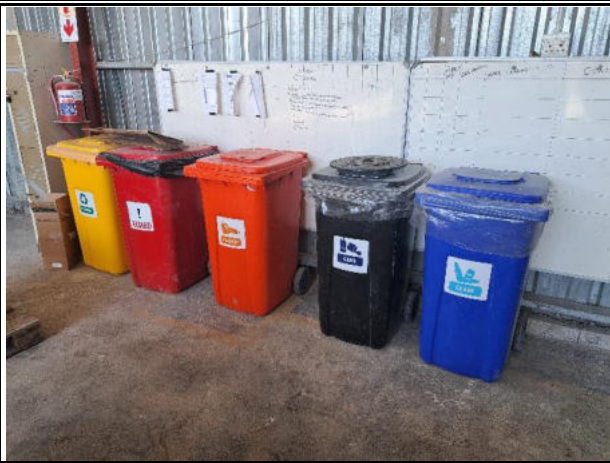
New refuse bins obtained

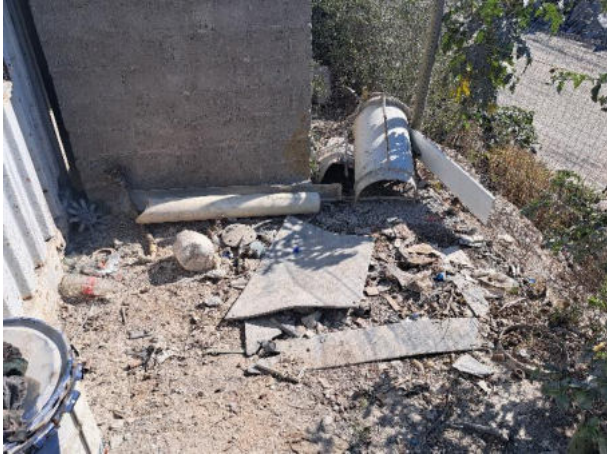
Litter to be cleaned

ECA contracted a service provider to remove the general waste from the site to the municipal landfill site. This service provider also supplied the site with new refuse bins. Mixing of general- and hazardous waste must be prevented, and all drums must be demarcated for either General Waste or Hazardous Waste. The litter between the offices and the fence line must be cleaned.

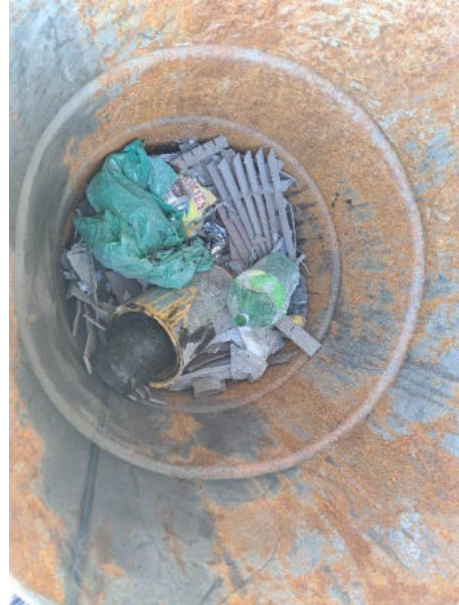
Mixing of waste to be stopped
